**Assessment of Soil
Cracking & River Bank
Slumping in the Lower
Murray**

Part 1 Report

REV C

November 2008

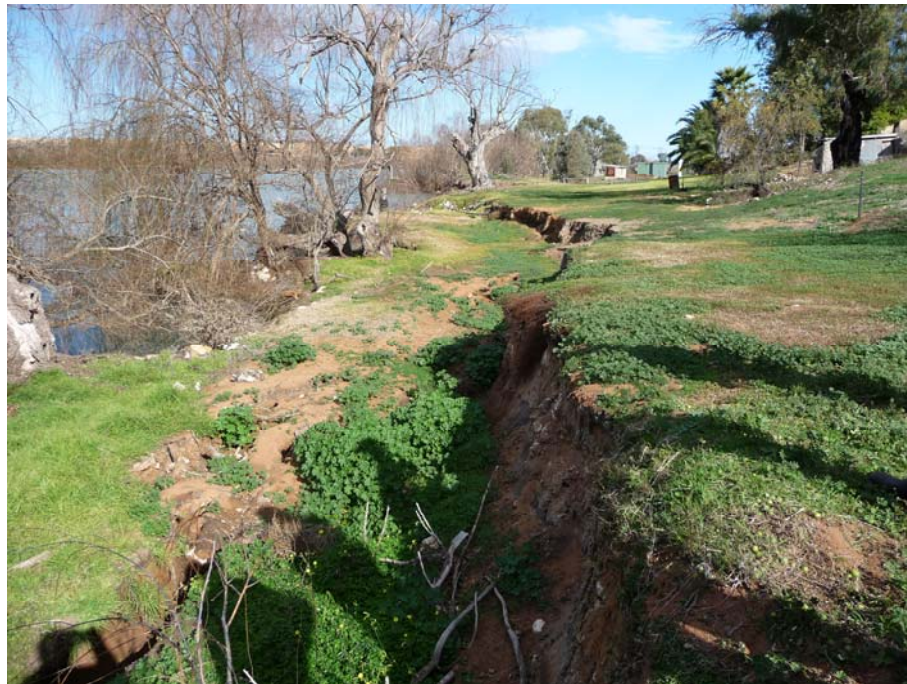
6.1 Jaensch Property

This property is at the north end of Toora Irrigation Area. Approximately 50m of bank has slumped by about 1m and has stayed largely intact. The section is about 4m wide at the widest point. A short section of willows remain within the slumped part.

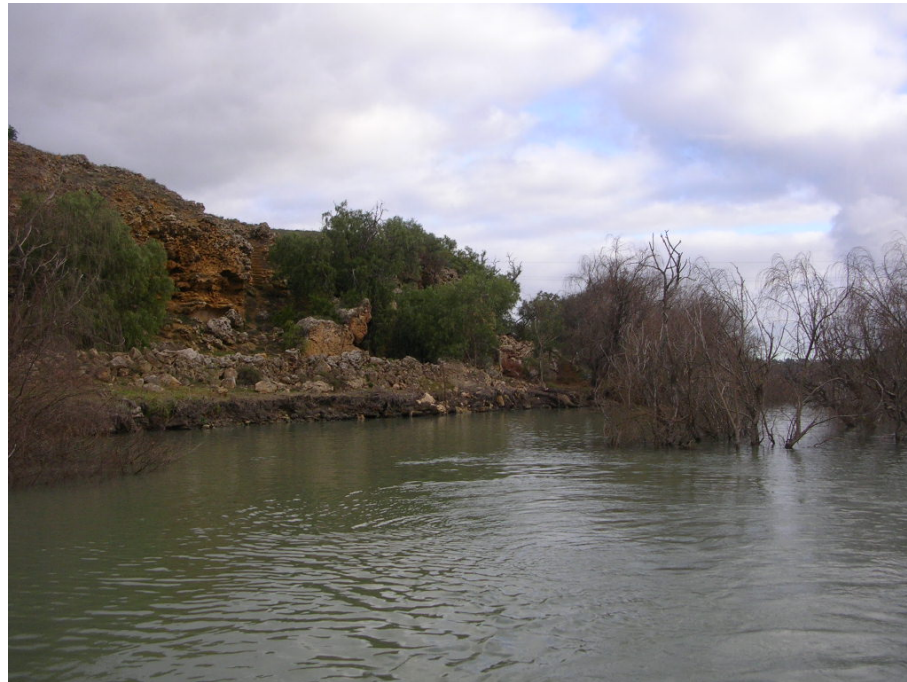
6.2 Avoca Dell

This site is practically opposite the Jaensch property and is at the base of low cliffs at the northern end of Avoca Dell reserve. Similar to the Jaensch site, about 30m of bank has slumped, remained intact and continues to support willows. The slumped section has moved away from the adjacent cliff forming an “island” and it is apparent that vessels have attempted to enter the newly created channel

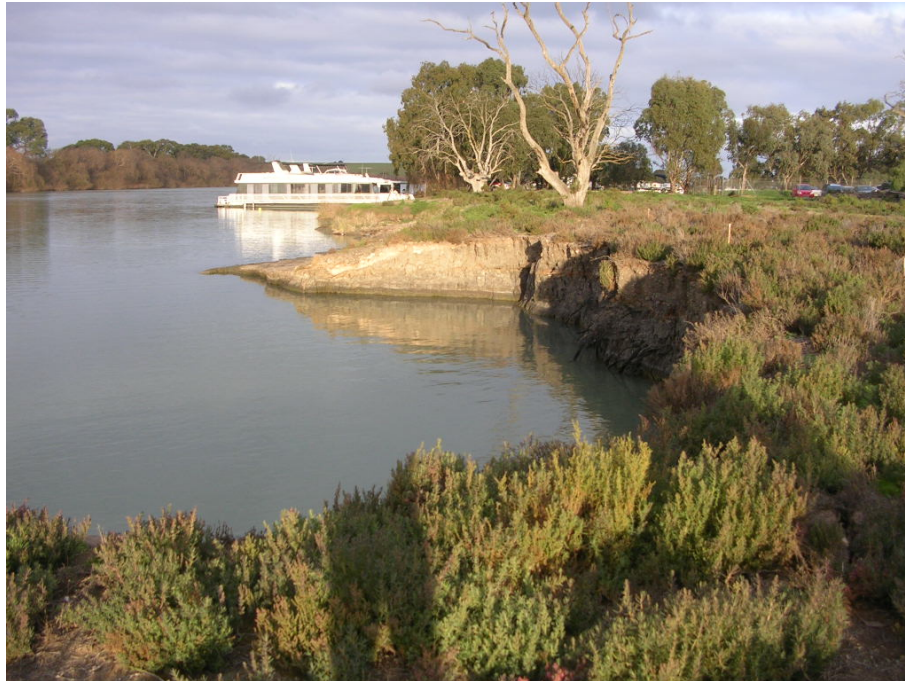
6.3 Long Island Marina

About 30m of bank has slumped penetrating up to 5m into the pre-existing alignment and the slump mass has largely disappeared. The adjacent banks and the eroded face we judge to have been filled ground. We understand that observations at the time of the movement were that tree stumps and other logs floated away with the slump mass. We understand that there is a sewerage pressure pipeline near the edge of the recently formed bank.

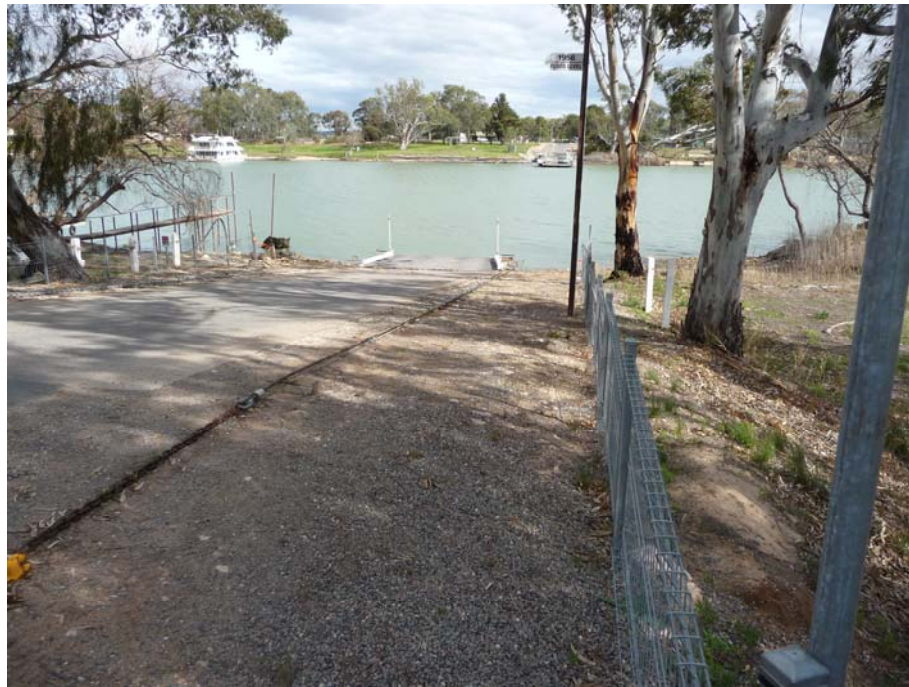
6.4 Walker Flat

Adjacent to and downstream from the Walker Flat ferry crossing on the right bank is a reserve with amenity grassed area and small boat mooring. There is a houseboat mooring downstream from the small boat mooring.

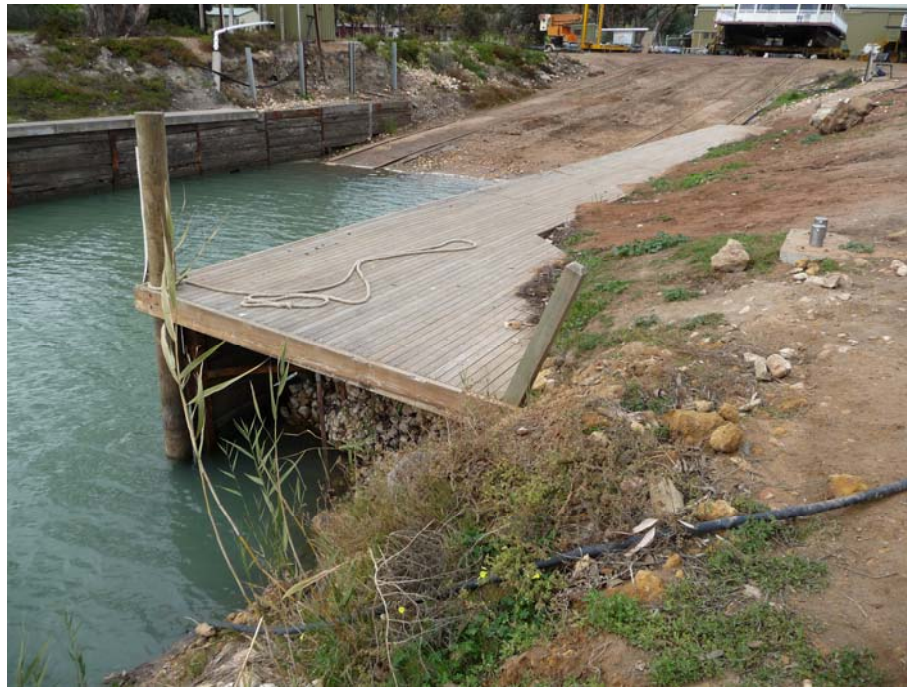
6.5 Houseboat Concepts Slipway

The houseboat construction site is adjacent to Kia Marina at Younghusband.

Houseboat Concepts has remedial action planned.

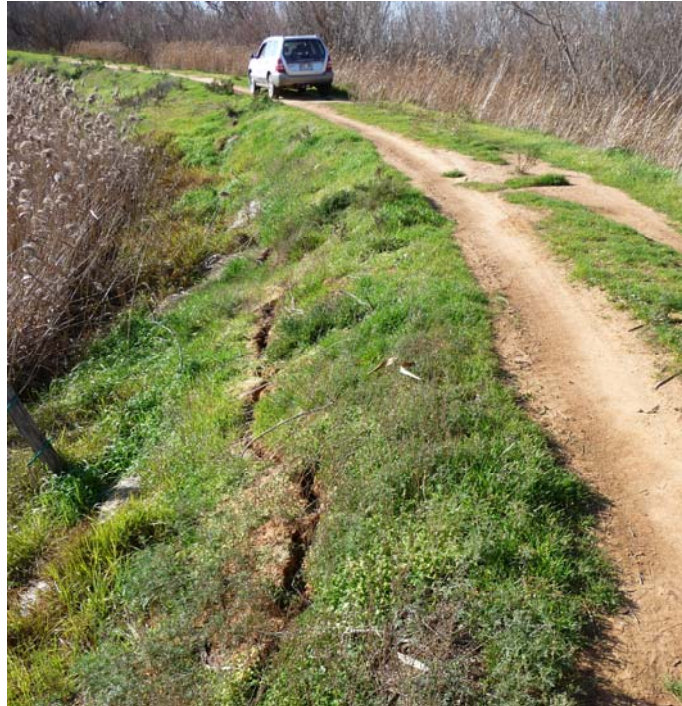
7.1 Mobilong

This irrigation area has been retired although water remains in the drains, possibly from seepage from the Preamimma Creek diversion works at the rear of the reclaimed area, from adjacent (un-irrigated) highland or from stormwater.

The levees have longitudinal cracking extending over at least 50% of their length. There is limited cracking of the inside face. Despite the cracking, vehicle access remains possible although the levee is narrow at the south end.

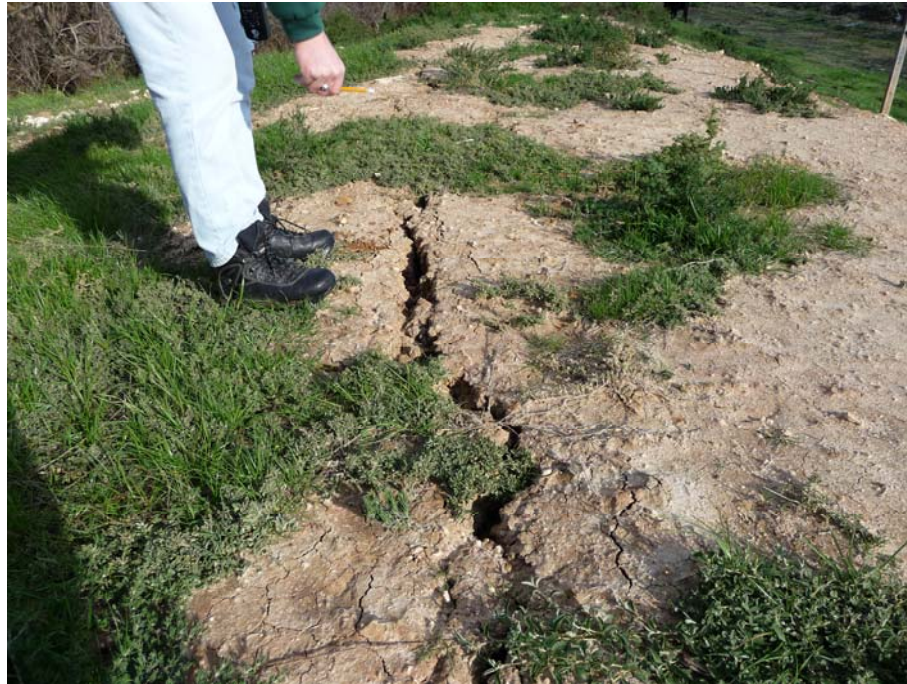
7.2 River Glen

The levees at River Glen are a mixture of red clay construction at the north end and black clay at the south end and are in poor condition with extensive longitudinal and inside face cracking. The bank faces are generally 1 horizontal to 1 vertical which is far steeper than would be considered good practice for permanent water retaining structures. Vehicle access is not possible.

These levees will require close observation when the river levels return to levels that will allow irrigation to recommence. It cannot be accurately predicted how raising of the water table within the levees will affect stability. If a high river flow were to occur such that the banks were overtopped causing water to wet the outside face of the levees, their integrity might be threatened. Any overtopping of the levees themselves is likely to cause breaching in many places.

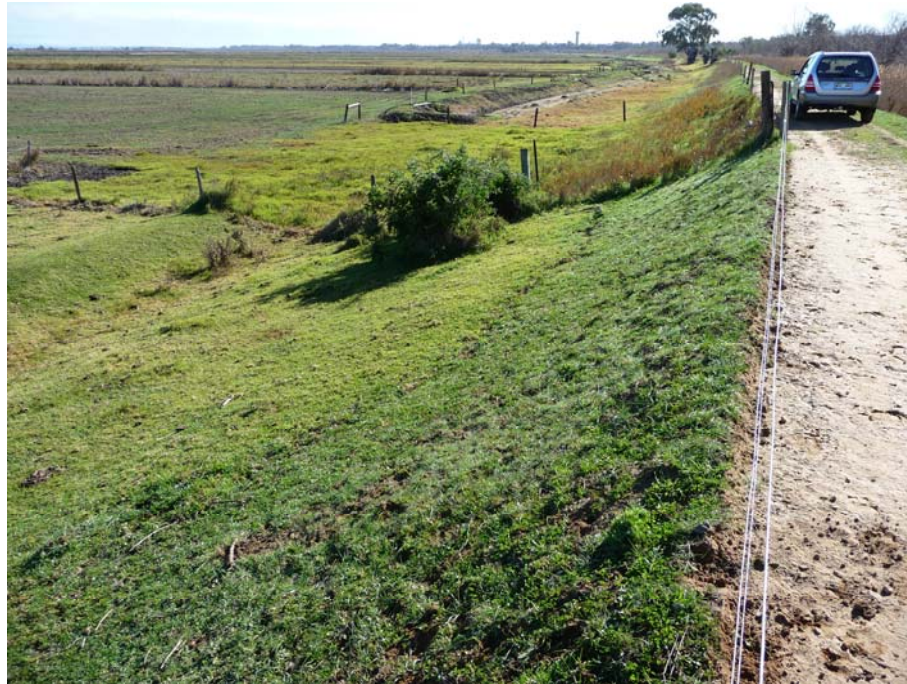
7.3 Jervois

While it appears that the levees at Jervois have been maintained over time, their extent and localised cracking poses a threat to the whole area. A breach or series of breaches would result in temporary loss of the area at least to one side of the causeway to the ferry. Breaching is only likely if a high river event occurs resulting in overtopping of the levees.

Limited reshaping and topping of these levees could be considered. Even restricted repairs would be expensive but might be judged worthwhile given the extent of the area and the existence of other dairy-related infrastructure investment.

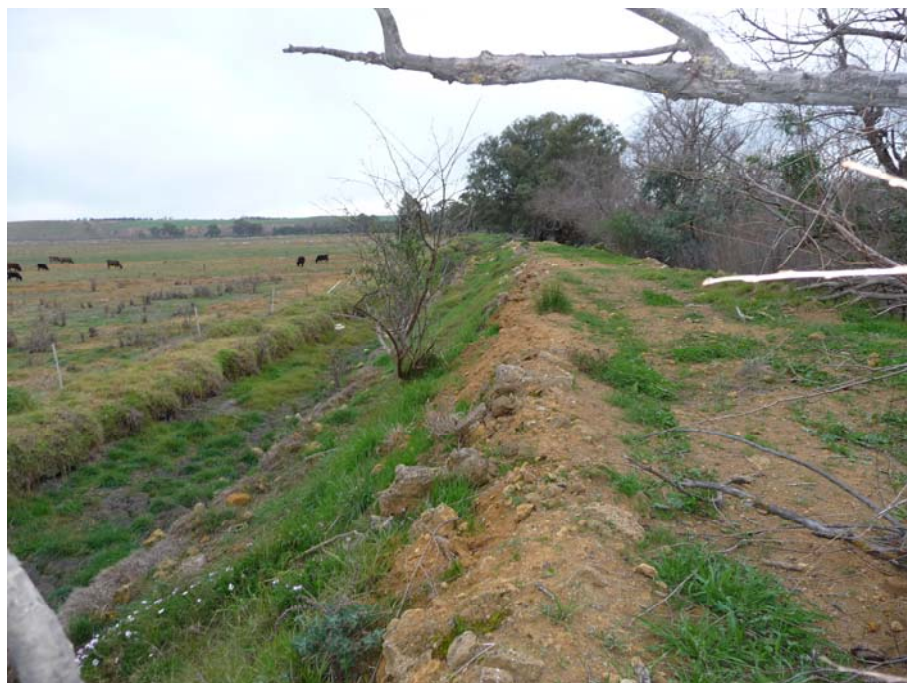
7.4 Glen Lossie

This irrigation area can be characterized by the history of ownership. There are 3 current owners. The north end is in generally good condition with levees constructed from black clay and reasonably well formed.

The centre portion has not been watered for several years and has the appearance of being neglected. Its singularly good feature is the condition of the levee. It is a remnant from the early period of construction when local black clay was used and placement and compaction was provided by animals and form was decided by following the shape of natural levees. It is deficient to the extent that it would not withstand overtopping. The raising that has taken place is very poor being only 0.5m wide and poorly levelled.

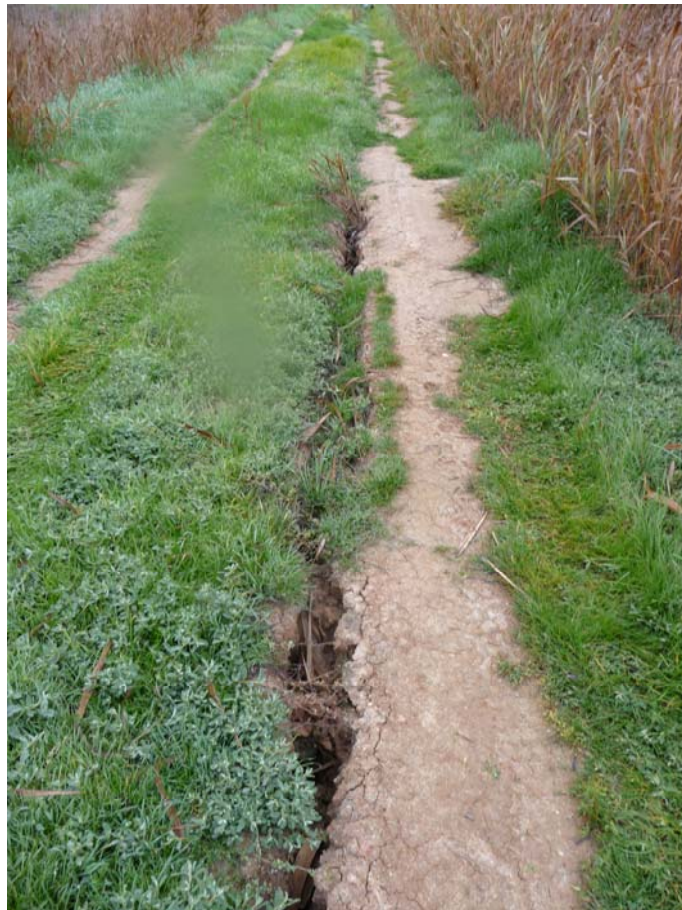
7.5 Monteith

There is extensive cracking and very poor formation of the levees at Monteith. We understand that this irrigation area is notable for a history of bank cracking. Maintenance over time has resulted in graded windrows spilling from the crest forming steep inside and outside bank slopes. Vehicle access remains possible.

We judge that the banks would continue to be functional with a river level returned to pool and fluctuating with regulated flows. A high river event that resulted in the levees overtopping would most likely result in major breaches and temporary loss of the area.

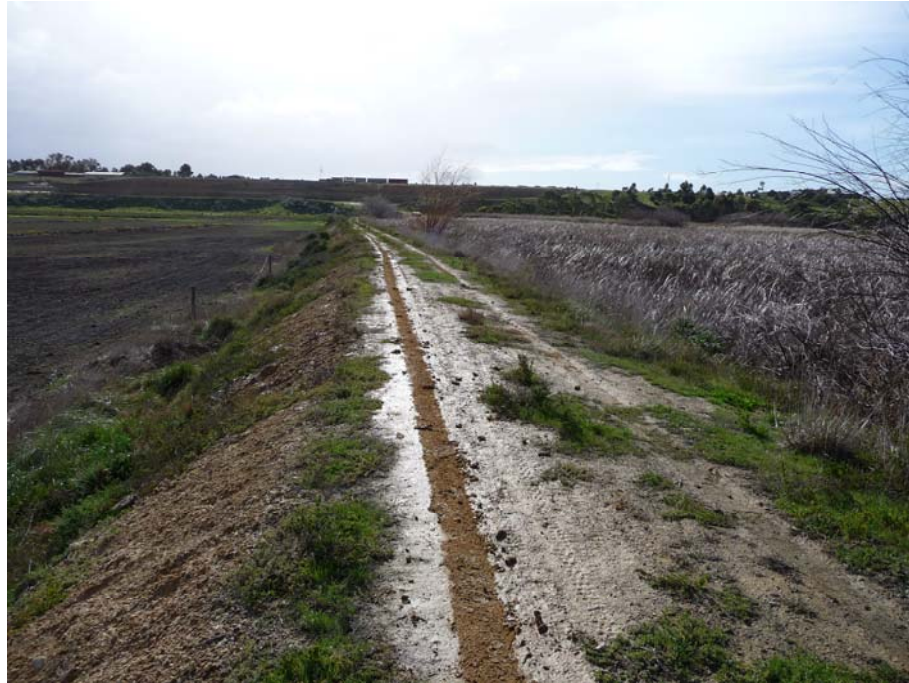
7.6 Westbrook

Westbrook is a small irrigation area between Murray Bridge and Tailem Bend. The banks are generally well formed although the side slopes are steep. There is no extensive cracking of the levee but the causeway at the south end is cracked and in poor condition. There is wetland to one side and reclaimed swamp to the other, the formation has a narrow crest and vehicle access is poor in wet conditions.

The integrity of the river levee and the causeway does not appear to be threatened by a return to pool level and fluctuation due to regulated flows. A high river event that overtopped the causeway could result in breaching and temporary loss of the area.

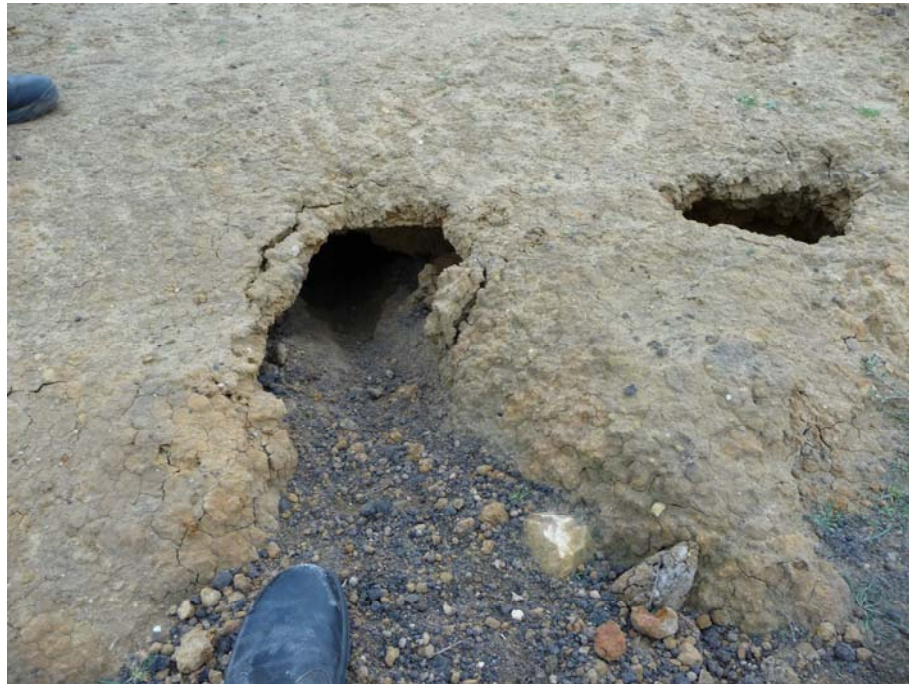
Vermin Holes

We observed a number of vermin holes in the levees and on several occasions saw foxes and rabbits on the reclaimed irrigation areas. The most spectacular vermin holes were near the southern end of Glen Lossie and appeared to be a warren of fox holes. These had penetrated deep enough for spoil from the original black clay core to be exposed on the newer red clay surface. We also observed ant action on the levee banks at various locations.

DWLBC have advised that regular fox baiting and rabbit control programmes, amongst other pest management practises, has been undertaken on the public levees for the past 4 years. The extent to which this has extended to the private levees is unknown however DWLBC suspect it is limited.

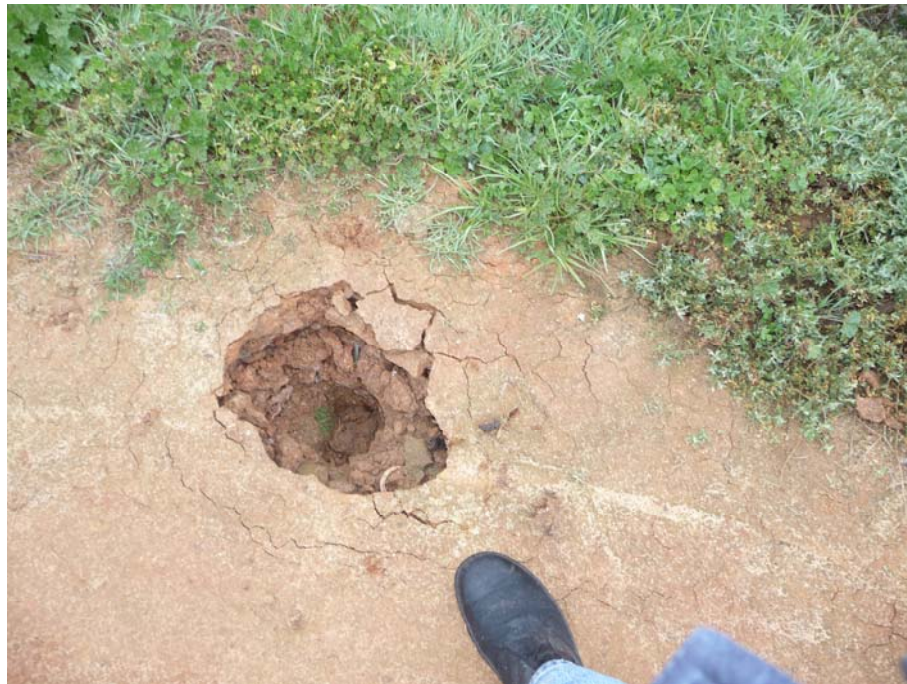
Dispersion / Crab Holes

Dispersion is triggered by accumulation of fresh water in the soil. That accumulation can be periodic. We noticed a trend of crab holes (the product of dispersion) occurring in the wheel tracks along the levee crests. We presume that even slight rutting is allowing water to pond at times and facilitating dispersion. The effect was noticeably less marked where the levees had a crowned crest, or as at Wall Flat a constructed road pavement at the crest. It may be sensible to adopt suitable crest treatments during future maintenance works, subject to appropriate Health and Safety protocols.

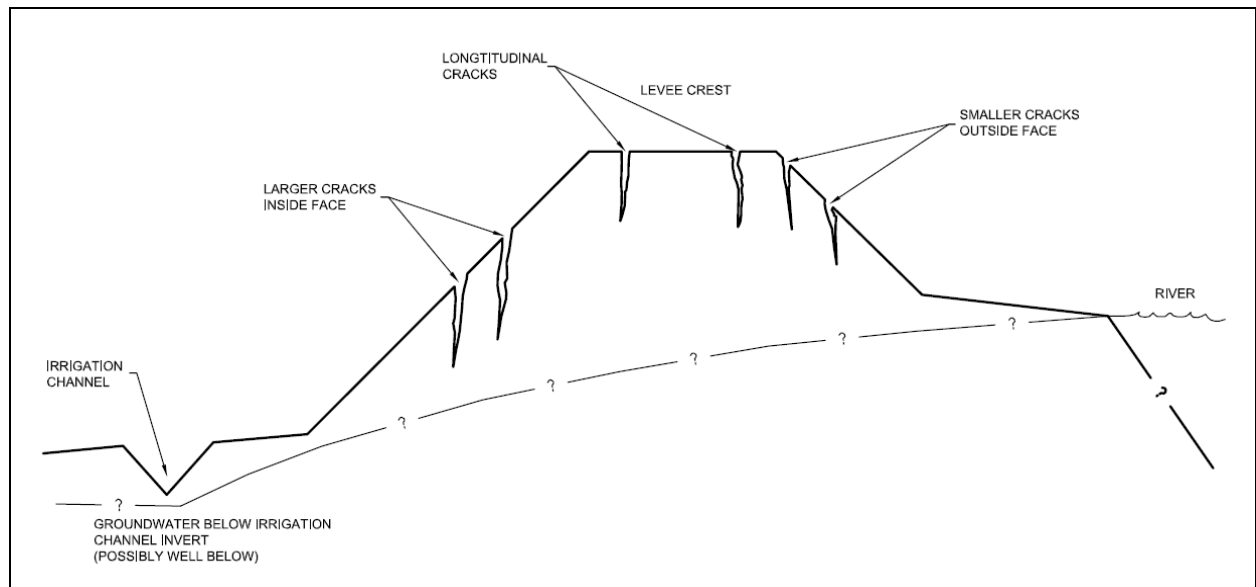
Figure 2 Levee At Present (typical)

This will lead to an overall tilt of the ground – including the levee shoulders - and cracking in the upper surface of levees and shoulders.

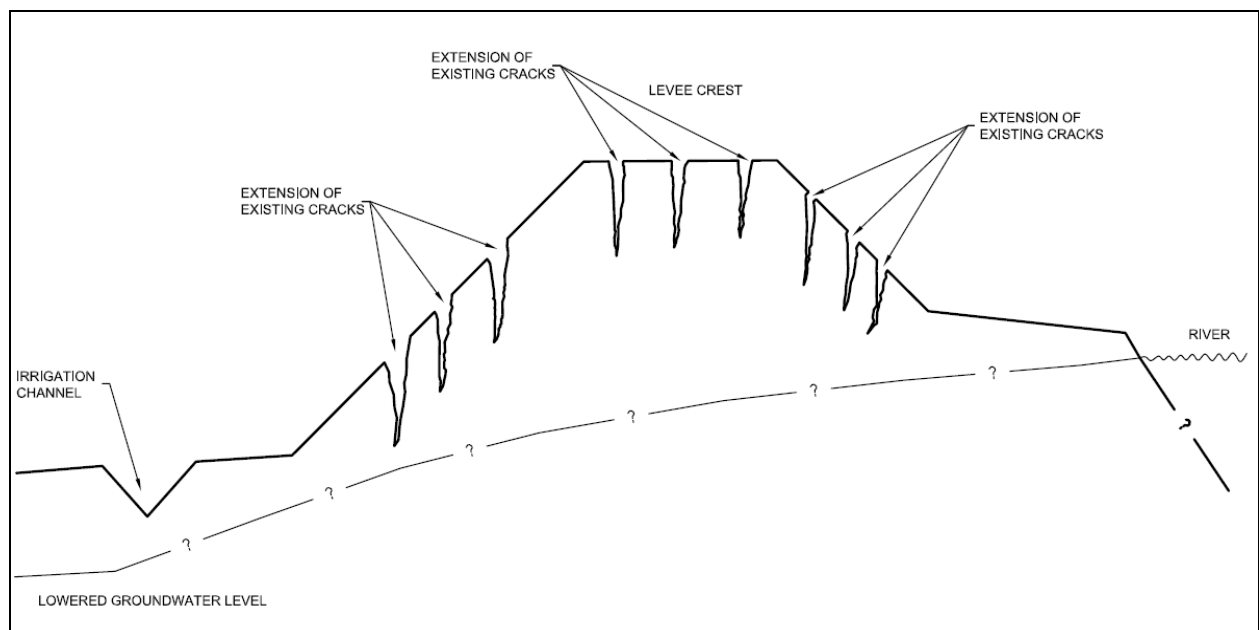
Figure 3 Lowered Water Level

In a few places we observed apparent slumping of the inside face, where we infer that the cracking has extended close to the toe of the bank, allowing a section of the soil to fall (refer Figure 3). However, this is relatively rare and we could not be sure that this had happened as a consequence of the reclaimed irrigation area's settlement.

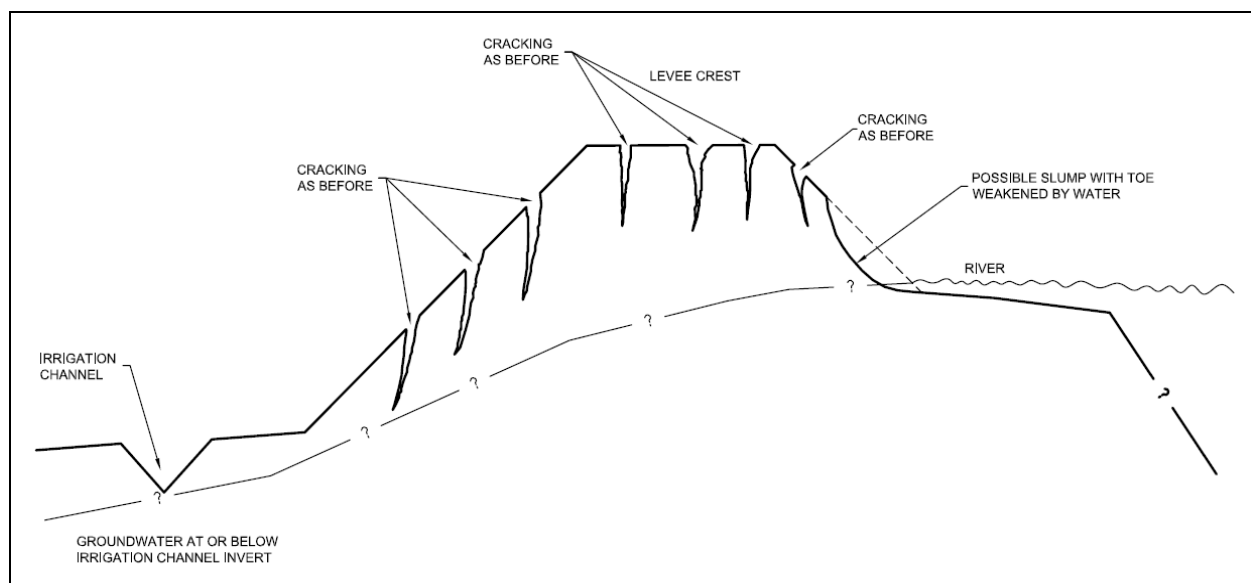
Figure 4 Restoration of Pool Level

We conclude that there is little reason to expect breach of the levees if pool level and regulated conditions are restored (refer Figure 4). We recommend that contingency planning be put in place to detect and repair the slumping of the outside bank that we expect to accompany such restoration.

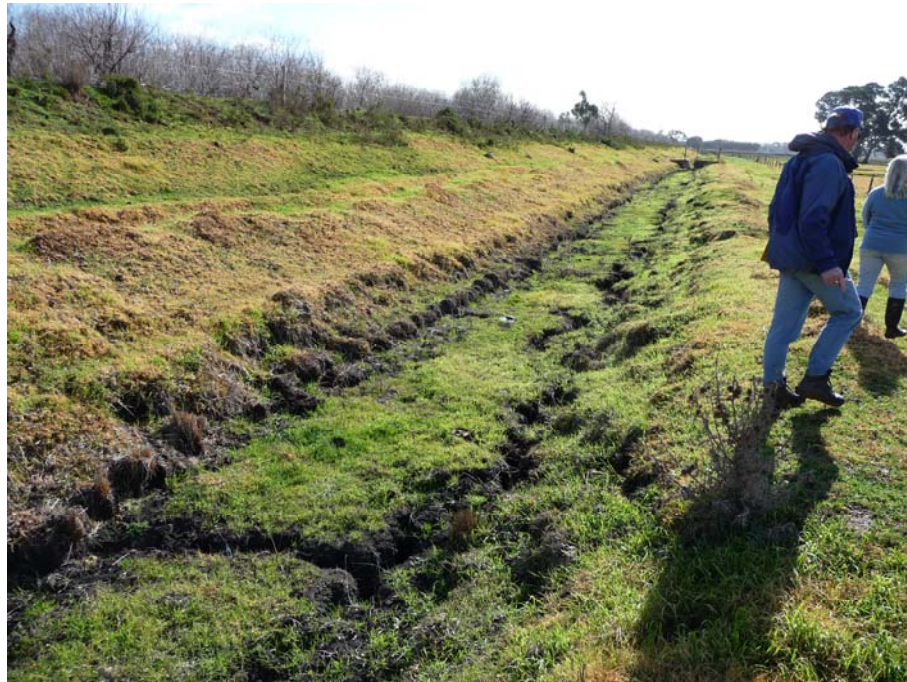
Lowering of water level within soils containing organics – as the soils of the reclaimed irrigation areas do – carries the risk of activating acid sulphate soil conditions. We have been informed by Tim Seeliger at Toora irrigation district that this has occurred already on his property; a verbal water quality result taken from a crack in a Toora paddock reportedly has pH 4.5. We have not been advised of, nor did we observe, any other cases. Notwithstanding it is therefore possible that acid sulphate conditions have already or will develop in some other reclaimed irrigation areas.

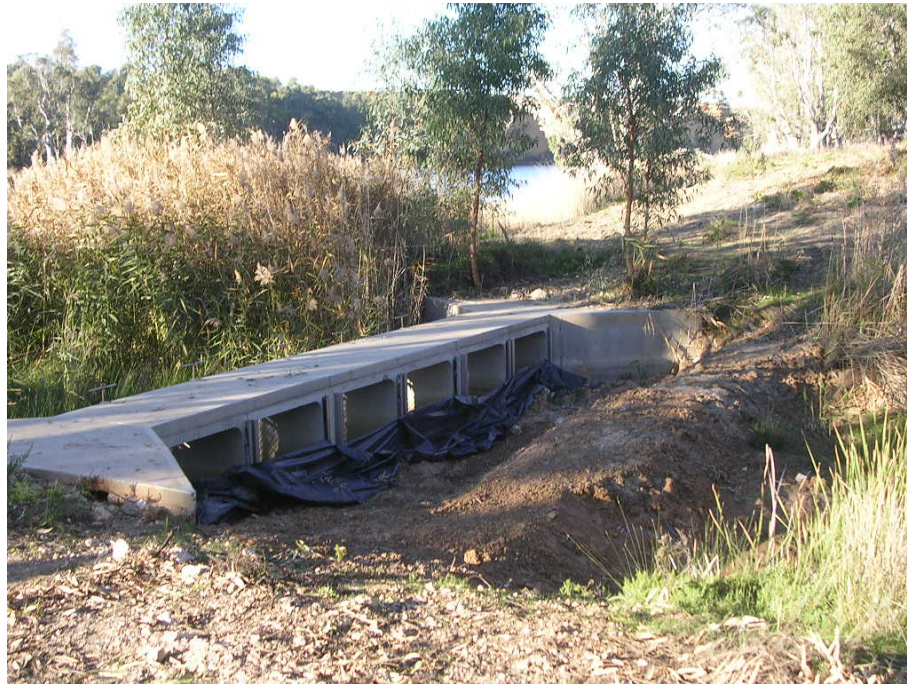
9.1 Morgan's Lagoon

The structure comprises 6 bays of culverts set into a concrete base slab, topped with a concrete slab and has wing walls both sides projecting at approximately 45° with a concrete slab continuous with slab over the culverts. There are trash racks to the river side and stop log grooves on the wetland side.

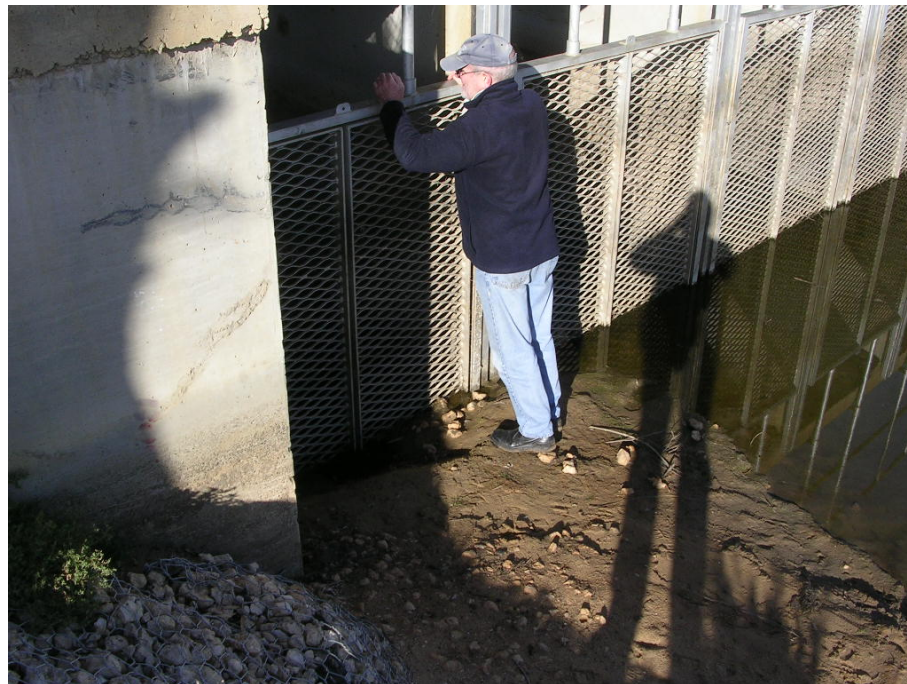
9.2 Avoca Inlet

The structure comprises 4 bays of culverts presumed to be set into a base slab and capped with a concrete slab. The abutments comprise a facing slab and short wing walls either side. There are trashracks on the river side with a manual rotation system consisting of 2 baffles for each culvert bay.

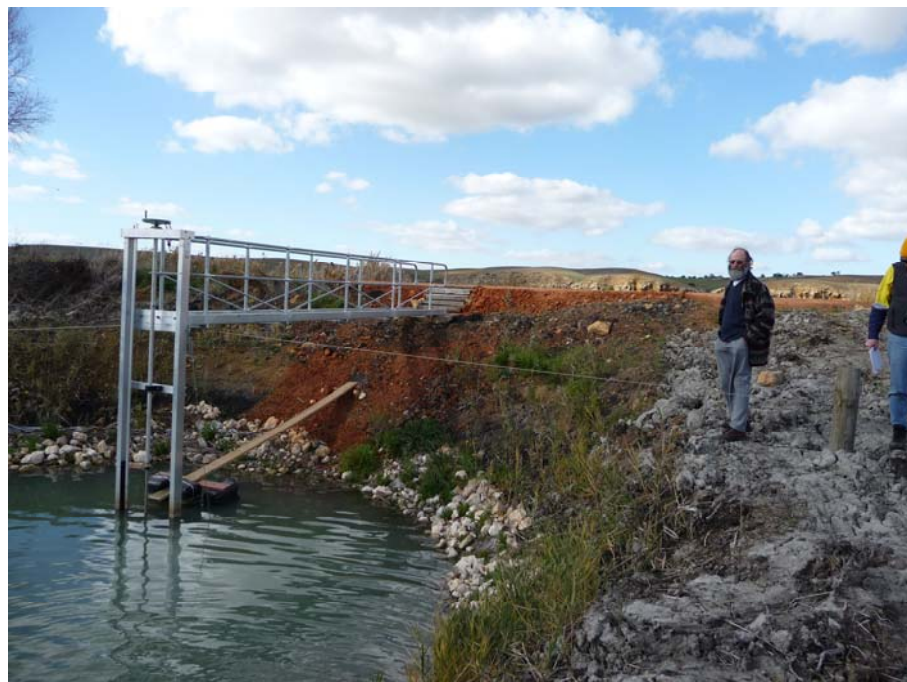
9.3 Paiwalla Wetland

The Paiwalla Wetland control structure comprises a submerged pipe through the embankment with an upturned bellmouth in the wetland and a handwheel operated sluice valve at the river side. The sluice valve operating mechanism which incorporates a linear position indicator, is accessed by a walkway bridge extending from the levee, braced by cables attached to piles. There is a floating boom across the inlet channel to protect against floating debris and to discourage mooring in the channel.

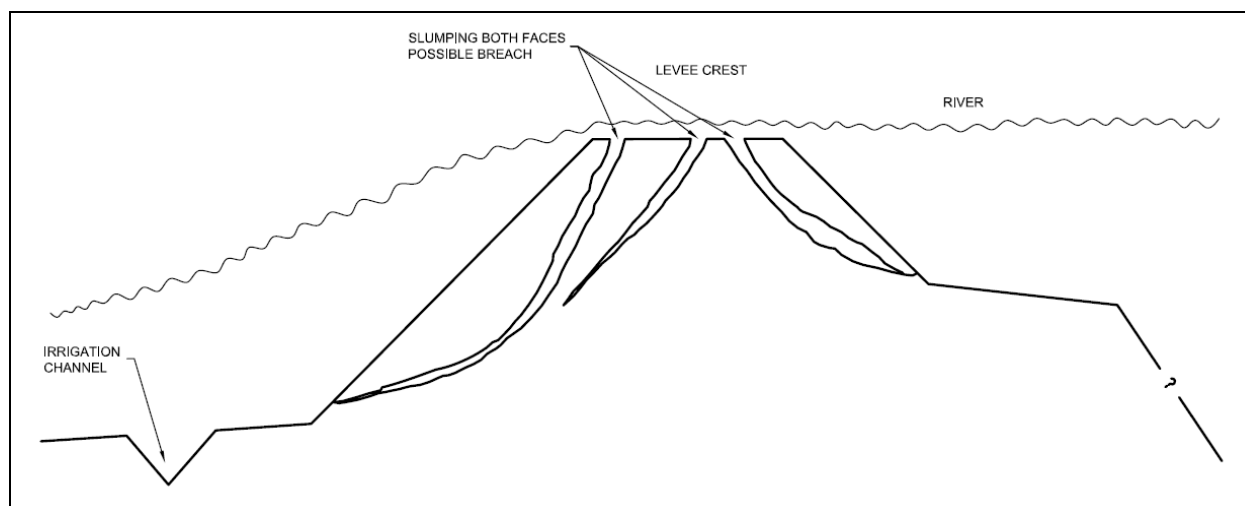
Figure 5 High Flow Event

Incidentally any breaching or overtopping of the levees, whether this occurred before or after the current conditions, would result in potentially significant quantities of water gravitating to the irrigation bays or retired land, depending on its location.
