Mr Richard Brown
Manager, Riverbank Collapse Hazard
Department for Water
GPO Box 2834
Adelaide SA 5001

LowerMurray_CalooteRiskAssessment_Final_20101111.docx
VE23346.10

**River Bank Collapse Hazard - Lower River Murray
Stability Risk Assessment for Caloote Landing**

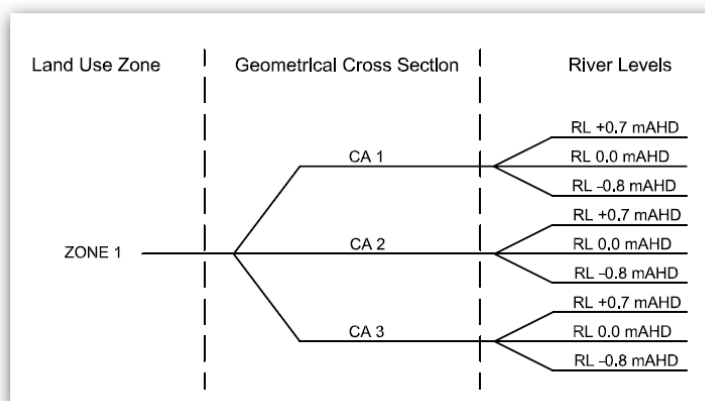
Figure 1 - Schematic Event Tree for Probability of Failure

The schematic event tree for the probability of failure has been presented in **Figure 1** below.

The slope stability models were run for each of the three riverbank slope geometries. The probability of failure of each section was then weighted by the likelihood factors presented in **Table 2** and summed to obtain the probability of failure in each zone (with each water level considered separately).

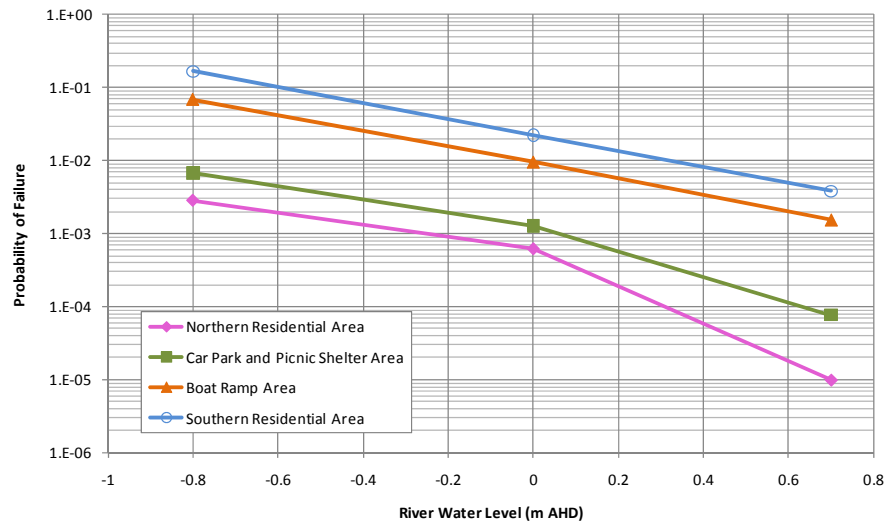
■ **Figure 2 - Probability of Failure and River Water Levels**

The results of the study have been summarised in **Figures 2 and 3** below, where it must be appreciated that the boundary lines between Risk Zones are indicative only.

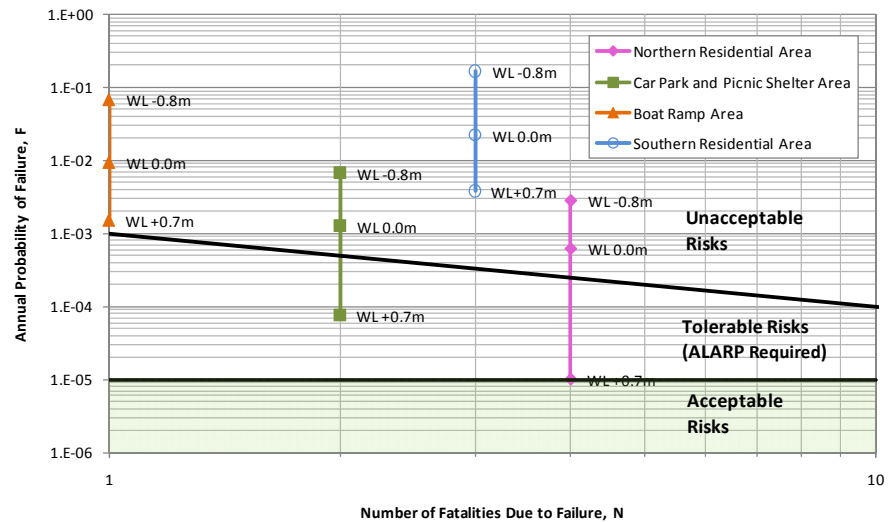
■ **Figure 3 - Comparison of Probability of Failure for Different River Water Levels at each Area with Tolerable and Acceptable Risks**

From **Figure 3**, it can be seen that for pool level +0.7m AHD, the car park, picnic shelter and northern residential area all fall within the tolerable risk zone and the boat ramp area is just above the tolerable risk boundary.

- The risk of failure at the Southern Residential Area is rated on **Figure 3** as unacceptable at all pool levels and the area should remain closed to the public as well as residents.

- The risk of failure at the Boat Ramp borders tolerable on **Figure 3** at pool level 0.7m AHD and rates as unacceptable at lower water levels. It is considered prudent that a practical form of local load testing be undertaken, using river water to apply a surcharge of water at depth 1m (total 10kPa) to simulate occupation loads of say 2.5kPa at pool level 0.0m AHD, in advance of formally reopening the boat ramp. Surcharging does not change the risk assessment described herein.

- The risks of failure at Car Park, existing Picnic Shelter and Northern Residential Areas are rated not acceptable for pool levels below RL 0.0m AHD at Caloote.

- The risks of failure at Car Park, Picnic Shelter and Northern Residential Areas are tolerable for pool levels above RL+0.0m AHD at Caloote. Mitigation requires application of ALARP principles. A suggested site design for managing access in these areas is shown in **Figure 6** attached.
