Study into River Bank Collapsing - Lower River Murray

INSPECTION REPORT

- Final
- 17 February 2010

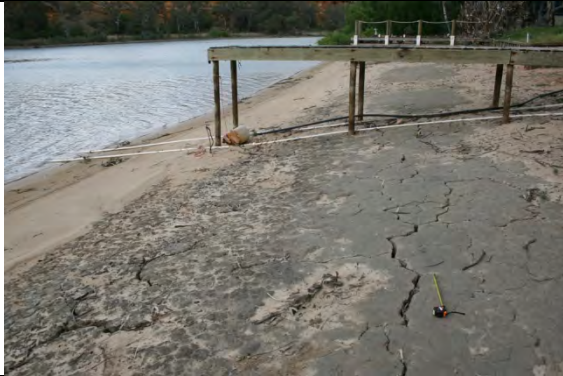
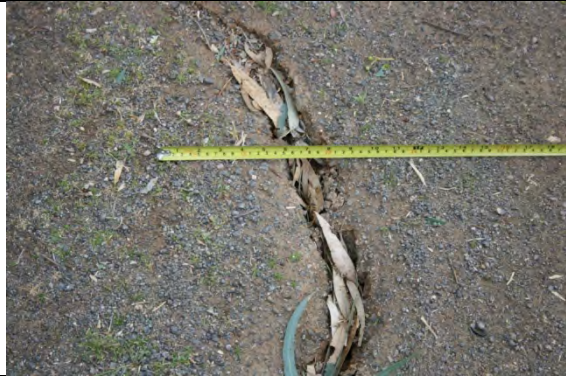
Incident Number: 32

Grey sandy clay with tension cracks.		Tension cracks in road leading to houses.			
Description of bank erosion problem					
<ul style="list-style-type: none"> Tension cracks noted in sandy clay exposed along shoreline [Photo ID 232 & 233]. Cracking also along road at back of houses [Photo ID 235, 236 & 237]. Road is located c.80 m from shoreline. Lateral movement of earth around house foundations [Photo ID 239], with movement in the direction of the river (c.2 cm). Slumping of ground (c. 4cm) also noted within the vicinity of paving tiles [Photo ID 240]. 					
Bank characteristics					
<ul style="list-style-type: none"> Low angle shoreline comprised of grey sandy clay with thin drape of pale sand forming veneer over the lower toe and upper bank [Photo ID 232]. Tension cracks c.2 cm in width and c.5 cm deep [Photo ID 233]. Small jetties along shoreline were originally constructed here in the 1980s and show no obvious signs of movement.

Erosion processes, failure mechanisms and weakening factors					
<ul style="list-style-type: none"> Desiccation of exposed sandy clay along the shoreline with tension cracks [Photo ID 233]. Recent evidence of ground movement impacting on area between road and water line. Tension cracks on road 3 to 5 m in length [Photo ID 235, 236 & 237]. Lowering of water level has contributed to desiccation of sandy clay material along shoreline. Anticipate slow slumping at this location. Failure and movement may be related to soft sandy clay material moving over a layer of harder material. 					
Likelihood of continued erosion/failure					
<ul style="list-style-type: none"> Almost certain that area will experience continued movement and cracking. 					
Rare (1)	Unlikely (2)	Moderate (3)	Likely (4)	Almost certain (5)	
Consequences of continued erosion/failure					
<ul style="list-style-type: none"> Large rotational failure could result in property damages and potential injury and fatality.

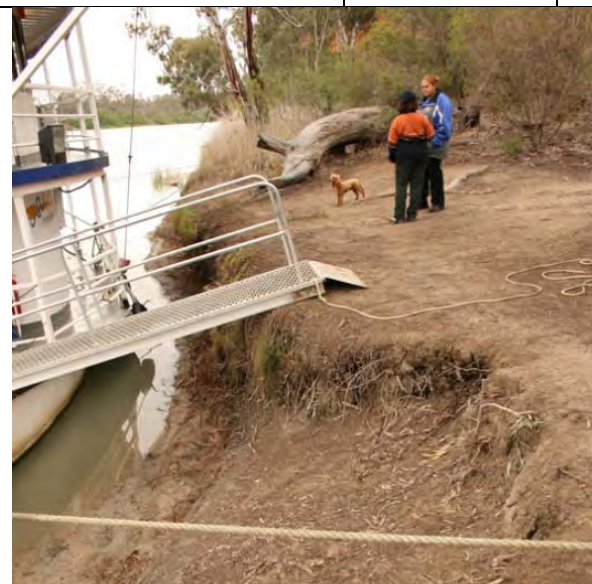
Boat mooring and degradation of bank.

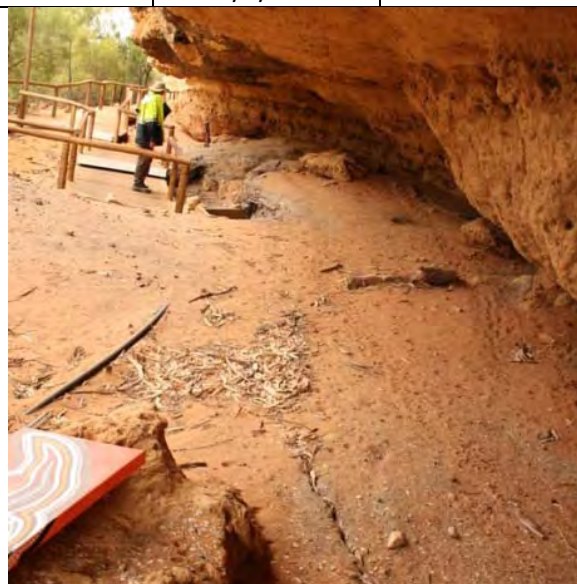
Tension crack at base of limestone cliffs.

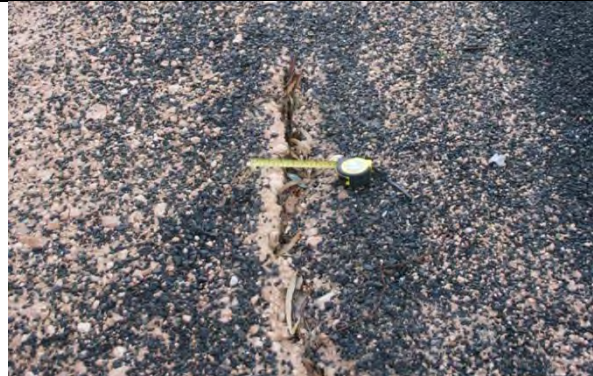
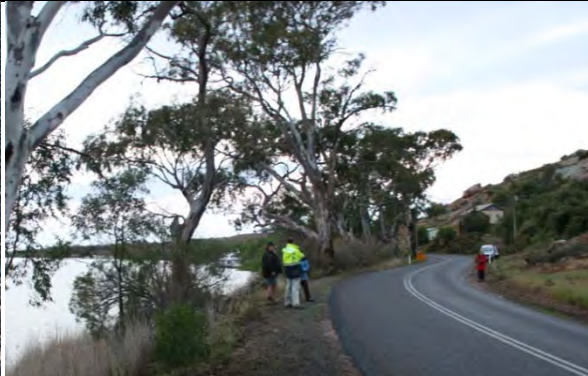
Incident Number: 24

Tension cracking along East Frond road.			Location where tension crack arc has developed.		
Description of erosion problem					
<ul style="list-style-type: none"> Numerous tension cracks (c. 4-7 cm in width and varying in length) along the length of East Front Road and in some instances there has been localised slumping of 2-3 cm [Photos ID 241-245, 248 & 249]. Quality of road construction is questionable. Noted that there has been a long history of problems and maintenance along this road. At one location, tension crack form an arc across road in the vicinity of two trees on banks [Photo ID 248 & 249]. 					
Bank characteristics					
<ul style="list-style-type: none"> River banks are layered and comprised of sand/silt, with overlying grey clay and upper sand.

Erosion processes, failure mechanisms and weakening factors					
<ul style="list-style-type: none"> Road embankment considered to be comprised of poor construction materials. Settlement over time had lead to formation of tension cracks and slumping. Drop in water level may be significant factor in contributing to failure at bend in road where tension crack arc has developed [Photo ID 248 & 249]. Water level at present c.4-5 m below road surface. Role of trees on banks uncertain, shallow roots may contribute to failure whereas deep roots are not likely to contribute to failure. 					
Likelihood of continued erosion/failure					
<ul style="list-style-type: none"> Almost certain that will experience continued movement and cracking. 					
Rare (1)	Unlikely (2)	Moderate (3)	Likely (4)	Almost certain (5)	
Consequences of continued erosion/failure					
<ul style="list-style-type: none"> Large rotational failure could result in damages to property, Government infrastructure and potential injury and fatality.

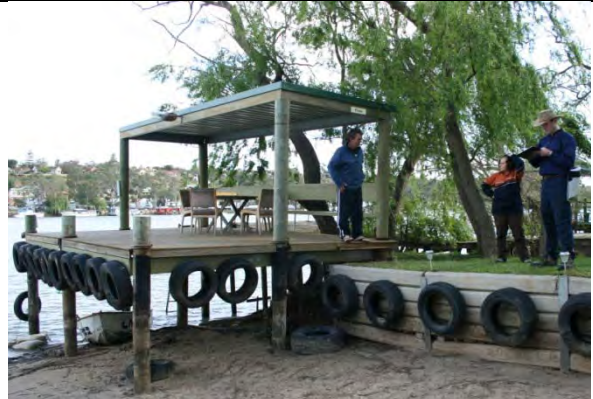
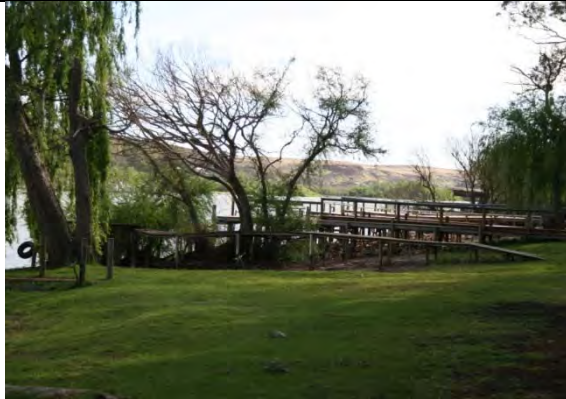
Incident Number: 27

Subsidence of land adjacent to platform.			Subsidence of jetties at this location.		
Description of erosion problem					
<ul style="list-style-type: none"> Subsidence of river banks and jetties that run along the edge of the river behind properties [Photo ID 1 & 3]. 					
Bank characteristics					
<ul style="list-style-type: none"> Generally a low gradient bank comprised of clay material at base which is covered in parts by sand deposits. This sand material is imported material brought in to provide a beach along the edge of the river. 					
Erosion processes, failure mechanisms and weakening factors					
<ul style="list-style-type: none"> No tension cracks observed along river frontage. Jetty piles are footed in plastic clay. Suspect subsidence relates to: <ul style="list-style-type: none"> plastic properties of wet clays and their compaction causing subsidence and consolidation when water is squeezed out under load (from construction of jetties and their use). changes in moisture status associated with fluctuating water levels causing expansion and shrinking of clays. quality of jetty construction and extent to which these structures were level at time they were built.

Likelihood of continued erosion/failure					
<ul style="list-style-type: none"> Likely that further bank subsidence will occur if water levels continue to lower. 					
Rare (1)	Unlikely (2)	Moderate (3)	Likely (4)	Almost certain (5)	
Consequences of continued erosion/failure					
<ul style="list-style-type: none"> Further bank subsidence could result in damages to jetties and potential injury. 					
<i>Social</i>	Insignificant (1)	Minor (2)	Moderate (3)	Major (4)	Catastrophic (5)
<i>Economic</i>	Insignificant (1)	Minor (2)	Moderate (3)	Major (4)	Catastrophic (5)
Recommendations					Priority
<p>Future Investigations</p> <ul style="list-style-type: none"> No further investigations of this area are advised at this time. <p>Management actions</p> <ul style="list-style-type: none"> No management recommendations. Problems considered low priority and are 					Low

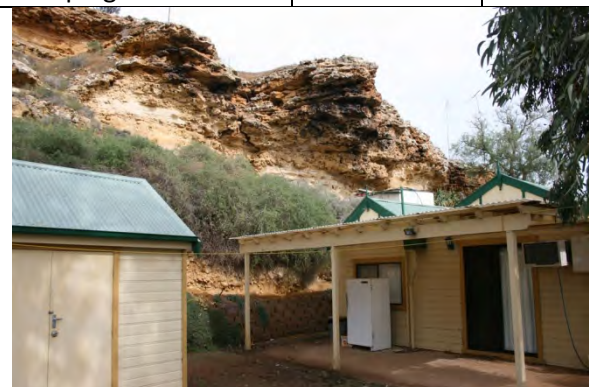
Limestone cliff overhang with tension cracks.

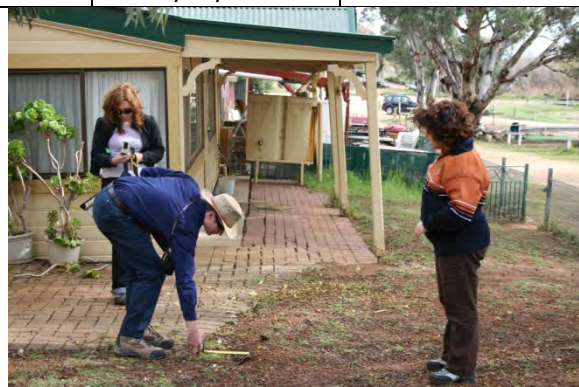
Tension cracks and slumping at front of house.

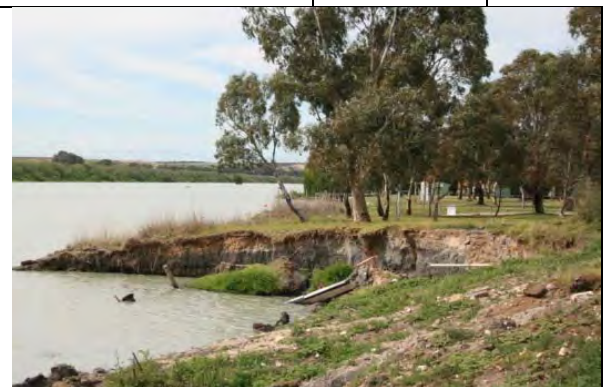
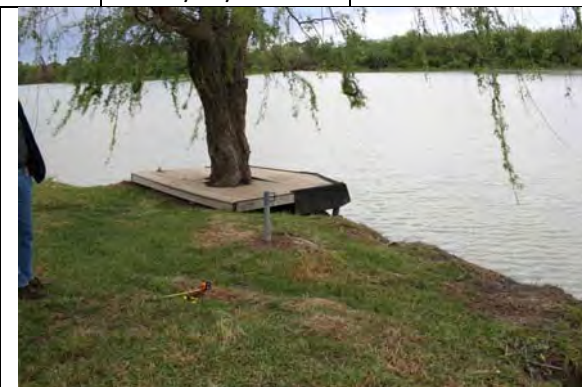
Incident Number: 7

Site of past failure at Woodlane Reserve.		Position of tension crack where tape is located.			
Description of erosion problem					
<ul style="list-style-type: none"> A large section of river bank slumped in area within vicinity of area where road runs close to river bank [Photo ID 15]. Initial slump damaged pumping station at site. Further slumping occurred, enlarging the slumped area of the first collapse, the loss of the pumping station and stobbie pole. 					
Bank characteristics					
<ul style="list-style-type: none"> Vertical banks at failure location c. 2.5 m in height and comprised of lower grey sand/silt/clay (1.5 to 2 m thick) covered with sand fill (0.5 m thickness). Edge of failed bank 5-10 m away from edge of road.

Erosion processes, failure mechanisms and weakening factors					
<ul style="list-style-type: none"> Large rotational slip at this location. Continued toppling and bank retreat within the vicinity of failure location is expected [Photo ID 15]. Cause of failure not known. Constructed road, 1.5 m high passes close to river within vicinity of failure location. Tension cracks noted in reserve area upstream of failure around tree as shown in above photo and Photo ID 12. 					
Likelihood of continued erosion/failure					
<ul style="list-style-type: none"> Likely that will experience continued movement and cracking. 					
Rare (1)	Unlikely (2)	Moderate (3)	Likely (4)	Almost certain (5)	
Consequences of continued erosion/failure					
<ul style="list-style-type: none"> Large rotational failure could result in potential injury and fatality (if someone is in the vicinity of the bank when failure occurs).

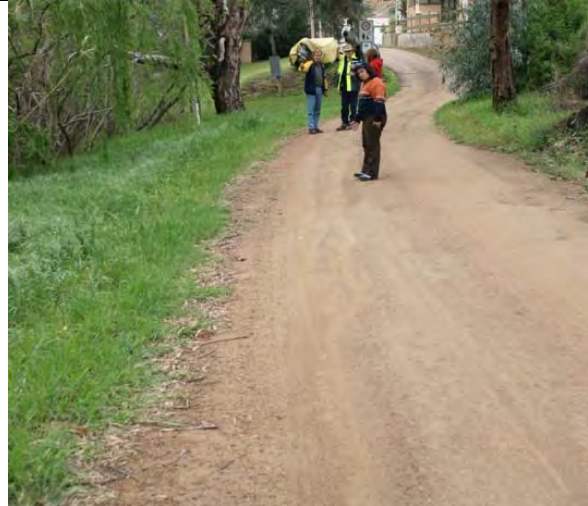
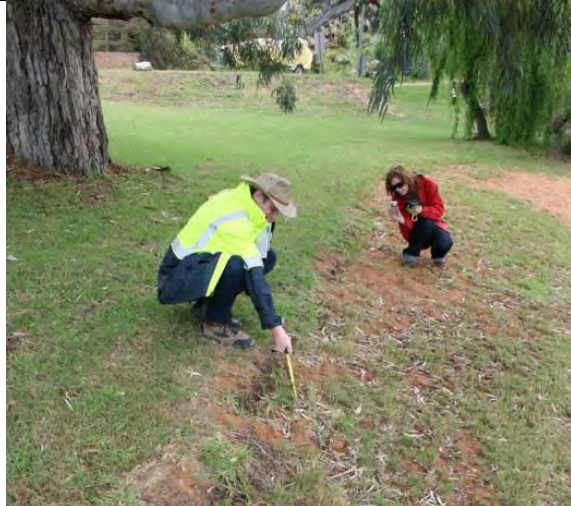
Incident Number: 23

Cracking and subsidence along Murrawong Road.			Slumping in reserve below houses.		
Description of erosion problem					
<ul style="list-style-type: none"> Cracking reported along Murrawong Road. This is the only access to and from residential area. 					
Bank characteristics					
<ul style="list-style-type: none"> Lack of clear bank exposures from which to describe bank characteristics. Silt/clay material at base of bank (1 m thick) with overlying sand material (1.5 m thick). Willows lining banks adjacent to entrance to residential area. 					
Erosion processes, failure mechanisms and weakening factors					
<ul style="list-style-type: none"> Cracking and subsidence in road noted at entrance to residential area [Photo ID 16] and along the river bank in grassed reserve [Photo ID 17 & 18]. Slumping of road and tension cracks may be attributed in part to drop in water level and effect this has in increasing surcharge. There is also very little setback from the river to the road at this location (c.5-10 m). It is not known the extent to which willows lining the banks have in increasing surcharge.

Likelihood of continued erosion/failure					
<ul style="list-style-type: none"> Almost certain that will experience continued subsidence and cracking. 					
Rare (1)	Unlikely (2)	Moderate (3)	Likely (4)	Almost certain (5)	
Consequences of continued erosion/failure					
<ul style="list-style-type: none"> Large rotational failure and continued erosion could result in potential injury and fatality. Road provides the only access point to the area. 					
<i>Social</i>	Insignificant (1)	Minor (2)	Moderate (3)	Major (4)	Catastrophic (5)
<i>Economic</i>	Insignificant (1)	Minor (2)	Moderate (3)	Major (4)	Catastrophic (5)
Recommendations					Priority
Future Investigations					Critical
<ul style="list-style-type: none"> Not advised at this time.

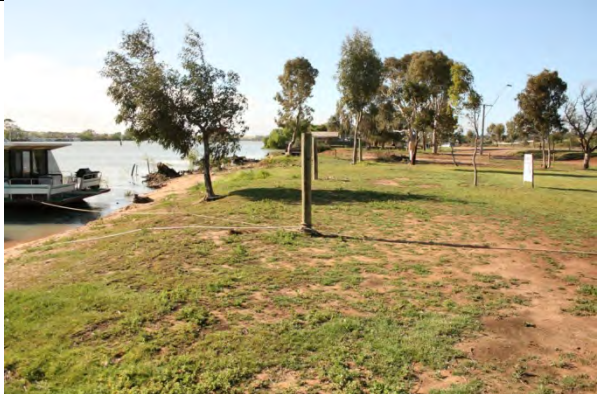
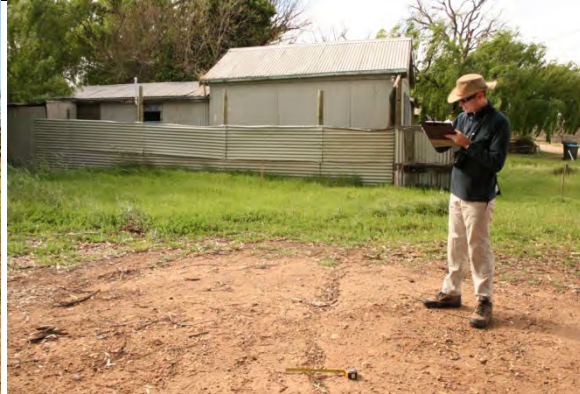
Incident Number: 51

Mooring of boat within high risk area.			Tension crack running along back of property.		
Description of erosion problem					
<ul style="list-style-type: none"> Tension cracks originally noted by council in SE corner of reserve and signs and bunting were subsequently erected. Council removed willows and vegetation along with a large amount of topsoil from the area, in an attempt to alleviate weight of the bank [Photo ID 42 & 45]. 					
Bank characteristics					
<ul style="list-style-type: none"> Banks comprised of organic rich silt/clay (c.1.5 m thick) with overlying sand (c.1 m thick). Depth to bedrock unknown at this location, granite outcrop noted nearby so may only require shallow boreholes (<5 m depth). Occasional willows along the edge of the bank within the vicinity of properties.

Erosion processes, failure mechanisms and weakening factors					
<ul style="list-style-type: none"> Desiccation of lower banks where clay unit has been exposed as Water Level has dropped. Tensions cracks have formed, which weakens materials leading to shallow failures [Photo ID 46, 47 & 48]. Tension cracks run along back of houses, 9 m from road with potential for development of large rotational slip [Photo ID 49]. Tension cracks also noted at boat ramp [Photo ID 43 & 44]. Lowering of water level has contributed to desiccation of clays along shoreline and also increases in bank surcharge. Possibility of hydraulic gradient from wetland areas located west of Riverfront Road discharging groundwater to river, with seepage weakening bank materials. 					
Likelihood of continued erosion/failure					
<ul style="list-style-type: none"> Almost certain that will experience continued movement and cracking.

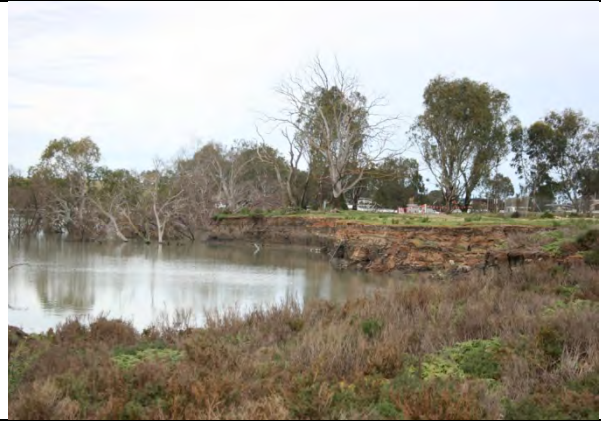
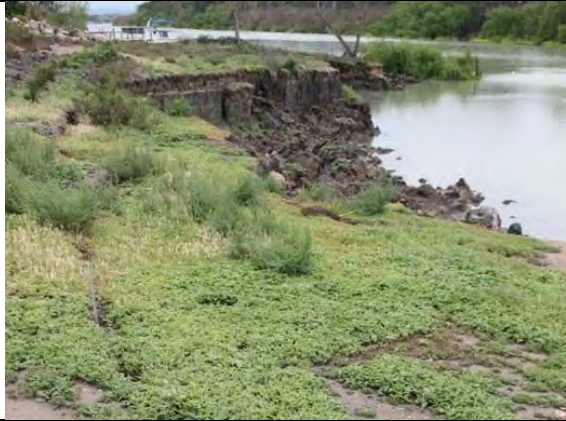
Incident Number: 1

Area of rotational slip.		Slab failure with deep tension cracks			
Description of erosion problem					
<ul style="list-style-type: none"> This section has experienced a number of large collapses. In the first instance, a 20 x 6 metre section slumped that resulted in three cars falling into the river, only one of which was recovered. Subsequent collapses resulted in the loss of historic River Red Gums and bank retreat. 					
Bank characteristics					
<ul style="list-style-type: none"> Vertical banks c.3m in height comprised of silt/clay material at base and overlying sand material (fill?). Further information on history of site would be informative as background to understanding the characteristics of the bank materials where failure has occurred.

Erosion processes, failure mechanisms and weakening factors					
<ul style="list-style-type: none"> Series of deep-seated rotational slips in which blocks of soil have slipped along a curved surface. Large tension cracks are continuing to form and open up, driving further bank retreat and toppling failure [Photo ID 30]. Condition of toe of bank is unknown, at some locations failed soil blocks lie where they have fallen forming a bench [Photo ID 23], but in other locations banks are vertical and it is not clear whether a toe has formed [Photo ID 26 & 29]. Concern that if failed material is removed through dredging this will initiate further bank instabilities. Possibly seepage through groundwater discharge into river. Very high water content in substrate noted in bore hole being drilled by Frazer at time of survey. 					
Likelihood of continued erosion/failure					
<ul style="list-style-type: none"> Almost certain that will experience continued movement and cracking and slumping.

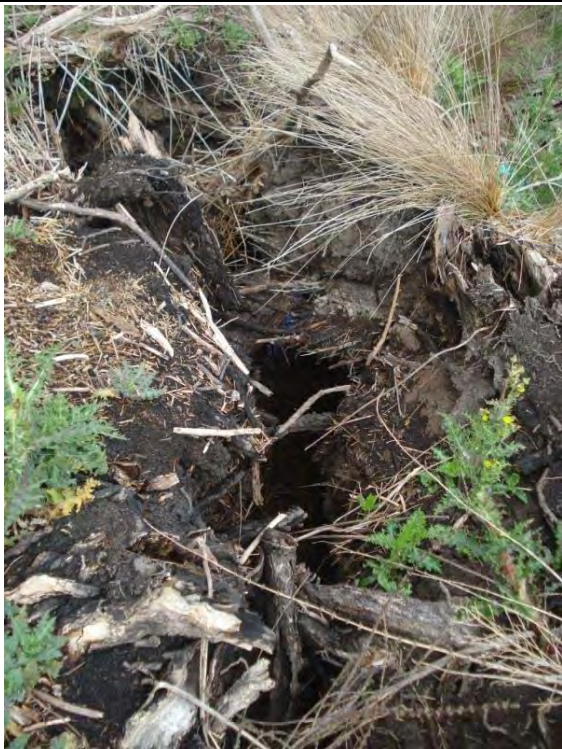
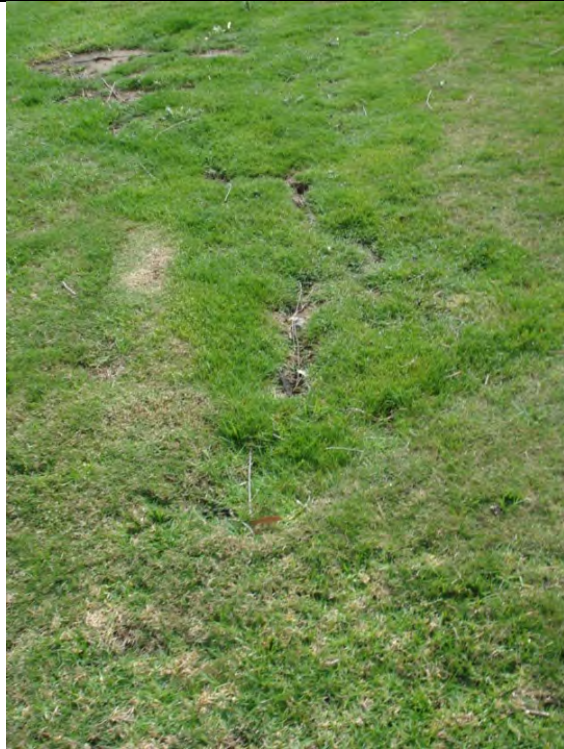
Incident Number: 20

Tension cracks in willow area [Photo ID 52]			Tensions cracks in reserve [Photo ID 54]		
Description of erosion problem					
<ul style="list-style-type: none"> Extensive tension cracks and rotational slip in area of willows. Tensions cracks 0.5 to 1 m wide and 1 m deep with water noted at base [Photo ID 52]. No immediate danger posed to houses as they are set back a considerable distance from river bank. 					
Bank characteristics					
<ul style="list-style-type: none"> Banks comprised predominantly of clay. Sand forms upper layer of bank at some locations. 					
Erosion processes, failure mechanisms and weakening factors					
<ul style="list-style-type: none"> Deep circular failure of bank in area of willows, followed by secondary break up of material (slab/cantilever failure). Tension cracks noted in Bells Landing Reserve [Photo ID 54] upstream of willow area. Tension crack and failures likely to be caused by increased surcharge of banks caused by lowering of water level.

Likelihood of continued erosion/failure					
<ul style="list-style-type: none"> Almost certain that area will experience continued movement and cracking. 					
Rare (1)	Unlikely (2)	Moderate (3)	Likely (4)	Almost certain (5)	
Consequences of continued erosion/failure					
<ul style="list-style-type: none"> Only minor impact as large set back to houses. Location is a public reserve so there is potential for injury and fatality if reserve is occupied when failure occurs. 					
Social	Insignificant (1)	Minor (2)	Moderate (3)	Major (4)	Catastrophic (5)

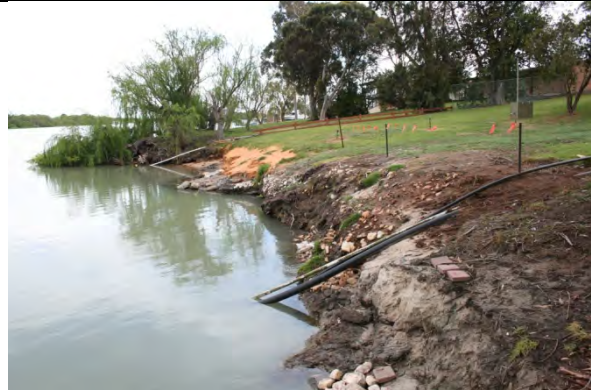
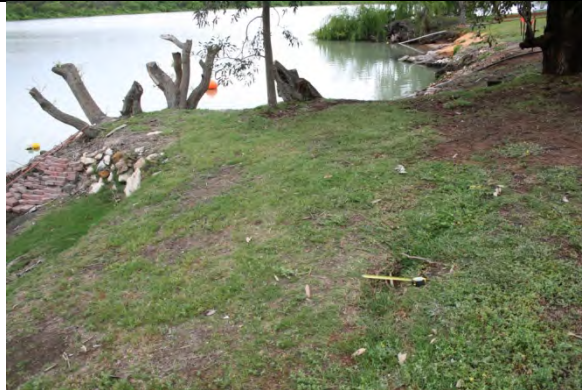
Incident Number: 30 and 4

Section where February 2009 failure occurred.					
Tension crack adjacent to bank.					
Description of erosion problem					
<ul style="list-style-type: none"> An area of approximately 25 x 4 metres slumped on 14 February 2009. A boat was temporarily lost, but no property damage was reported. Reported by locals that material at toe of bank has dispersed so that there is now a deep drop-off at river bank. 					
Bank characteristics					
<ul style="list-style-type: none"> Banks comprised of sandy organic clay (c.1.5 m thick) with overlying sand (c.0.5 m thick). Where failures have occurred there is a steep drop off-to water. Unable to determine from visual inspection if failed material has settled below water level and formed a toe or if material has dispersed.

Erosion processes, failure mechanisms and weakening factors					
<ul style="list-style-type: none"> Area has experienced large primary rotational failure. Continued retreat of banks is occurring through secondary toppling/cantilever failures. Active undercutting highlights weak and erodible characteristics of clay materials in bank profile [Photo ID 35]. Changes in moisture status associated with fluctuating water levels cause expansion and shrinking of clays, formation of tension cracks [Photo ID 36] which weakens bank materials and increases their susceptibility to failure. 					
Likelihood of continued erosion/failure					
<ul style="list-style-type: none"> Likely that will experience continued movement and cracking. 					
Rare (1)	Unlikely (2)	Moderate (3)	Likely (4)	Almost certain (5)	
Consequences of continued erosion/failure					
<ul style="list-style-type: none"> Large rotational failure or toppling failure could result in property damages and potential injury and fatality.

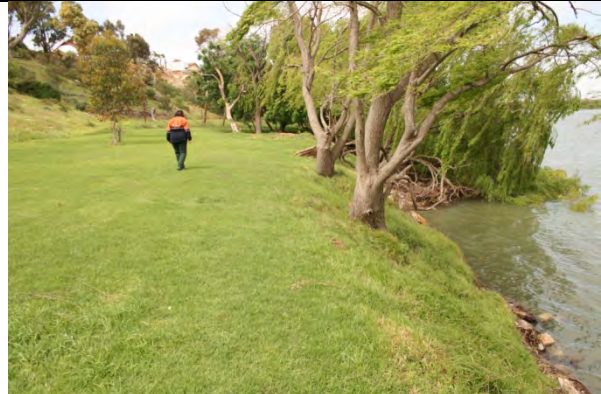
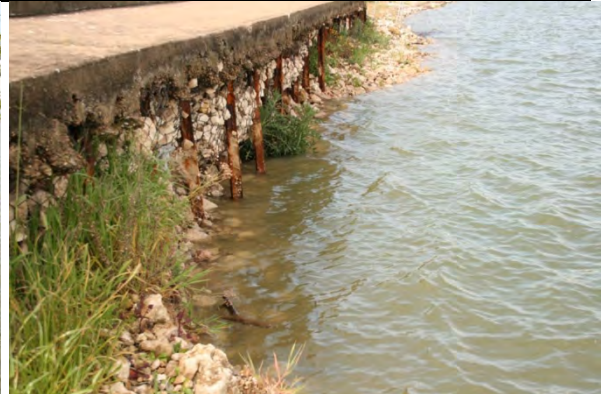
Incident Number: 6

<p>Picnic area downstream from rowing club. Tension cracks 2-4 m from top of bank.</p>		<p>Possible slumping of rock beaching around steel supports. Subsidence & cracking of concrete.</p>			
Description of erosion problem					
<ul style="list-style-type: none"> Slumping and cracking reported along pedestrian walkway situated on top of river bank and area around rowing club. 					
Bank characteristics					
<ul style="list-style-type: none"> No clear bank exposures, silt/clay material. Gabion rock nets and steel supports underlie pedestrian walkway [Photo ID 57]. Rock beaching lines the river bank supporting concrete foot path. 					
Erosion processes, failure mechanisms and weakening factors					
<ul style="list-style-type: none"> A number of tension cracks have formed 2-4 m from bank downstream of rowing club in grassed recreation reserve, below picnic benches [Photo ID 56]. The position of these tension cracks are obscured by grass cover. Cracking and subsidence of pedestrian walkway along the top of the river bank. Rock beaching appears to have slumped below rowing club [Photo ID 59]. Further information on site history is required to confirm this is the case. Lowering of water level may be cause of tension crack and bank failures.

Likelihood of continued erosion/failure					
<ul style="list-style-type: none"> Likely that will experience continued movement and cracking. 					
Rare (1)	Unlikely (2)	Moderate (3)	Likely (4)	Almost certain (5)	
Consequences of continued erosion/failure					
<ul style="list-style-type: none"> Continued erosion could result in property damages (in particular the rowing club), potential injury and fatality. 					
<i>Social</i>	Insignificant (1)	Minor (2)	Moderate (3)	Major (4)	Catastrophic (5)
<i>Economic</i>	Insignificant (1)	Minor (2)	Moderate (3)	Major (4)	Catastrophic (5)
Recommendations				Priority	
<p>Future Investigations</p> <ul style="list-style-type: none"> Not advised at this time. 				Critical

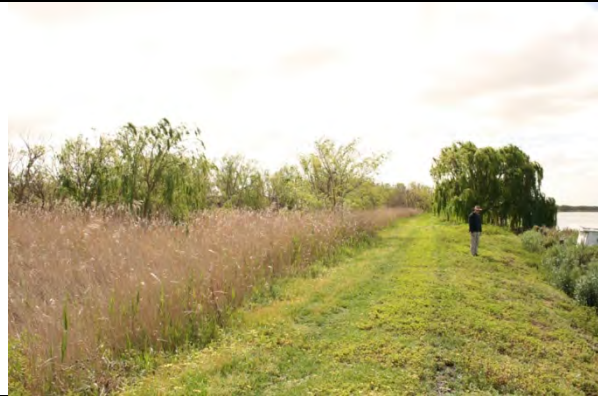
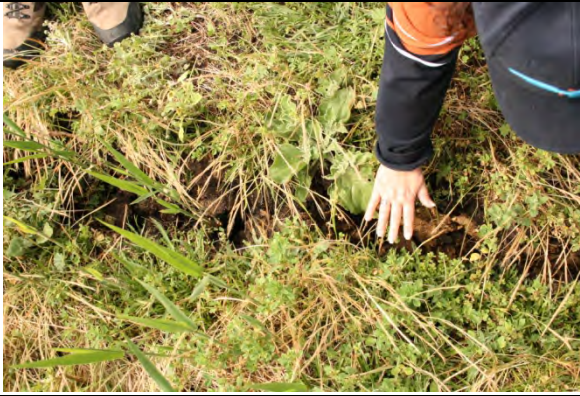
Incident Number: 47

Embankment with 50-60 m long tension cracks.			Tension cracks c.15 cm wide.		
Description of erosion problem					
<ul style="list-style-type: none"> Tension cracks noted along this c.10m wide embankment that separates the river from marina. This embankment presently provides access to boats moored outside and inside the marina [Photo ID 73 & 74]. 					
Bank characteristics					
<ul style="list-style-type: none"> Embankment comprised of soft organic clays. Embankment has a height of c.2.5 m and width of 10 m. 					
Erosion processes, failure mechanisms and weakening factors					
<ul style="list-style-type: none"> Large tension cracks run along the length of the embankment and reach lengths of 50 to 60 m, with widths of c.15 cm and depths > 1.5 m. Rotational failures likely with material slumping into the Marina [Photo ID 70, 71 & 72]. Changes in moisture status associated with fluctuating water levels causing expansion and shrinking of clays, lowering of water level results in increased surcharge of banks, weakening the strength of clay materials triggering failure of embankment.

Likelihood of continued erosion/failure					
<ul style="list-style-type: none"> Likely that will experience continued movement and cracking. 					
Rare (1)	Unlikely (2)	Moderate (3)	Likely (4)	Almost certain (5)	
Consequences of continued erosion/failure					
<ul style="list-style-type: none"> Potential for damage to cars driving on embankment and houseboats moored in the marina. 					
<i>Social</i>	Insignificant (1)	Minor (2)	Moderate (3)	Major (4)	Catastrophic (5)
<i>Economic</i>	Insignificant (1)	Minor (2)	Moderate (3)	Major (4)	Catastrophic (5)
Recommendations					Priority
<p>Future Investigations</p> <ul style="list-style-type: none"> Not advised at this time. <p>Management actions</p> <ul style="list-style-type: none"> Fence of embankment to stop vehicle and pedestrian access. 					Critical
