**REVIEW OF MANAGEMENT OPTIONS FOR FOUR
RIVER BANK COLLAPSE HIGH RISK SITES**

Department of Environment, Water and Natural
Resources

07093AA-AD Final report
12 December 2012

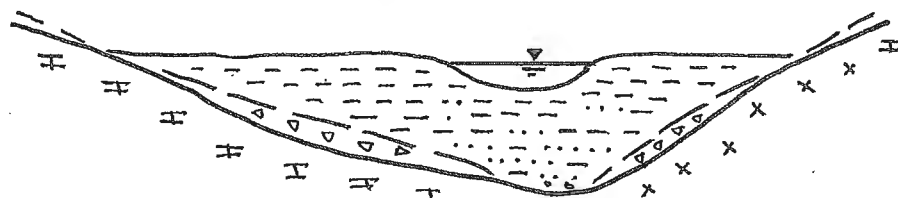
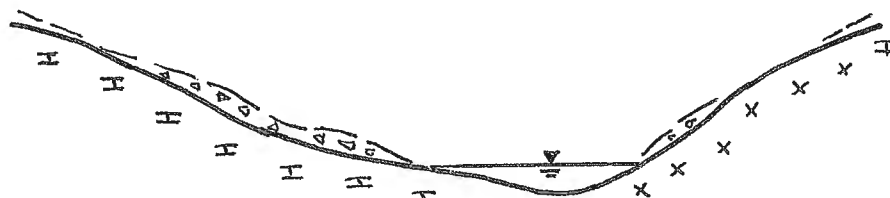
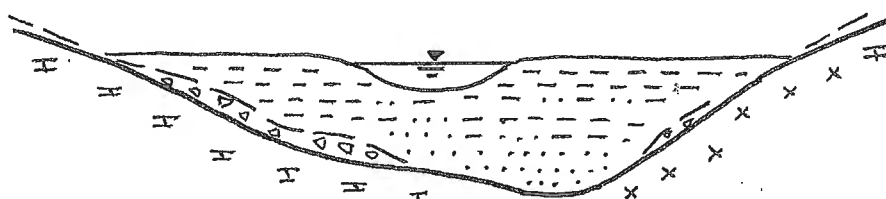
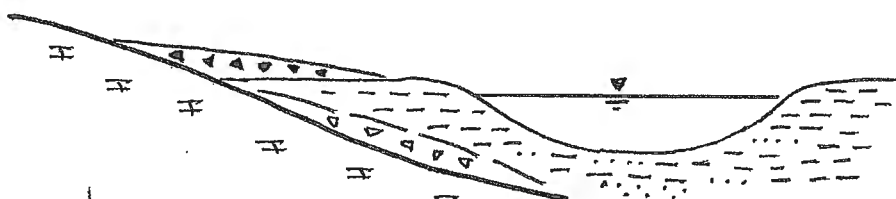
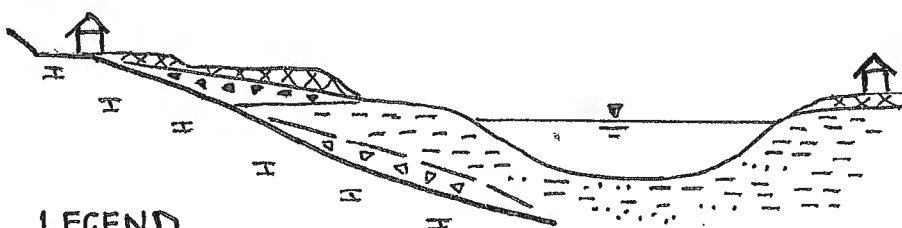
figure no: FIGURE 1

The first four sketches on Figure 1 summarise what has happened in the past 120,000 years (until European settlement). The bottom sketch summarises the present situation where the landscape has been modified by cut and fill and there is infrastructure close to the river. From the riverbank collapse point of view the most significant subsurface material is the Soft Clay which underlies the banks of the river. As discussed in Section 3.1 and Appendix C, most if not all of the riverbank collapses in the past few years have been because the Soft Clay next to the river has failed (given way).

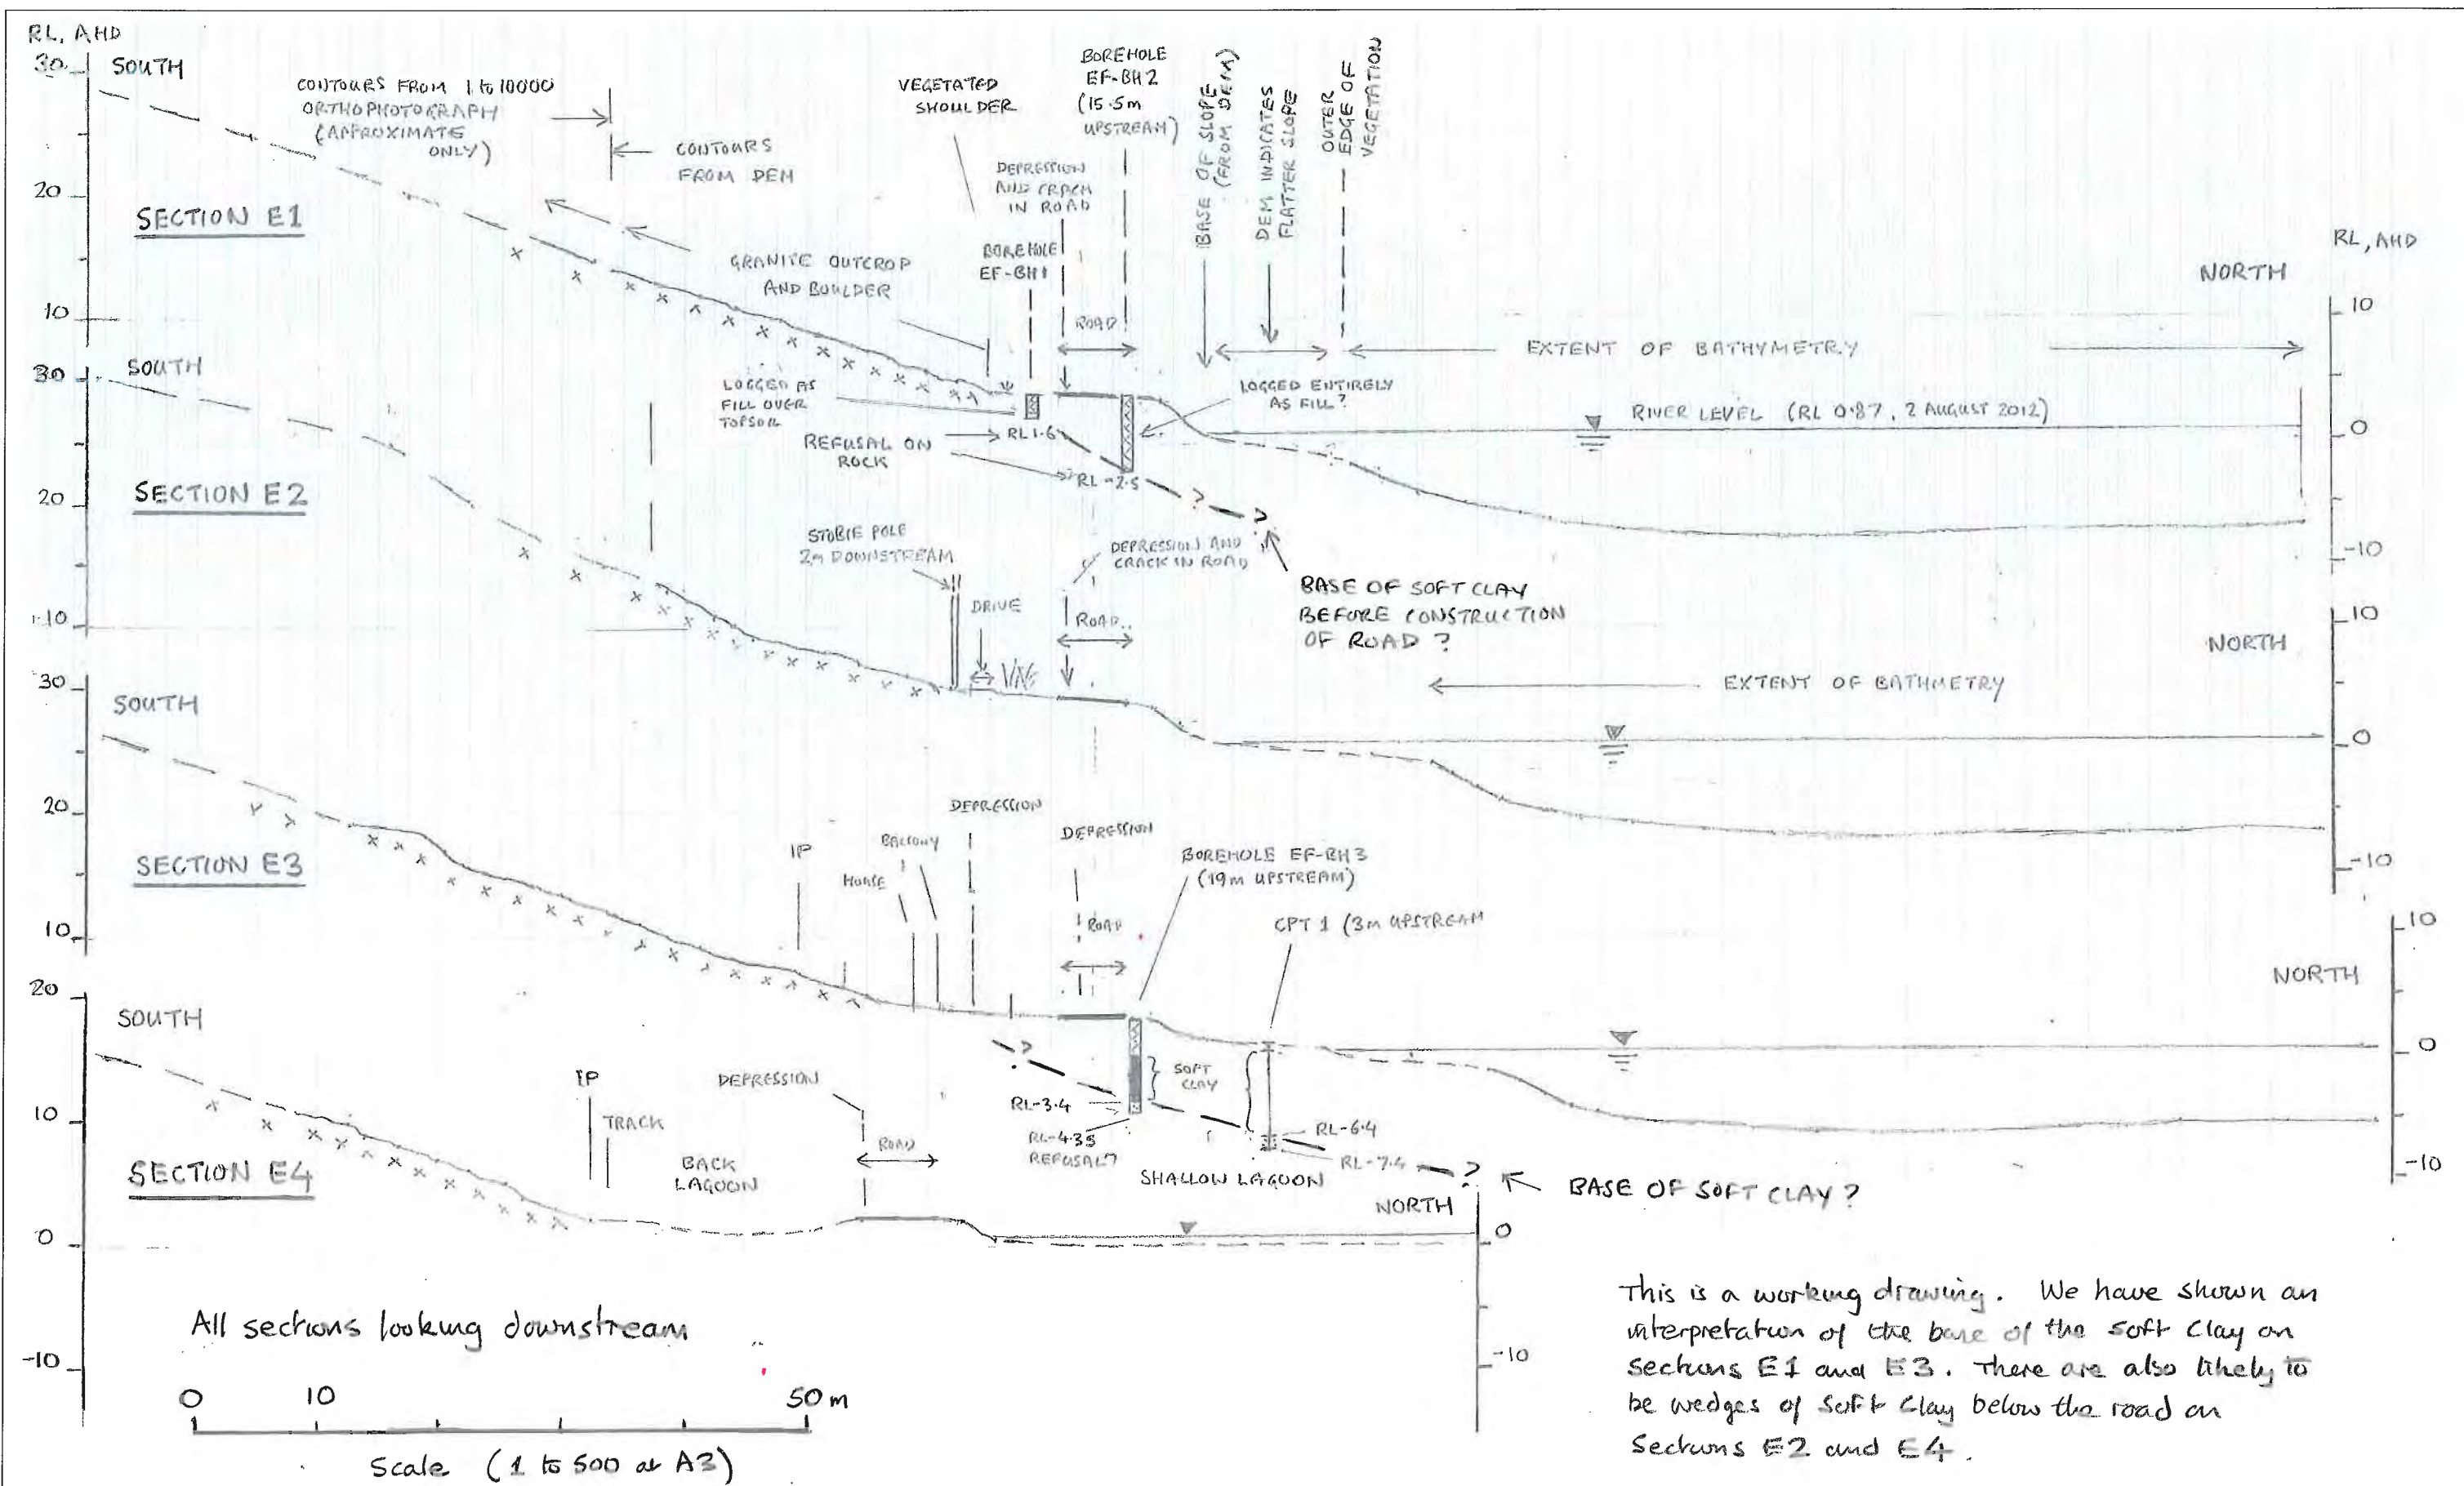
This is a working drawing. We have shown an interpretation of the base of the soft clay on sections E1 and E3. There are also likely to be wedges of soft clay below the road on sections E2 and E4.

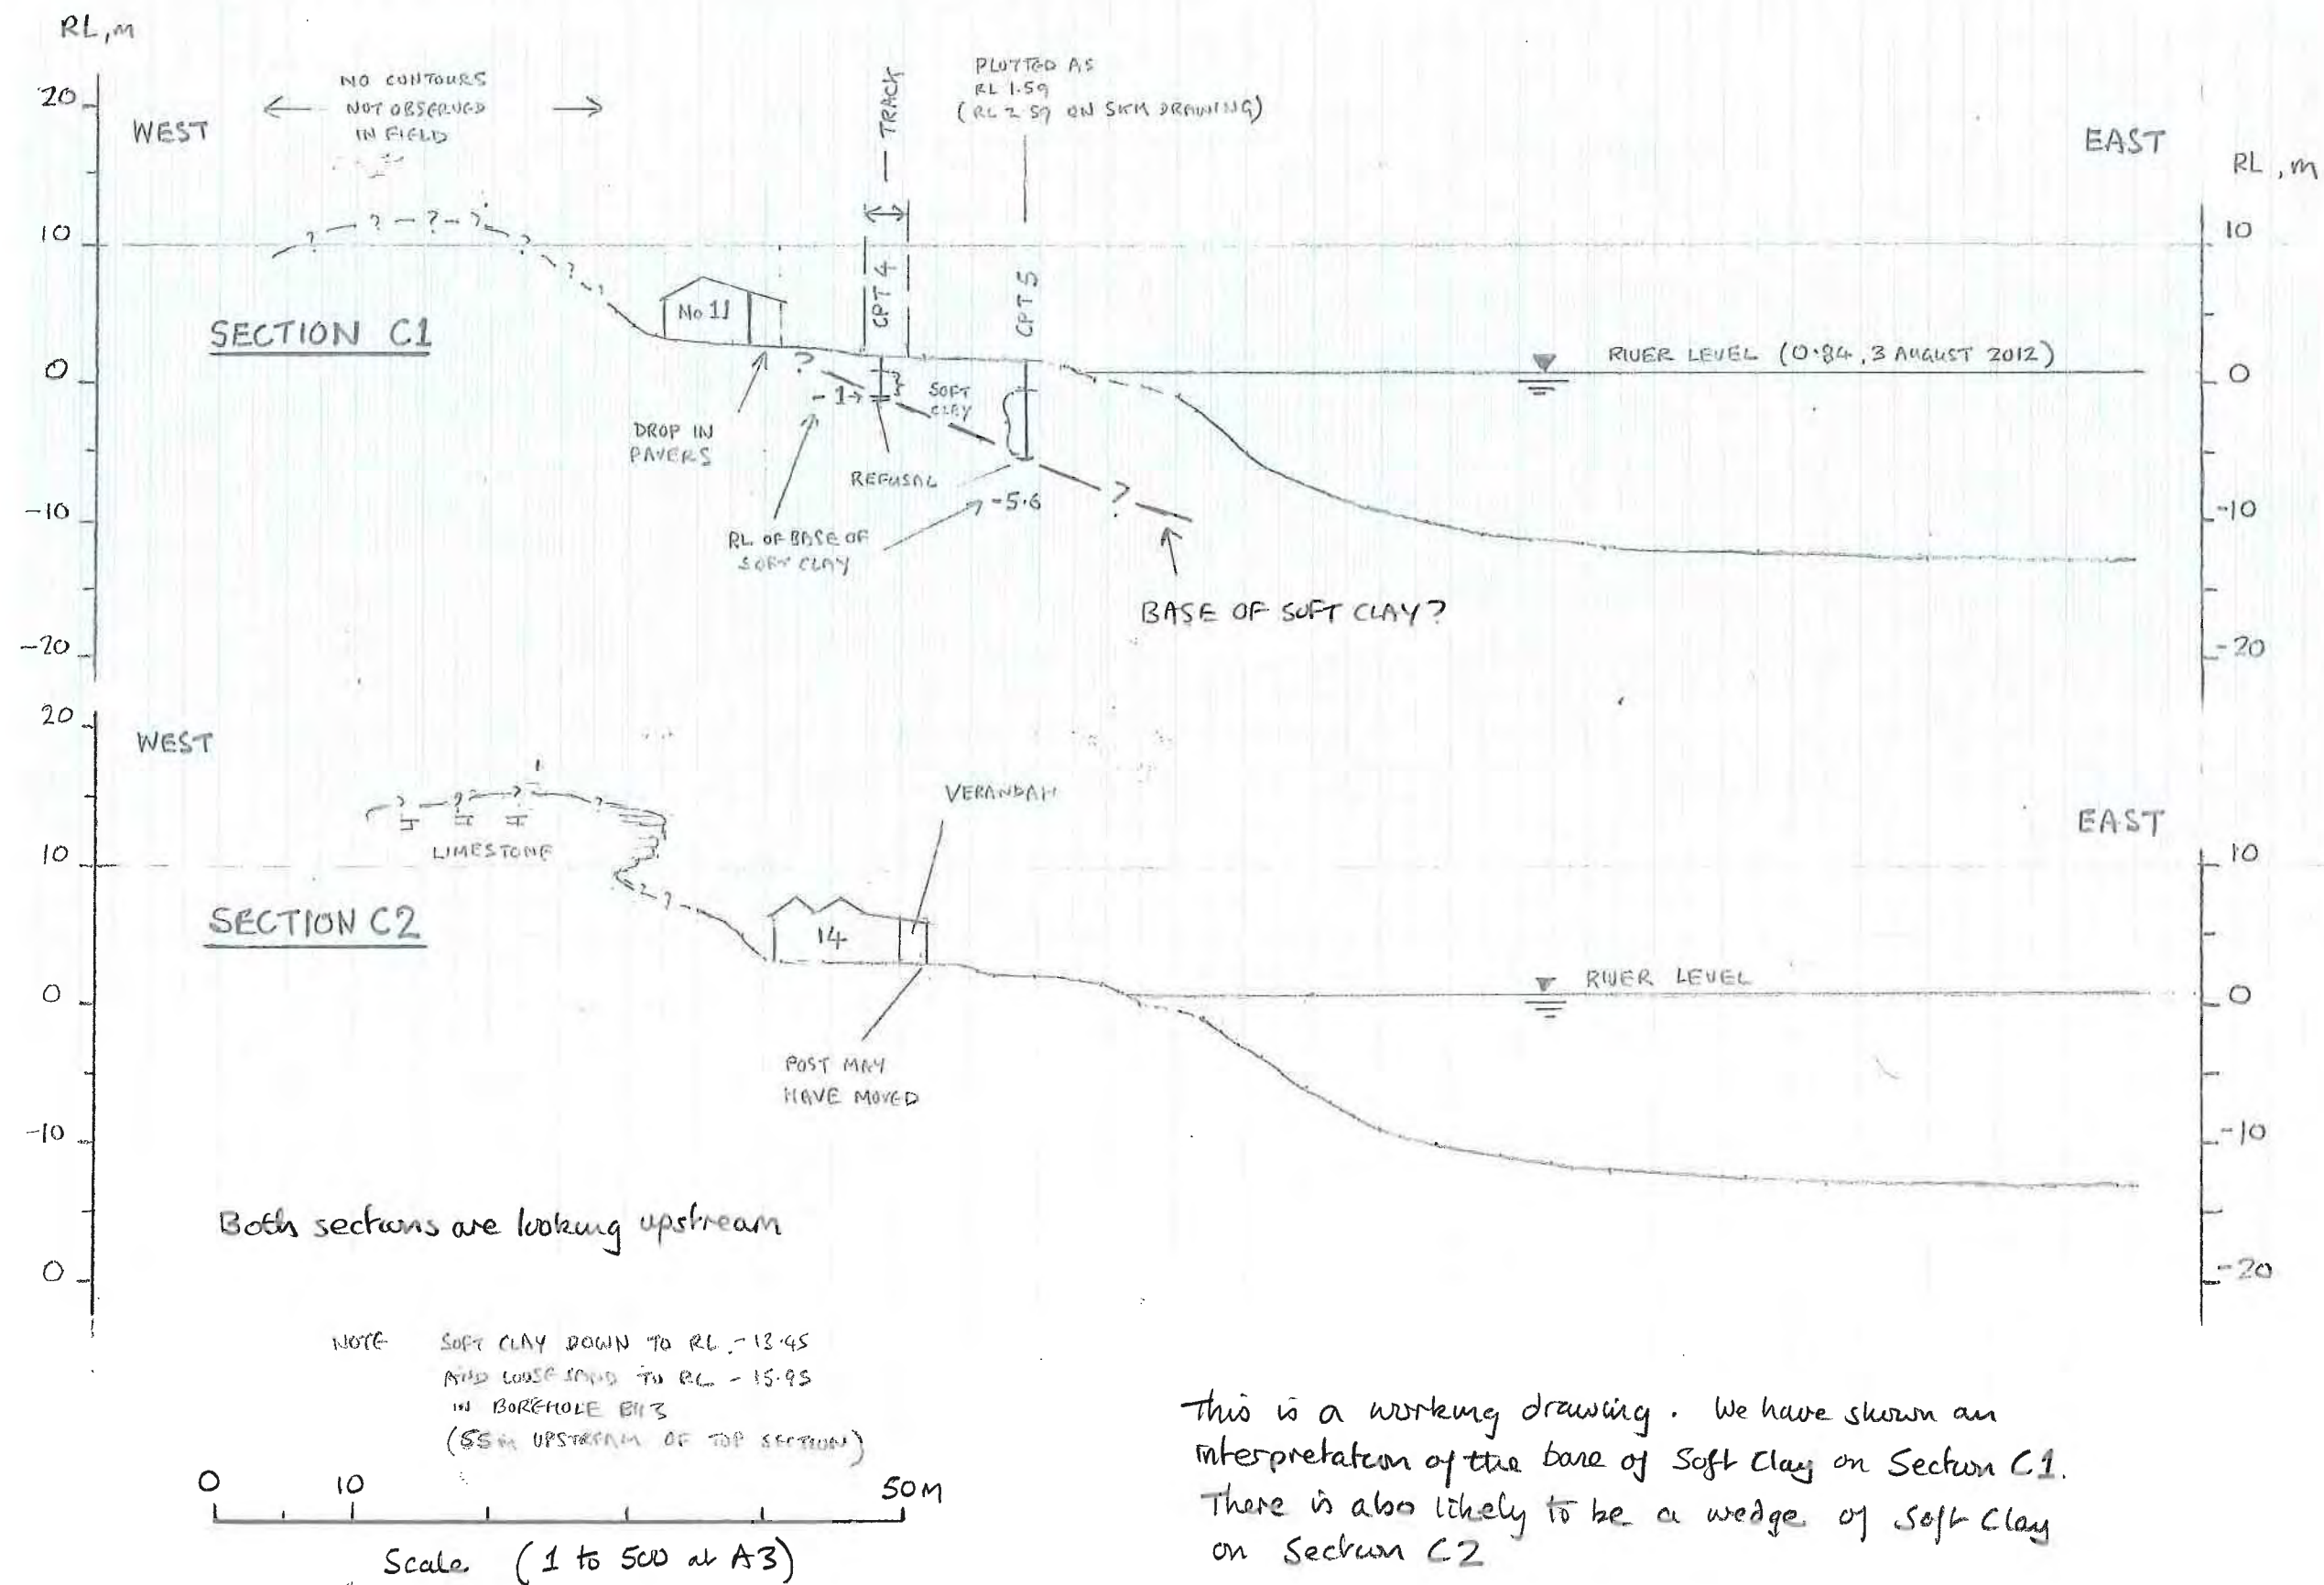
This is a working drawing. We have shown an interpretation of the base of Soft Clay on Section C1. There is also likely to be a wedge of Soft Clay on Section C2

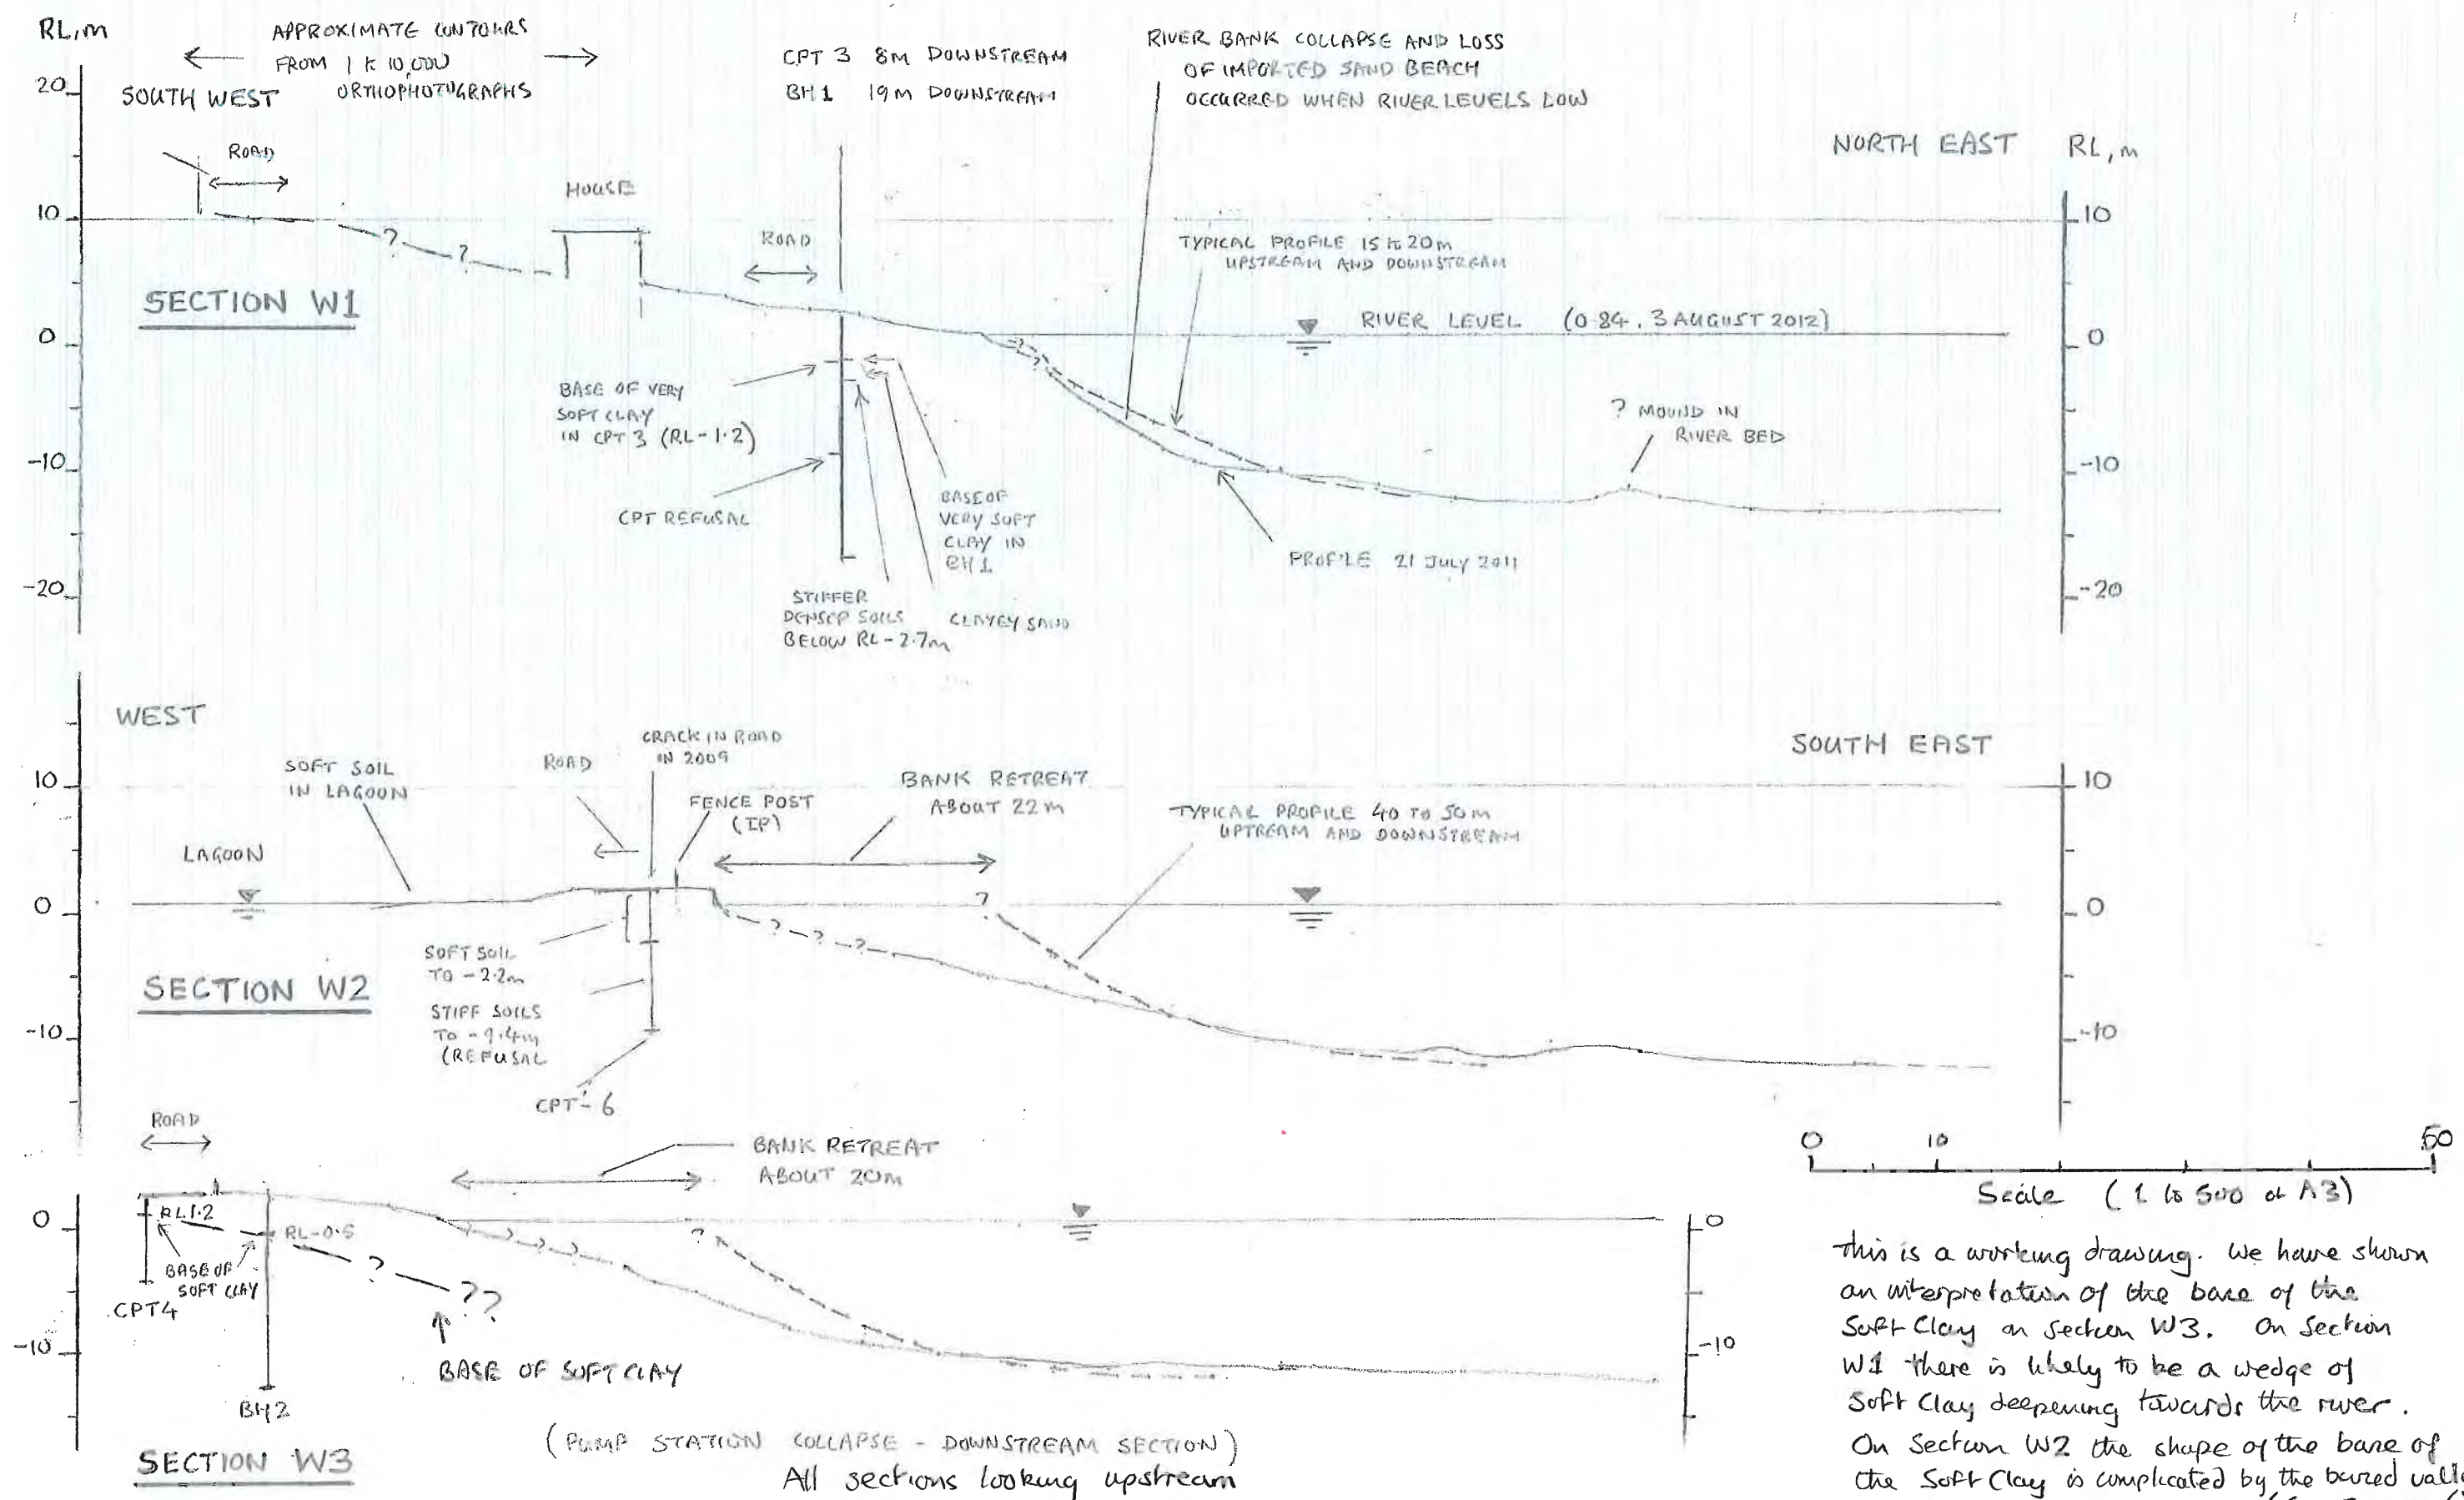
This is a working drawing. We have shown an interpretation of the base of the Soft Clay on Section W3. On Section W1 there is likely to be a wedge of Soft Clay deepening towards the river. On Section W2 the shape of the base of the Soft Clay is complicated by the buried valley (See Figure 6)
