10 August 2010

Reference No. 107662007-010-L-Rev1

## **LANDSLIDE RISK MANAGEMENT MANNUM CARAVAN PARK, SOUTH AUSTRALIA**

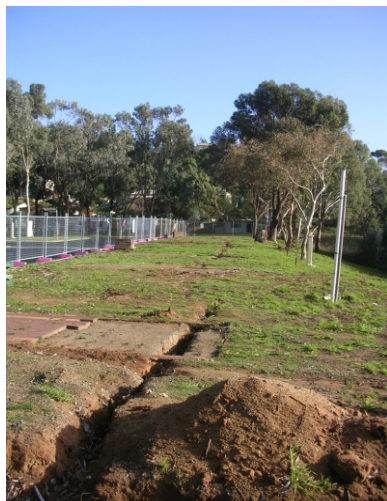
Photo 1  
 Marion Road  
 looking North West

The photographs show that the ground is cracked with the cracks generally orientated approximately parallel with the crest of the slope that falls towards the Bird Sanctuary. The slope is between about 2 m and 3 m high – it was impractical to measure it – and has a face angle generally around 25° (about 2 horizontal to 1 vertical).

The cracks coincide generally with service trenches, and service conduits are exposed in the base of some cracks. At the Purnong Road end, the cracks bend towards the Bird Sanctuary and apparently peter out a few metres beyond the temporary fence shown in the photo.

The openings in the ground are up to about 200 mm wide, but this may be somewhat misleading as we understand that some trenching and other earthworks have been performed in the area since cracking was originally observed which has probably affected the crack width.

Public access to much of the area potentially at risk of landslide is already controlled by fencing. We recommend that the fence be realigned to the north western side of Ariel Street – that Ariel Street be closed – to include all areas in which landsliding is presently apparent. It would also be prudent to close Marion Way along the Bird Sanctuary frontage. Although there are no clear signs to date that landsliding has progressed this far behind the slope crest, the possibility cannot be ruled out.

We recommend that the measurement of ground movements currently undertaken along Marion Way should be extended to include the whole of the Caravan Park swamp and river frontage along Marion Way, Ariel Street and Bogan Street. We recommend that measuring points (pegs or similar) should be placed in pairs, one well away from the slope crest – the land side of the various streets would appear to be appropriate at present – and the other close to the slope crest (subject to appropriate risk management).

We recommend that as far as is reasonably practicable, stormwater runoff should be directed away from the areas at risk of landslide. Water entry into cracks in the ground is likely to destabilise the slopes. It would be prudent to decommission any services in these areas also as these are likely to be affected by landsliding when it occurs.

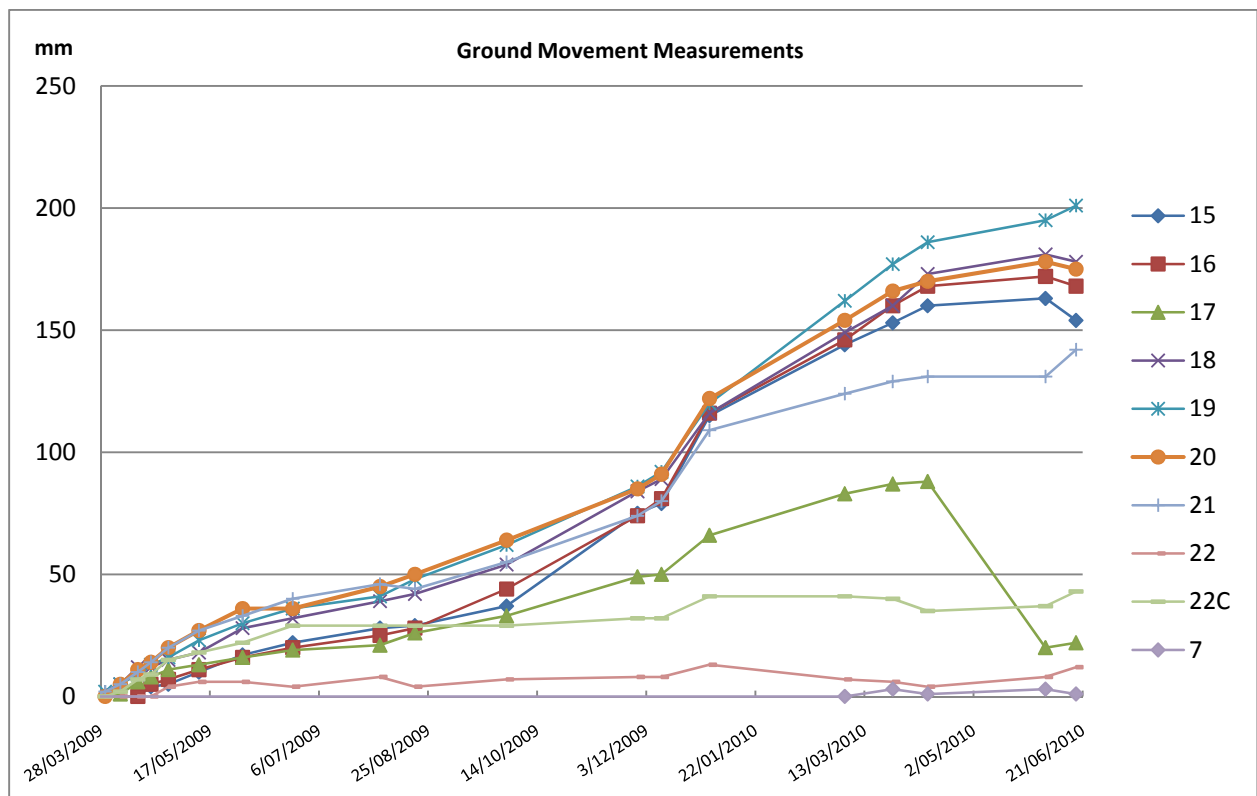
The graph indicates ongoing horizontal movement of the ground surface, with the majority of sites experiencing at least 140 mm horizontal extension over approximately 6 m measurement length.

The limited extent of ground movement at site 22 may be associated with the tree near the measuring sites, which could potentially be buttressing the slope locally. Site 7 is relatively far from the slope compared with the other sites. The measured movements may provide an indication of the repeatability and reliability of these measurements, which might on that basis be inferred to be accurate to about ±5 mm.

We judge that landsliding is occurring in this area. The sharp increase in the measured rate of movement during December 2009 may be associated with the corresponding sharp increase in measured water level during that time. Although the measured ground movements subsequently slowed during a period when the River level rise also slowed, they have not ceased.

The latest rounds of movement measurements show more scatter than previous rounds, and some apparent reversal of movement. This is likely to imply that horizontal movement is being redistributed in the ground as

landsliding behaviour extends further from the crest of the slope – that at least some movement is now occurring behind the present reference points.

We recommend monitoring of at least each caravan/camping site. Measurements should be taken between these pairs weekly or more frequently. These measurements should be checked for signs of any acceleration of movement after each reading. At the same time, the ground outside of the fenced area should be monitored for any signs that the present cracking or vertical ground movements are extending. If this does occur, it will be necessary to extent the quarantined and monitored area.

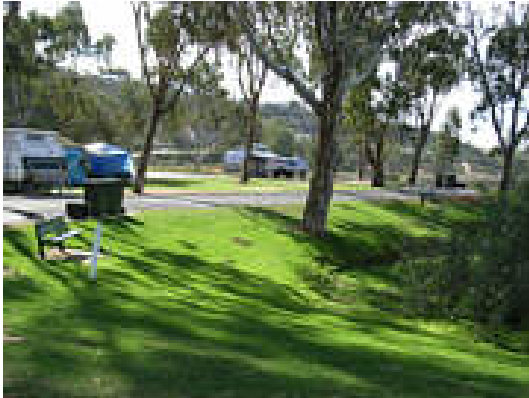
Photo 3 Ariel Street, looking north

The photographs above show Ariel Street and the ground falling towards the River. The left one is from the Caravan Park website, the other was taken during our site visit and shows significant distortion of the roadway surface since the first photograph was taken.

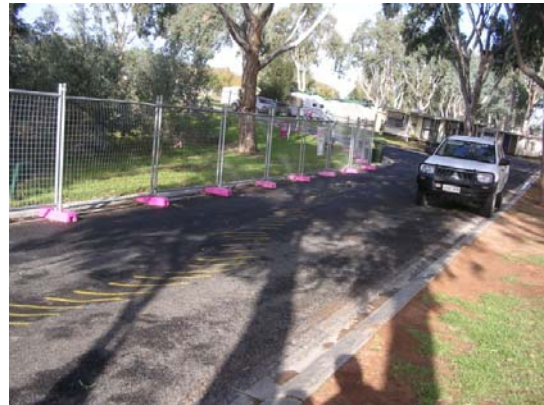
Photo 4 Ariel Street looking south

We understand that this distortion has occurred since about late December 2009, and that some cracking in the roadway has been repaired during that period. We judge that there is about 0.3 m difference in level across the roadway. We understand that movement is ongoing and represents the development of landsliding of this area, although this has not yet led to full rupture of the soil.

We judge that the situation near Ariel and Bogan Streets is similar even though the manifestations of landsliding might appear different. The relatively rapid development of vertical movement in the roadway of Ariel Street and the size of that movement is cause for concern.

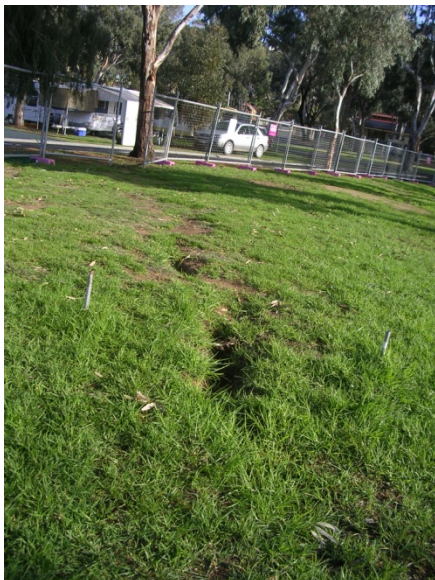
Photo 5: Bogan Street, looking North West

Cracking in the ground near Bogan Street is shown on the photograph above. This is similar to, although not as severe as, the cracking near Marion Way and is oriented diagonally across the slope (the crack runs approximately east-west).

The slope along the Ariel Street and Bogan Street frontages is similar to that at Marion Way – between about 2 m and 3 m high with a slope angle around 2 horizontal to 1 vertical.

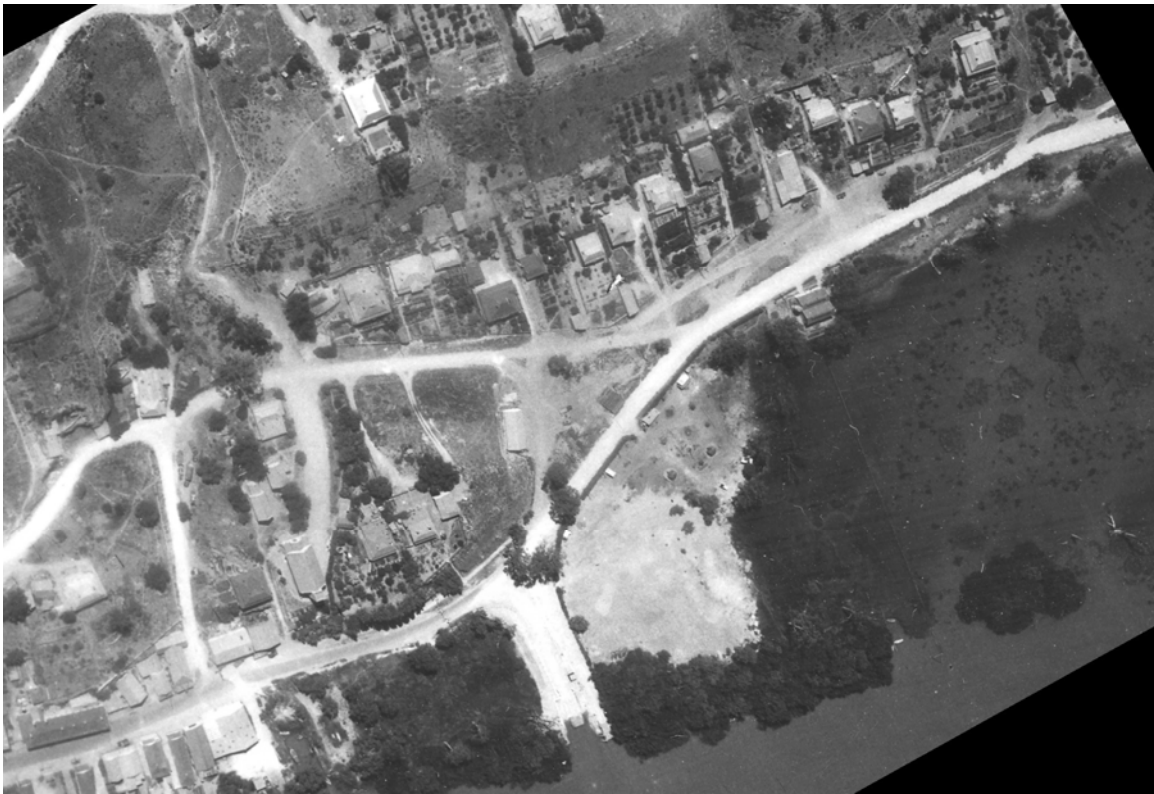
1954 aerial photograph

Aerial photographs of the area taken in 1954, 1963, 1976 and 1979 are presented in Attachment A. The photo's indicate that development of a caravan park from the informal camping area commenced between 1954 and 1963, possibly after this area and most of the lower-lying portions of Mannum were flooded in 1956. Filling to extend the land into the original swamp area towards the northeast is visible in 1976. In the 1979 photograph, the land is close to its present area.
