11 November 2010

## **River Bank Collapse Hazard - Lower River Murray Stability Risk Assessment for Caloote Landing**

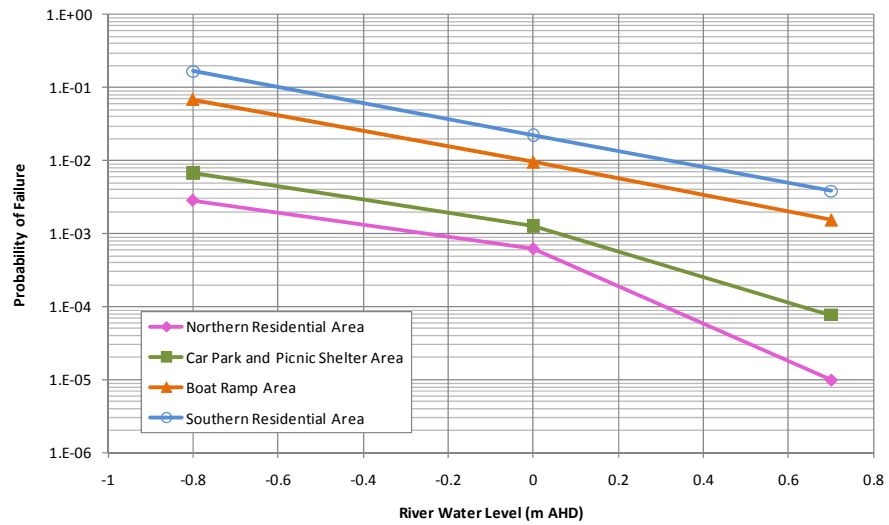
■ **Figure 2 - Probability of Failure and River Water Levels**

The results of the study have been summarised in **Figures 2 and 3** below, where it must be appreciated that the boundary lines between Risk Zones are indicative only.

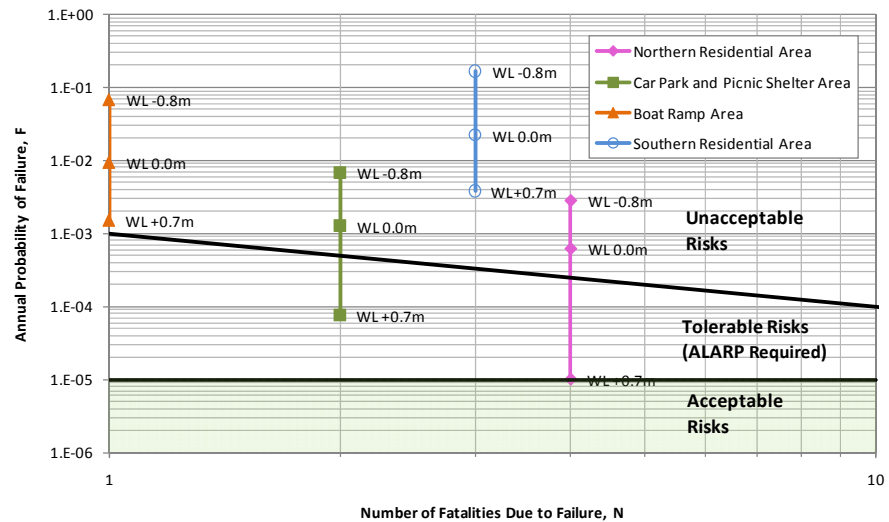
■ **Figure 3 - Comparison of Probability of Failure for Different River Water Levels at each Area with Tolerable and Acceptable Risks**

From **Figure 3**, it can be seen that for pool level +0.7m AHD, the car park, picnic shelter and northern residential area all fall within the tolerable risk zone and the boat ramp area is just above the tolerable risk boundary.

- The risk of failure at the Southern Residential Area is rated on **Figure 3** as unacceptable at all pool levels and the area should remain closed to the public as well as residents.

- The risk of failure at the Boat Ramp borders tolerable on **Figure 3** at pool level 0.7m AHD and rates as unacceptable at lower water levels. It is considered prudent that a practical form of local load testing be undertaken, using river water to apply a surcharge of water at depth 1m (total 10kPa) to simulate occupation loads of say 2.5kPa at pool level 0.0m AHD, in advance of formally reopening the boat ramp. Surcharging does not change the risk assessment described herein.

- The risks of failure at Car Park, existing Picnic Shelter and Northern Residential Areas are rated not acceptable for pool levels below RL 0.0m AHD at Caloote.

- The risks of failure at Car Park, Picnic Shelter and Northern Residential Areas are tolerable for pool levels above RL+0.0m AHD at Caloote. Mitigation requires application of ALARP principles. A suggested site design for managing access in these areas is shown in **Figure 6** attached.
