# Study into River Bank Collapsing for Lower River Murray

### GEOTECHNICAL INVESTIGATION REPORT

- Rev E FINAL
- February 2010

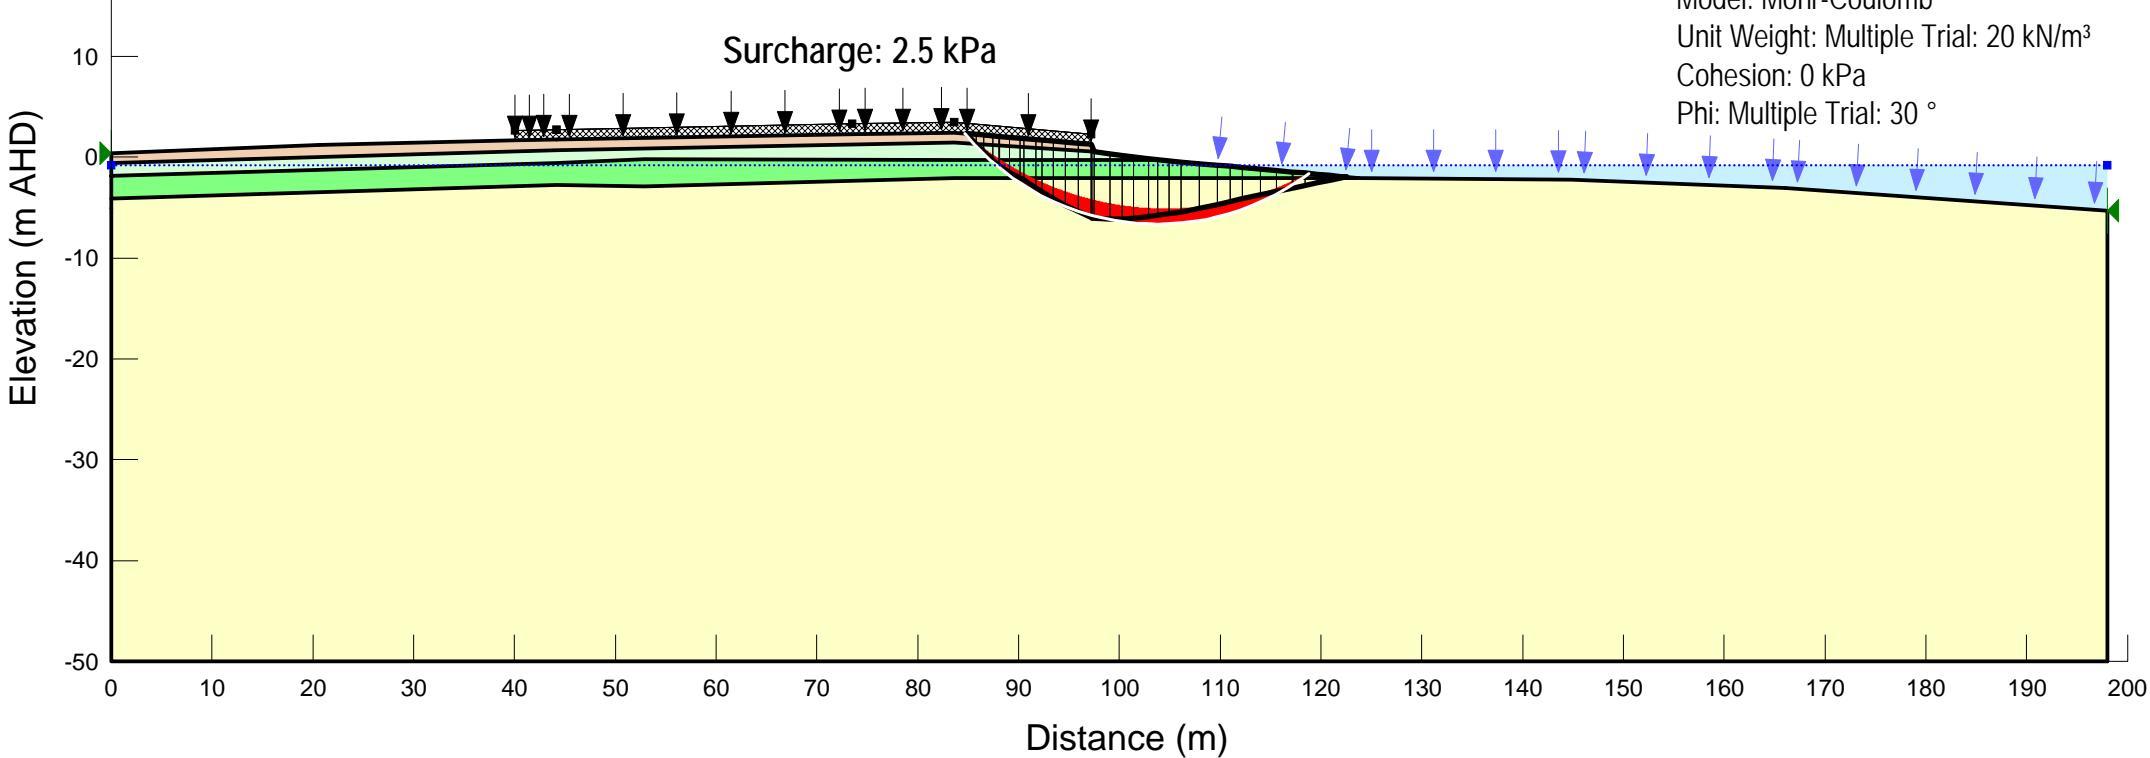
Assessment of the Existing Conditions River Water Level at -1.50m AHD Surcharge of the Properties and Cars Inferred Sub-surface Profile

Factor of Safety = 3.73

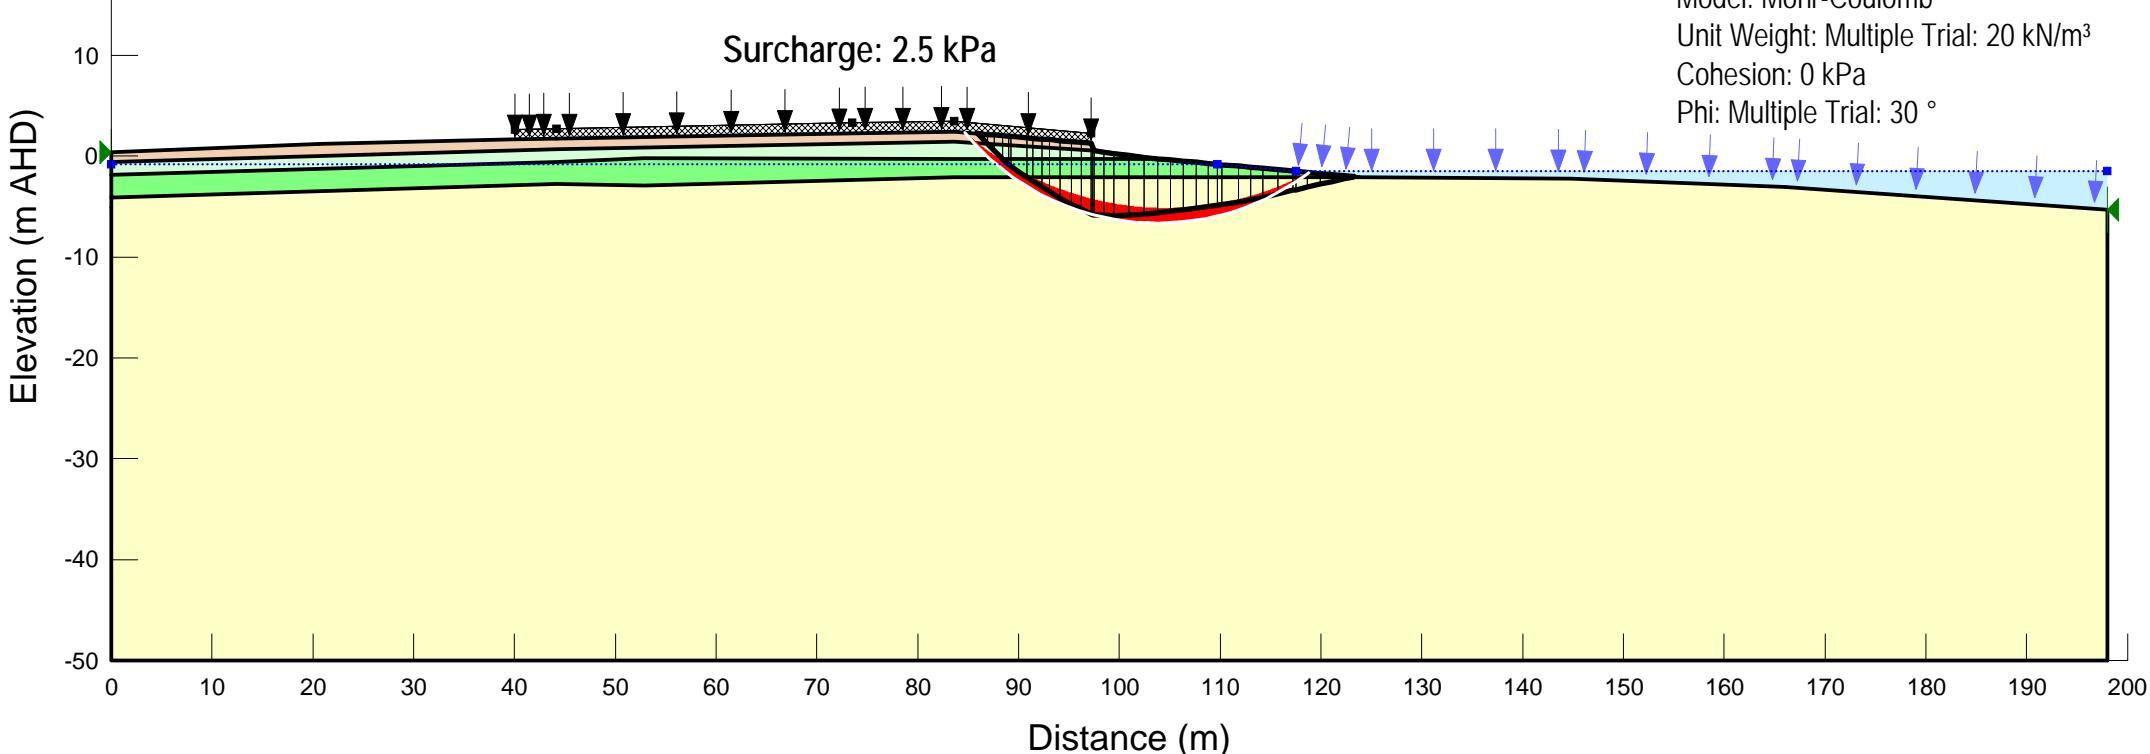
Assessment of the Existing Conditions River Water Level at -0.80m AHD Surcharge of the Properties and Cars Worst Case Sub-surface Profile

Factor of Safety = 1.67

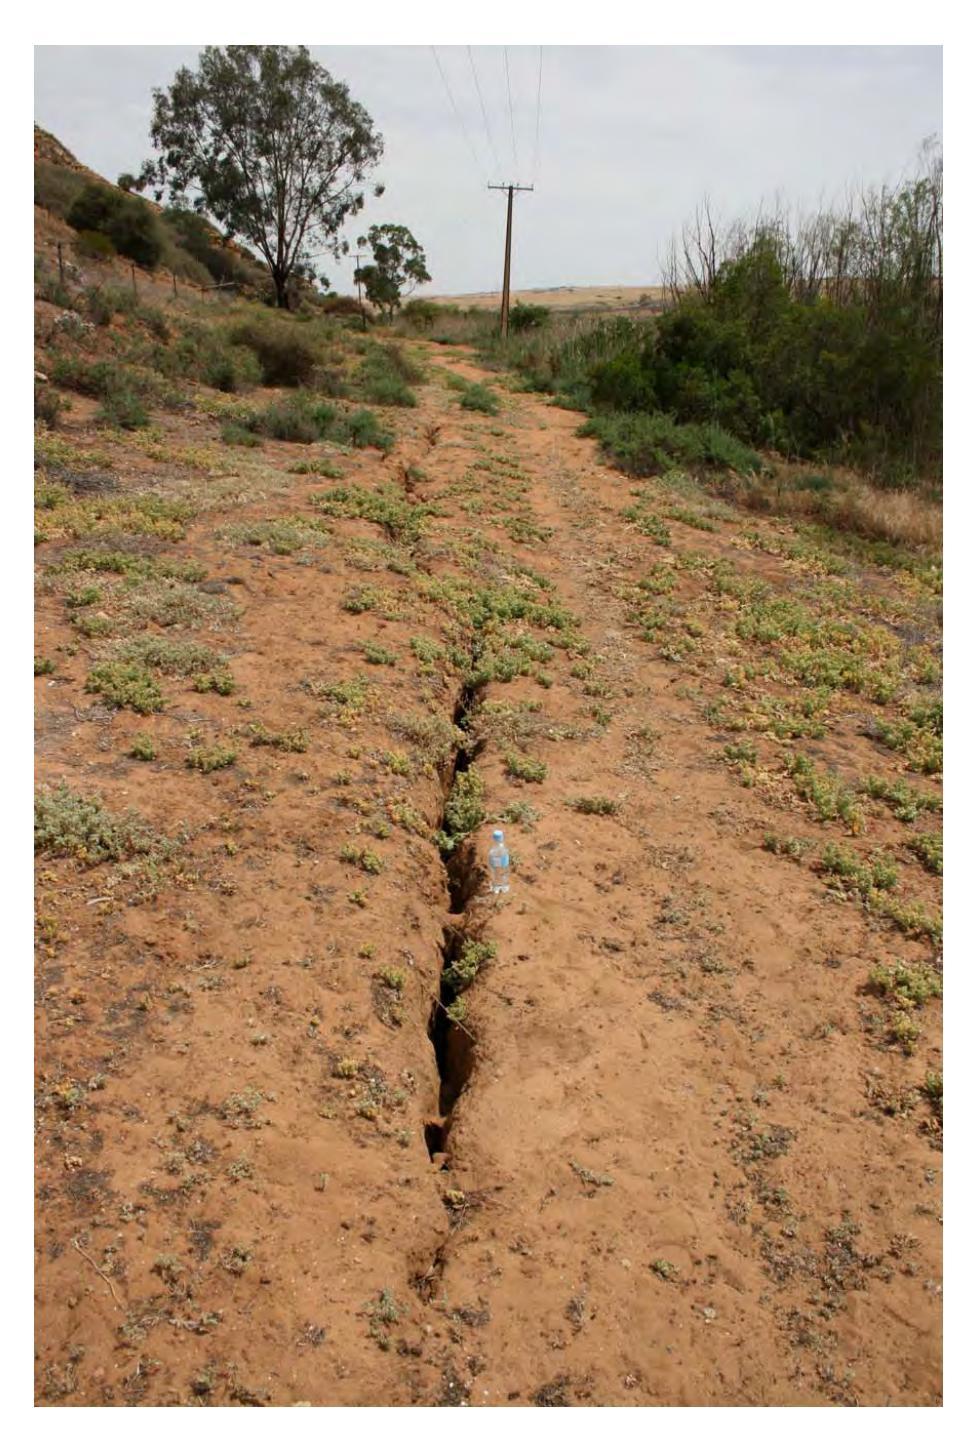
Photo 4 Caloote Tension Crack

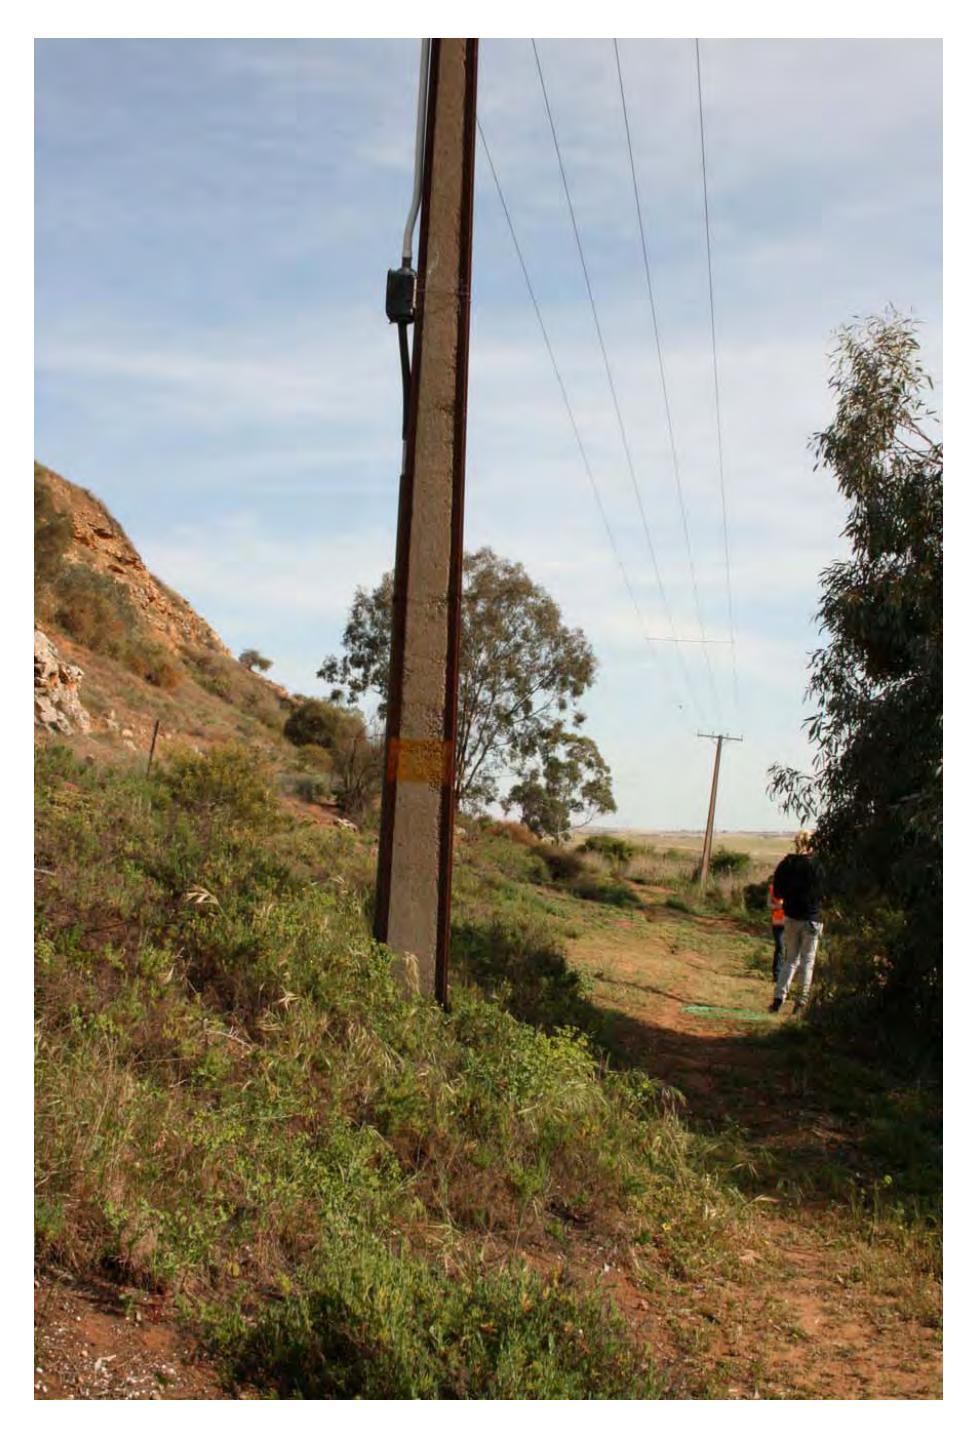
Photo 5 Caloote Tension Crack

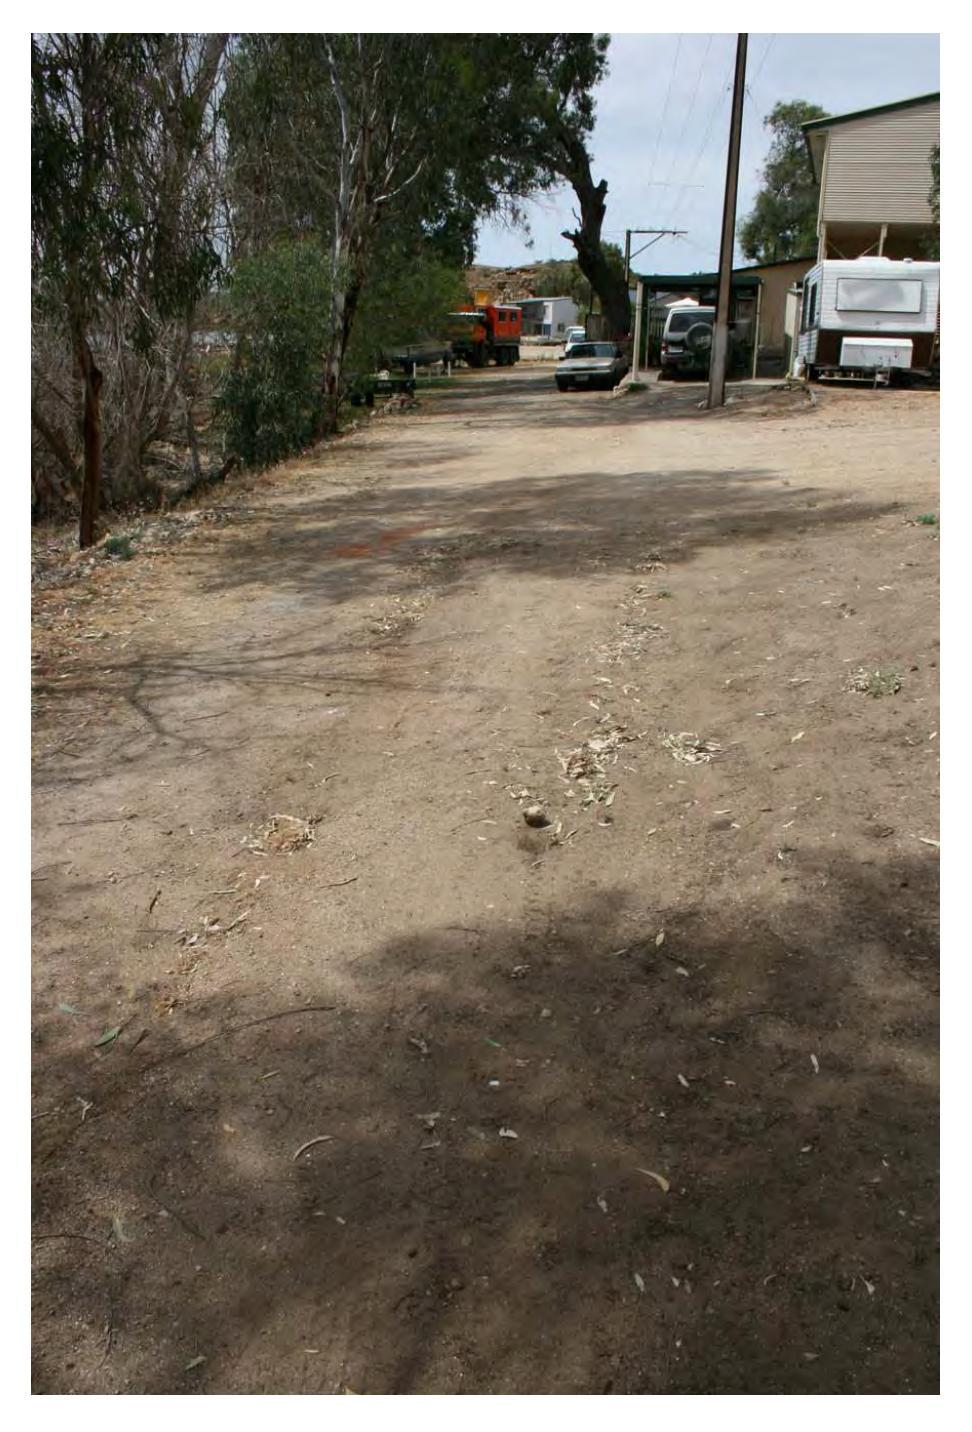
Photo 6 Caloote Tension Crack

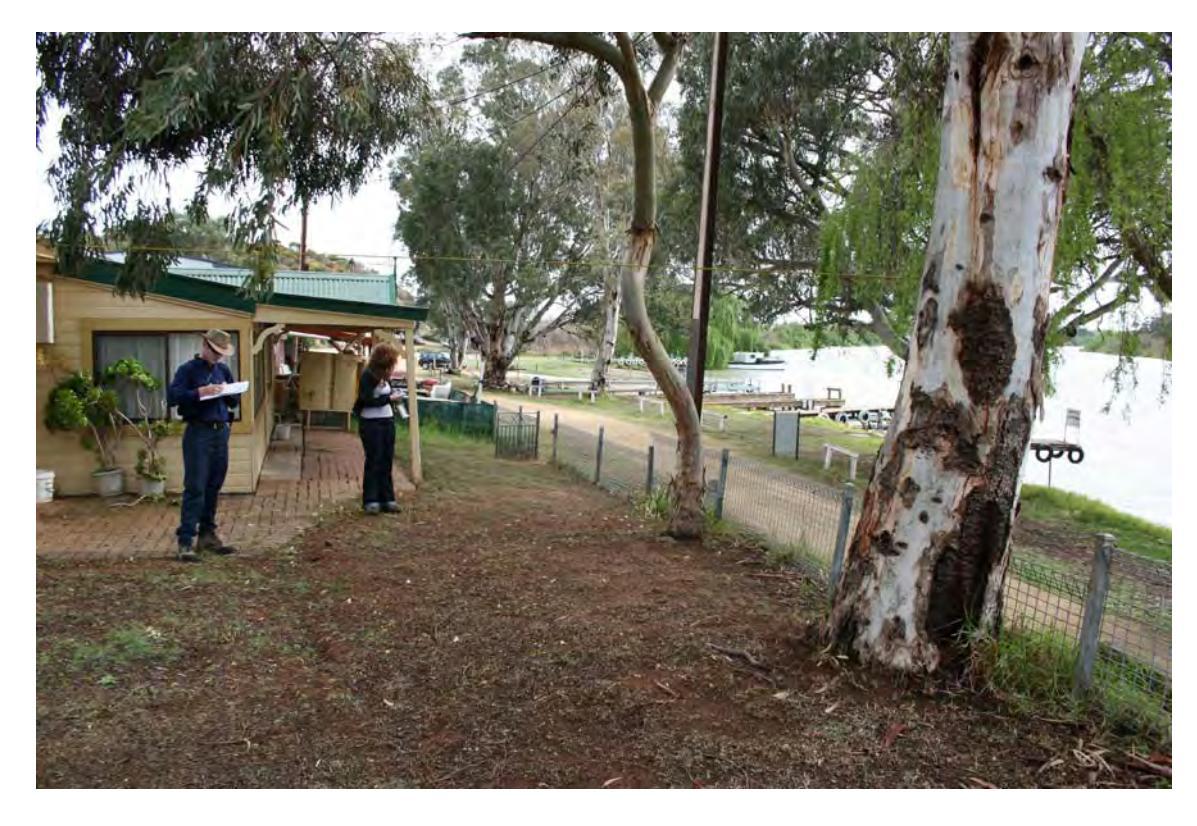
Photo 7 Caloote Tension Crack

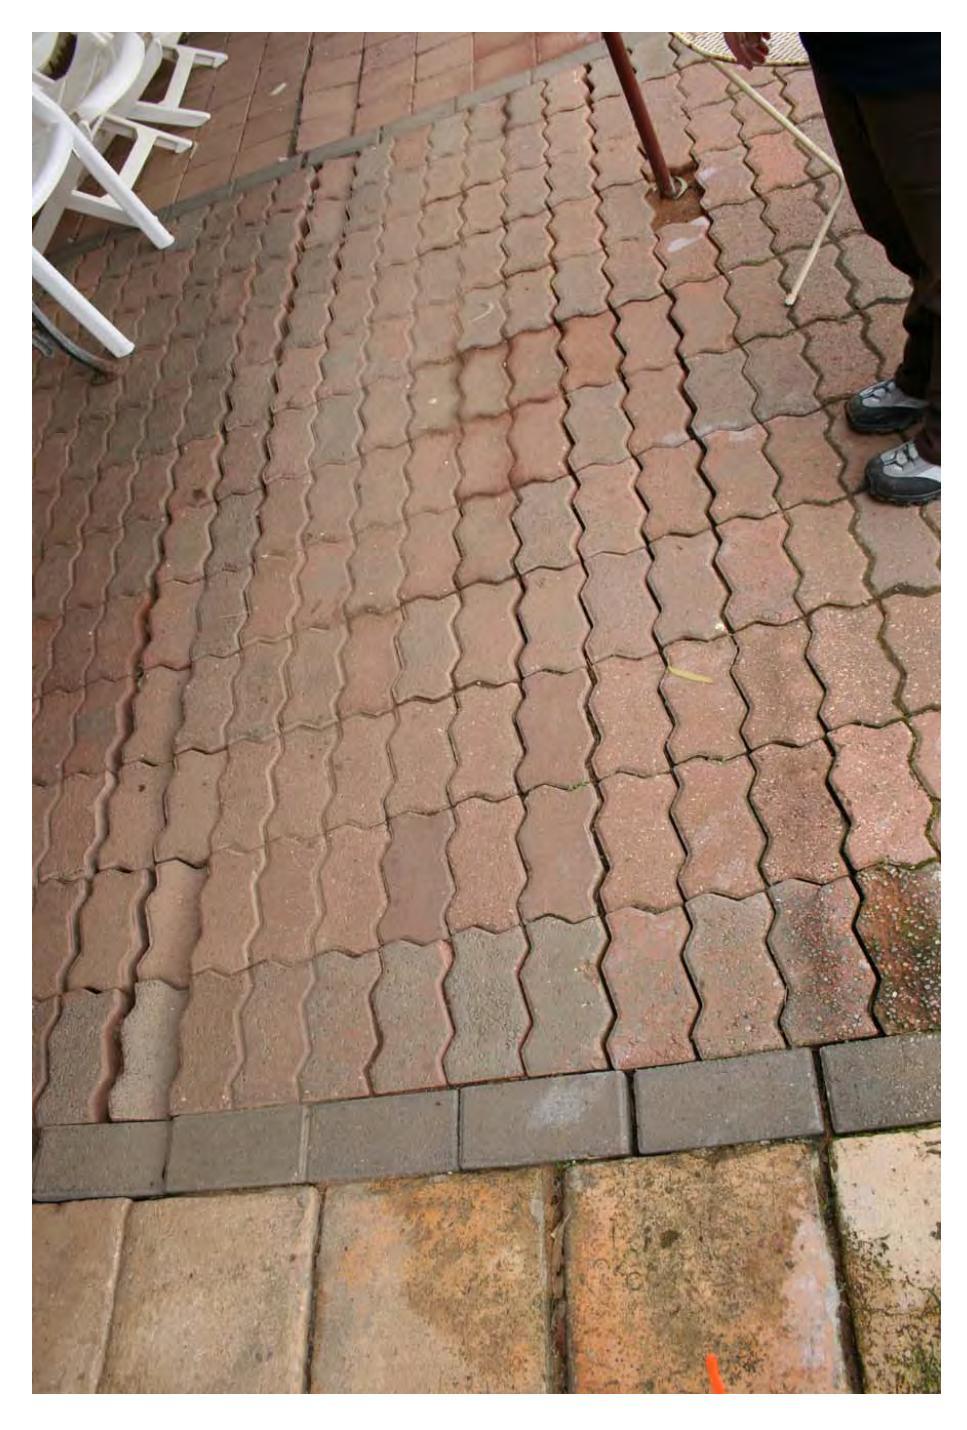
Photo 8 Caloote Tension Crack

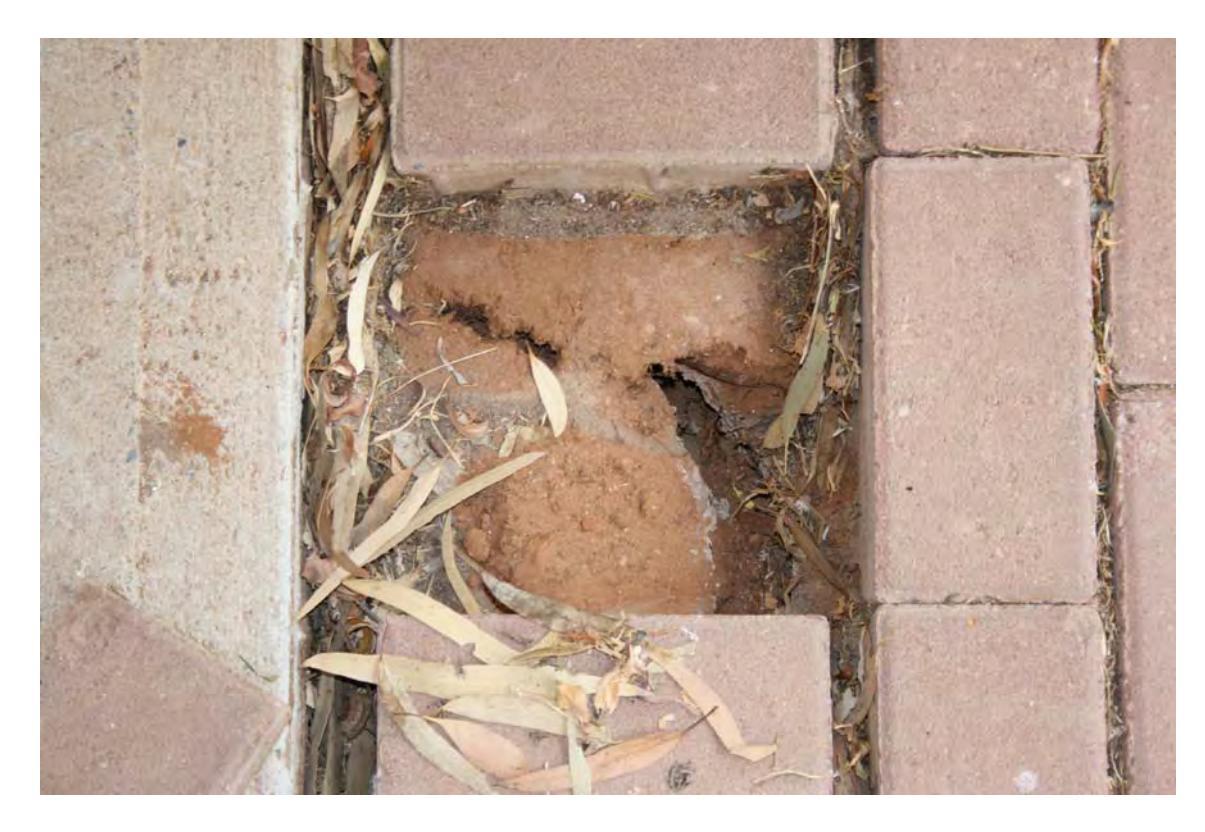
Photo 9 Caloote Tension Crack

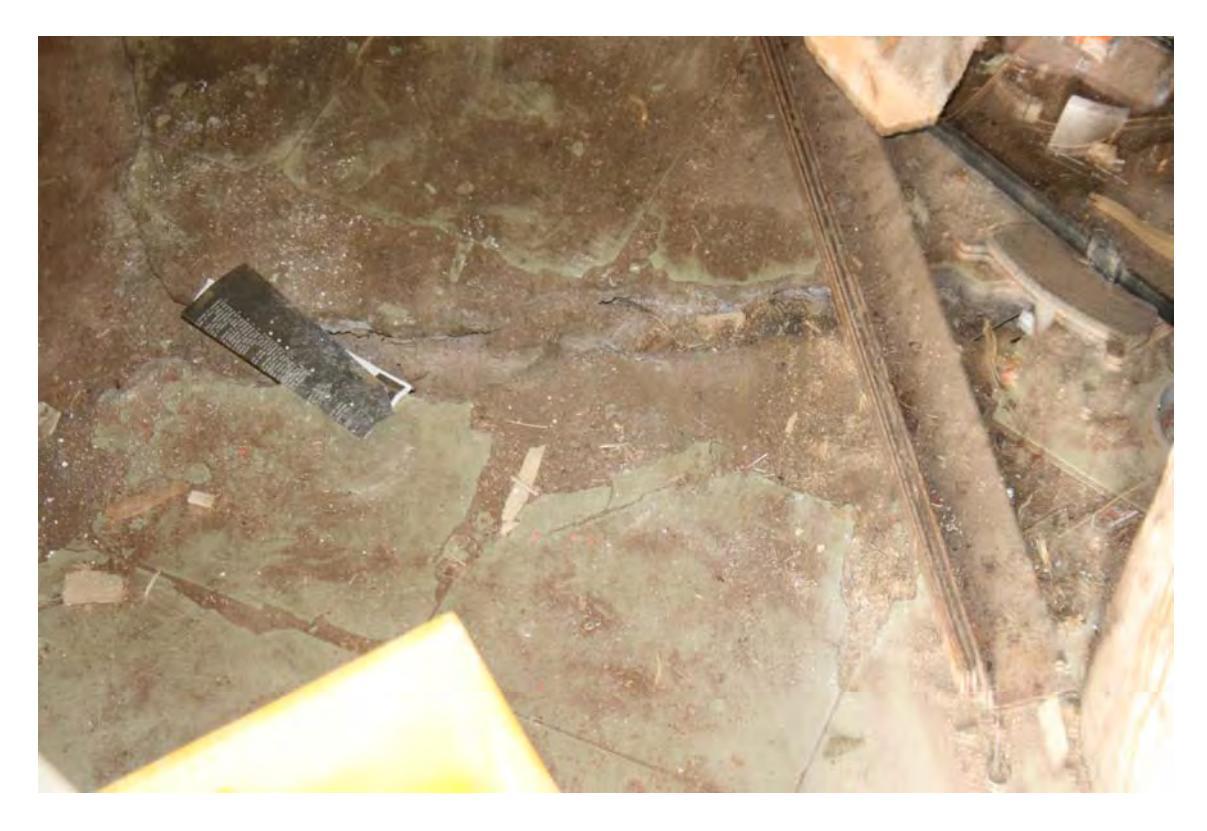
Photo 10 Caloote Tension Crack

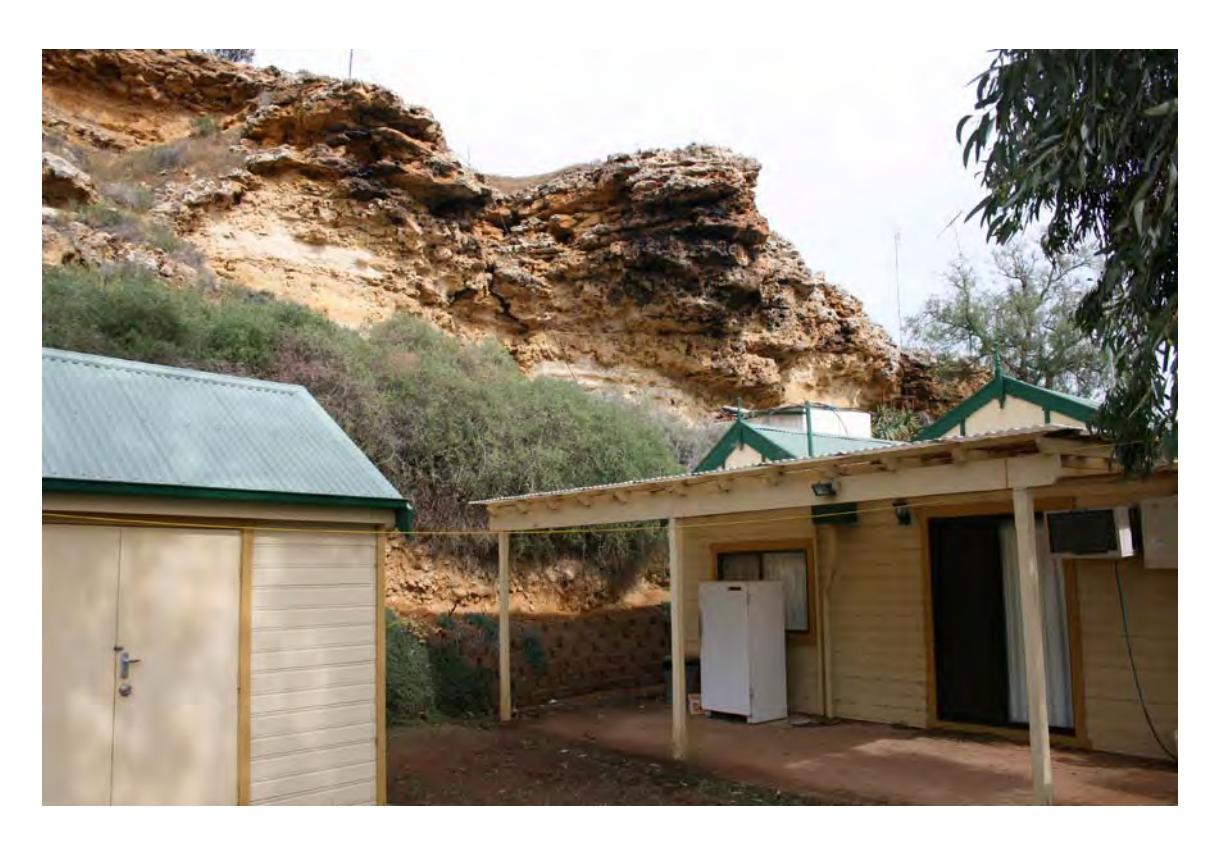
Photo 11 Caloote Cliff Overhanging Houses

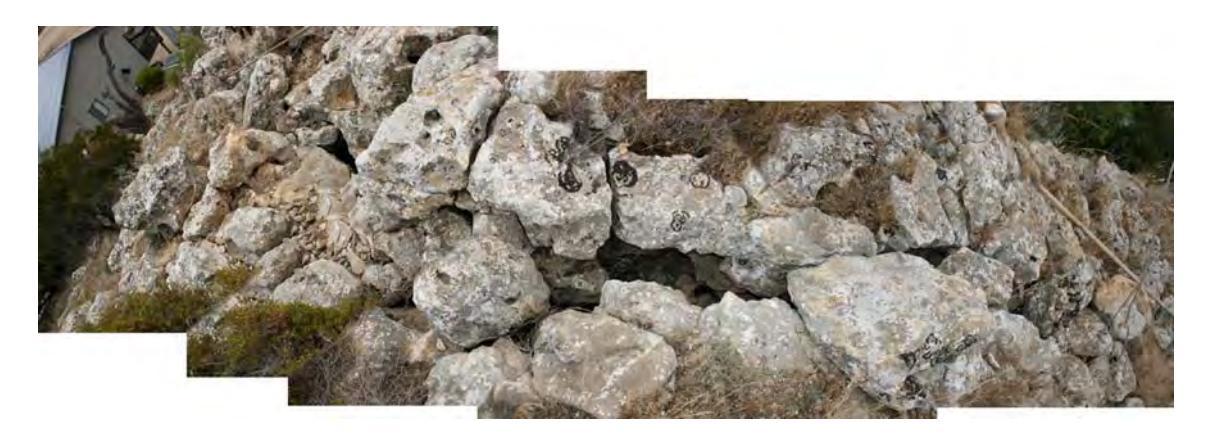
Photo 12 Caloote Evidence of Crack Progression
