24 March 2010

LowerMurray\_PartA\_FloodEffects\_v7.DOCX VE23346.02

# Part A: Lower River Murray - Influence of NSW Floodwaters on the potential for a River Bank collapse to occur

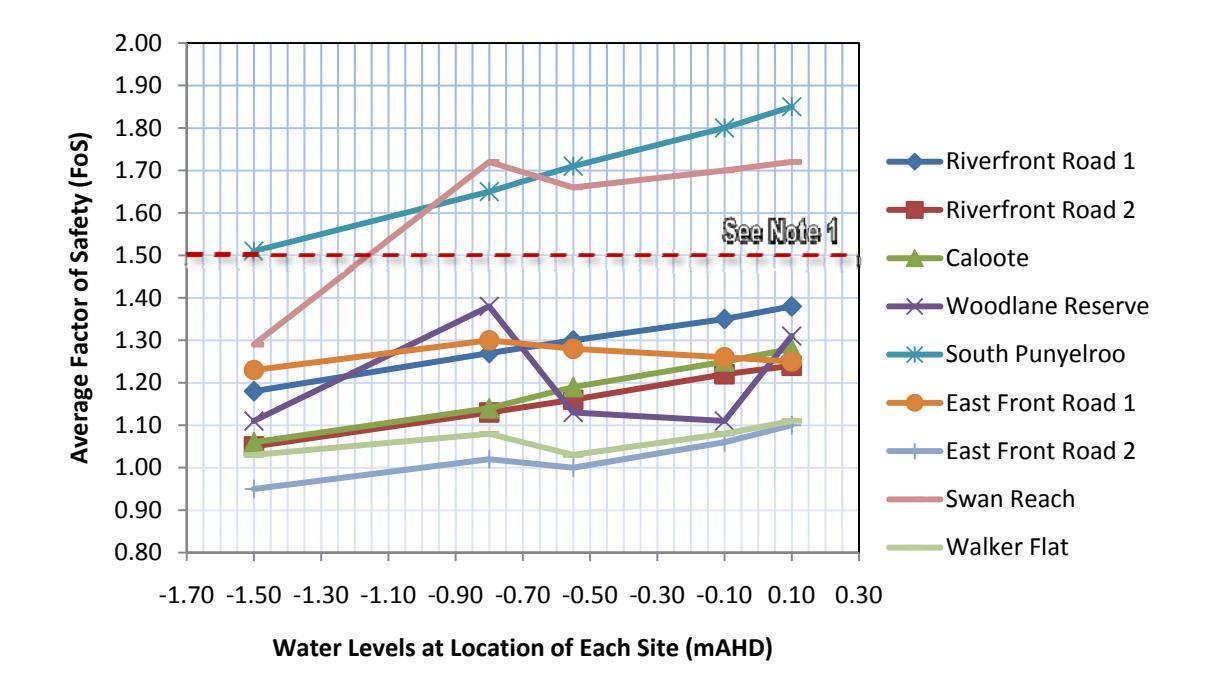
#### Figure 2: Summary of FoS at investigated sites for different water levels at each site

The results of the stability analyses indicate that:

- At Riverfront Road and Caloote, raising water levels increases the FoS, but not to figures above 1.5.
- At Woodlane Reserve, Walker Flat and East Front Road, the Factors of Safety have been reduced by water level rise to -0.55 and -0.1 m AHD and remain below FoS 1.5 to WL +0.10m AHD;
- Only South Punyelroo remains with FoS above 1.5 for the water level range considered.
- At Swan Reach, considering a worst condition for the depth of the existing crack and the slope of the soft layers underlying the site, raising the water level reduces the FoS but not

to less than 1.5. Lowering the river level to RL-1.50mAHD will result in a FoS less than 1.50 at Swan Reach;

- In Woodlane Reserve, sandy layers provide a significant proportion of the forces resisting slope stability failure. Unfortunately, in this situation, an increase in water level leads to a reduction in the resisting forces. However, the Factor of Safety is already less than 1.5, so the implications are not significant, as the site has already been designated "High Risk". Existing fencing needs to remain in place for the foreseeable future. Long term unrestricted access may require remedial works which would require a separate study.

- The existing cracks do not reduce the Factor of Safety due to water level rise;
- Owing to the very slow rate of river drawdown (650mm in 8 months, a maximum 100mm per month or 3mm per day), the slow rate of fall in water level will not affect stability as "rapid drawdown" conditions do not exist;
