Morambro Creek and Nyroca Channel PWCs and Morambro Creek PSWA

Surface water status report
2011–12

Government of South Australia
Department of Environment,
Water and Natural Resources

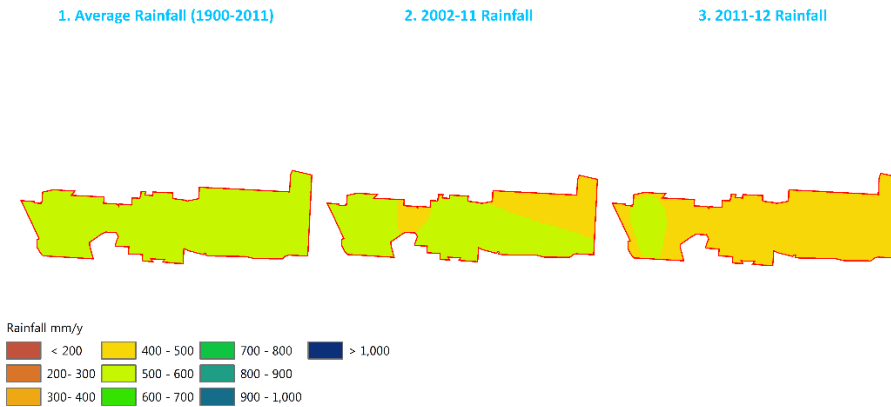
Figure 2. Annual rainfall distributions for the PA

Rainfall in the PA is typical of the South East, with hot, dry summers and cool, wet winters. The three panels of Figure 2 indicate that a part from a portion on the western side of the PA, rainfall was below average for the year 2011–12 (panel 3) in comparison to the long-term and short-term averages (panels 1 and 2).

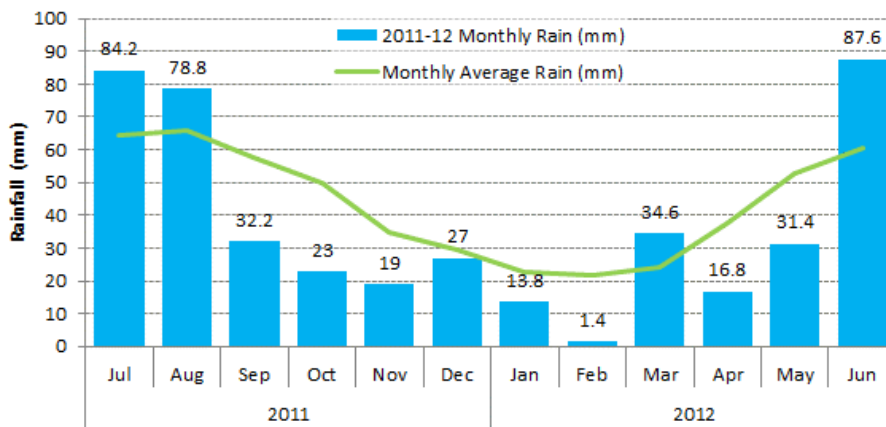
Figure 3. Monthly rainfalls at Frances (M026007)

The Frances Bureau of Meteorology (BoM) rainfall station received a below average rainfall of 450 mm in 2011–12 in comparison to its long-term average of 521 mm (Figure 3). Above average rainfall was received predominantly in the winter months across 2011–12 with September to February and April and May receiving well below average rainfall. October, February and April received less than half the monthly average rainfall.

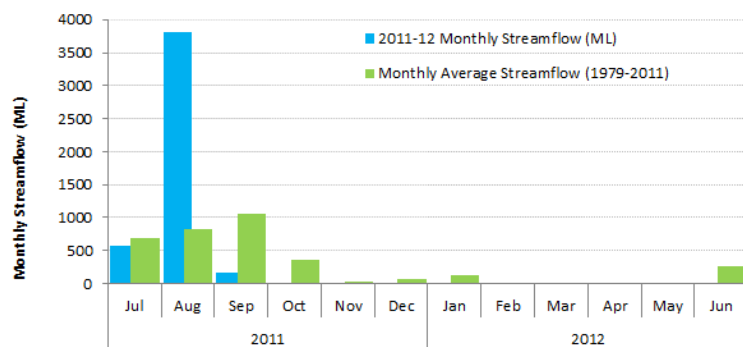
Figure 4. Monthly streamflow at Morambro Creek (A2390531)

Morambro Creek at Bordertown–Naracoorte Road Bridge gauging station (A2390531) experienced an above average annual streamflow of 4550 megalitres (ML) for 2011–12 (32% higher than the 3459 ML long-term average). The monthly breakdown of streamflow for 2011–12 (Figure 4) highlights that August was the only month to receive well above average streamflow. August alone received 84% of the annual total with all other months receiving below average streamflow. No streamflow was recorded from November to June.

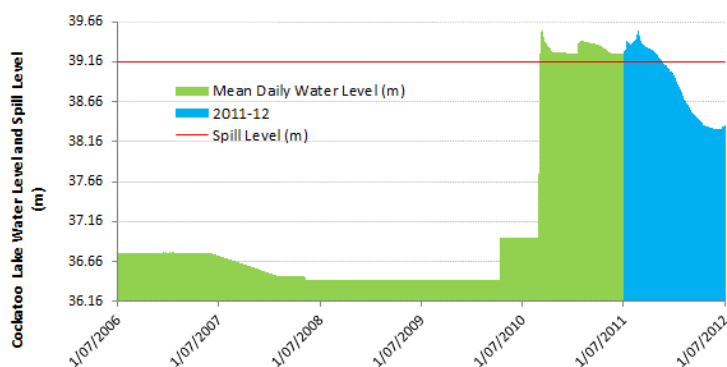
Figure 5. Water level at Cockatoo Lake (A2391074)

The Cockatoo Lake monitoring station (A2391074) is approximately 15 km downstream of the Morambro Creek gauging station and monitors water level only. The estimated base level of the lake is 36.16 m AHD with a spill level of 39.15 m AHD. Spill from Cockatoo Lake flows along Nyroca Channel for approximately 30 km and ultimately discharges into the Marcollat Watercourse. Cockatoo Lake exceeded capacity for 140 days (38% of total days) during 2011–12 (Figure 5) but failed to exceed capacity in the second half of the year due to reduced streamflow in Morambro Creek.

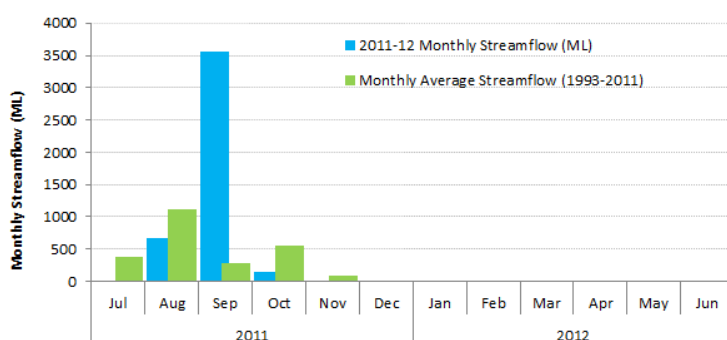
Figure 6. Monthly streamflow at Jip Jip Weir (A2391074)

Jip Jip Weir (A2391023) is located at the downstream end of the Marcollat Watercourse, downstream of a regulator for the Marcollat system. This surface water monitoring site is located outside of the PA and is not used to determine the surface water status, however, flows recorded at Jip Jip Weir affect the taking of water from the PA. Jip Jip Weir received 4378 ML of streamflow in 2011–12 (Figure 6), the first year of recorded streamflow since its 24 ML in 2003–04. The last significant streamflow recorded at Jip Jip was 16 526 ML in 1996–07.

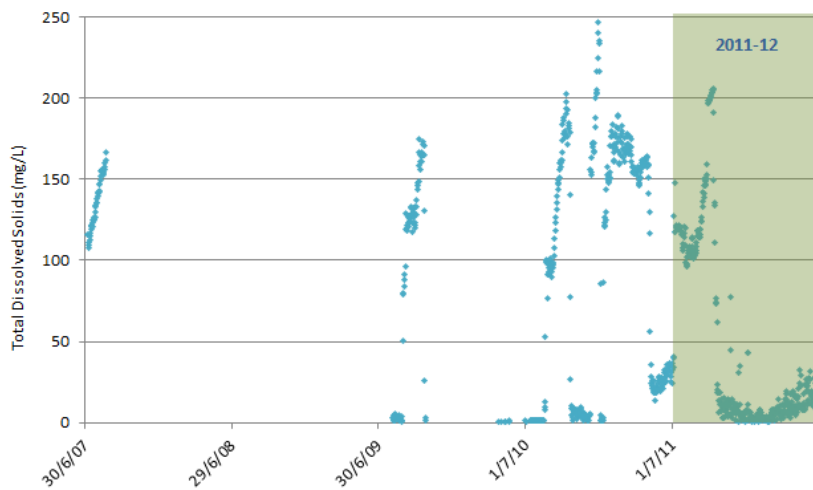
Figure 7. Salinity data at Morambro Creek from 2007–2012

Due to the ephemeral nature of Morambro Creek, streamflow is generated in response to heavy rainfall and is short lived, resulting in large data gaps when the stream is dry. Salinity data suggests that streamflow is consistently very fresh, with all data less than 250 mg/L Total Dissolved Solids (Figure 7). The range of salinity for 2011-12 is less than the previous year with the majority of salinity for the year being less than 50 mg/L.
