Lakeshore erosion monitoring data analysis

Department of Environment, Water and Natural Resources

May, 2014

DEWNR Technical Note 2014/03

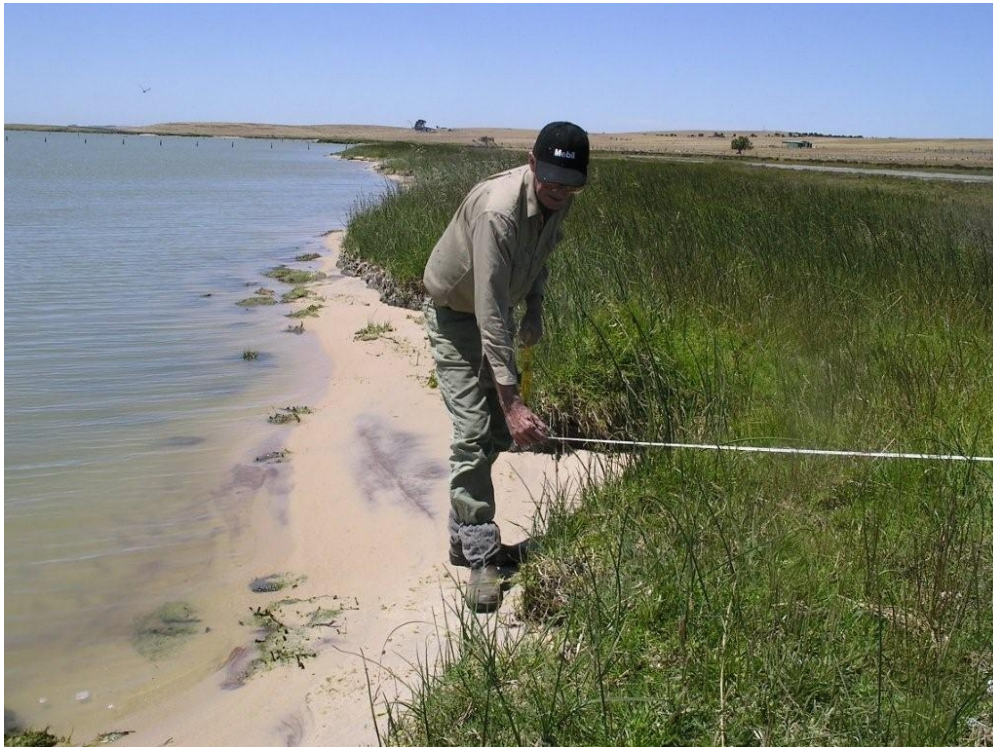
Figure 2-1. Measuring shoreline erosion from base marker

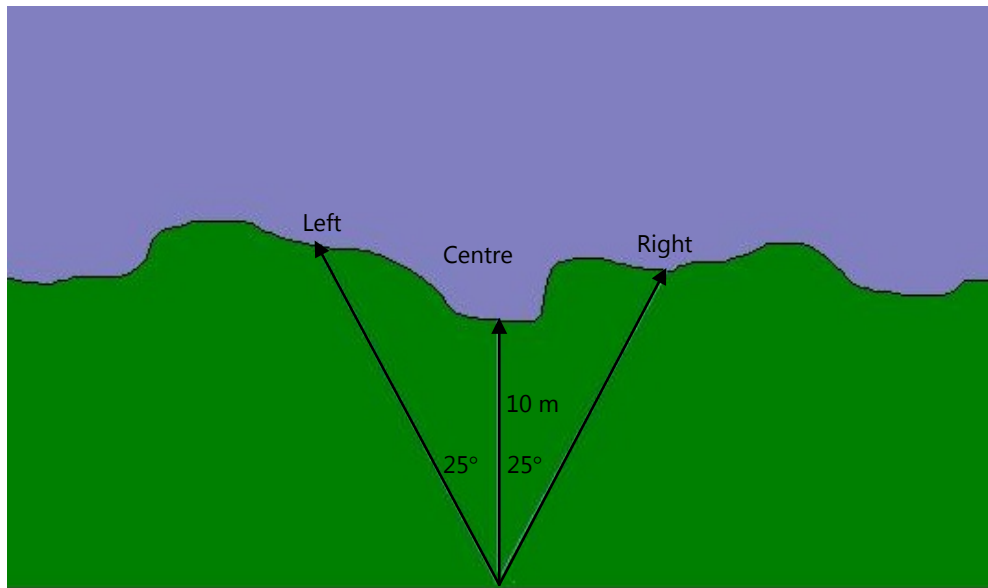
Figure 2-2. Shoreline distance measurements from a base marker located 10 m from the shoreline

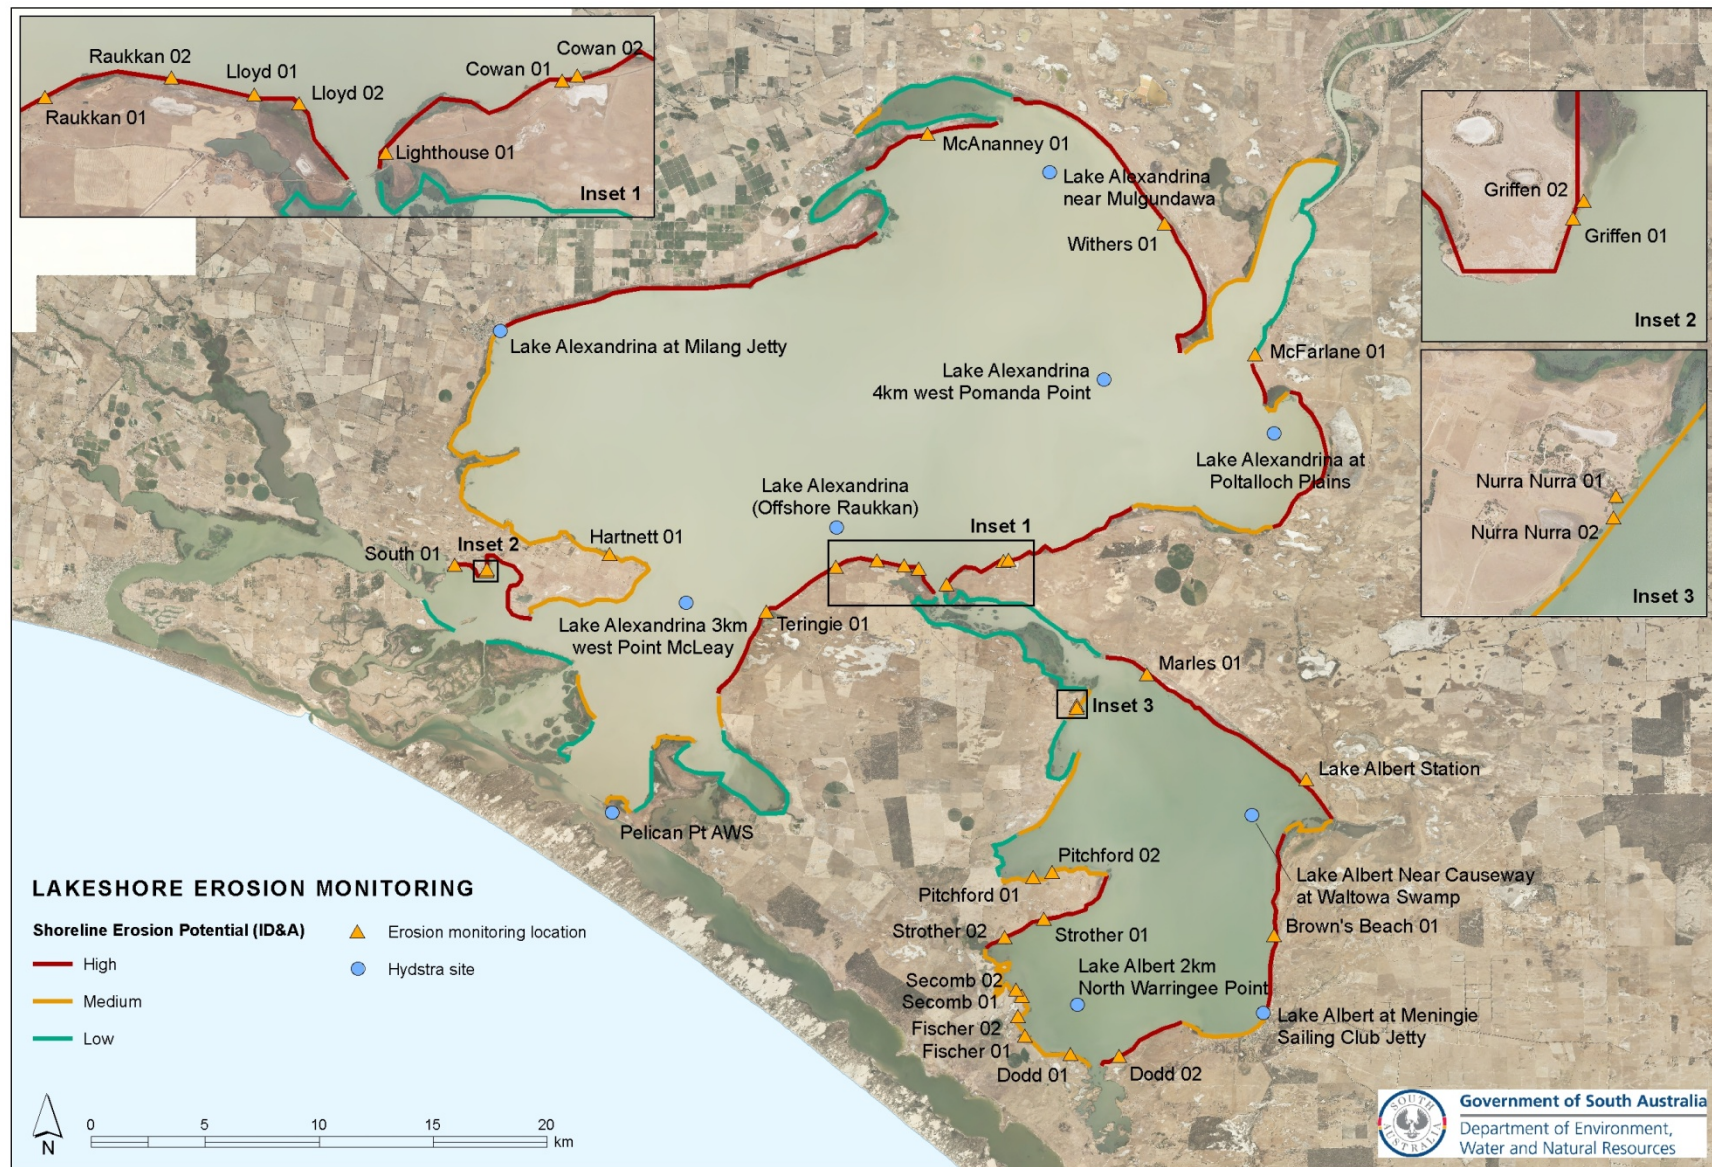
Figure 2-3. Lakeshore erosion monitoring locations and Hydstra data source locations

A map showing the locations of the erosion monitoring sites and the sources of Hydstra data used in the analyses is provided (Figure 2-3). The lakeshore erosion potential (low, medium, high) markings indicated on the map are derived from the ID&A (2001) report referred to in Section 1; they are not based on the field monitoring data analyses presented in this report.

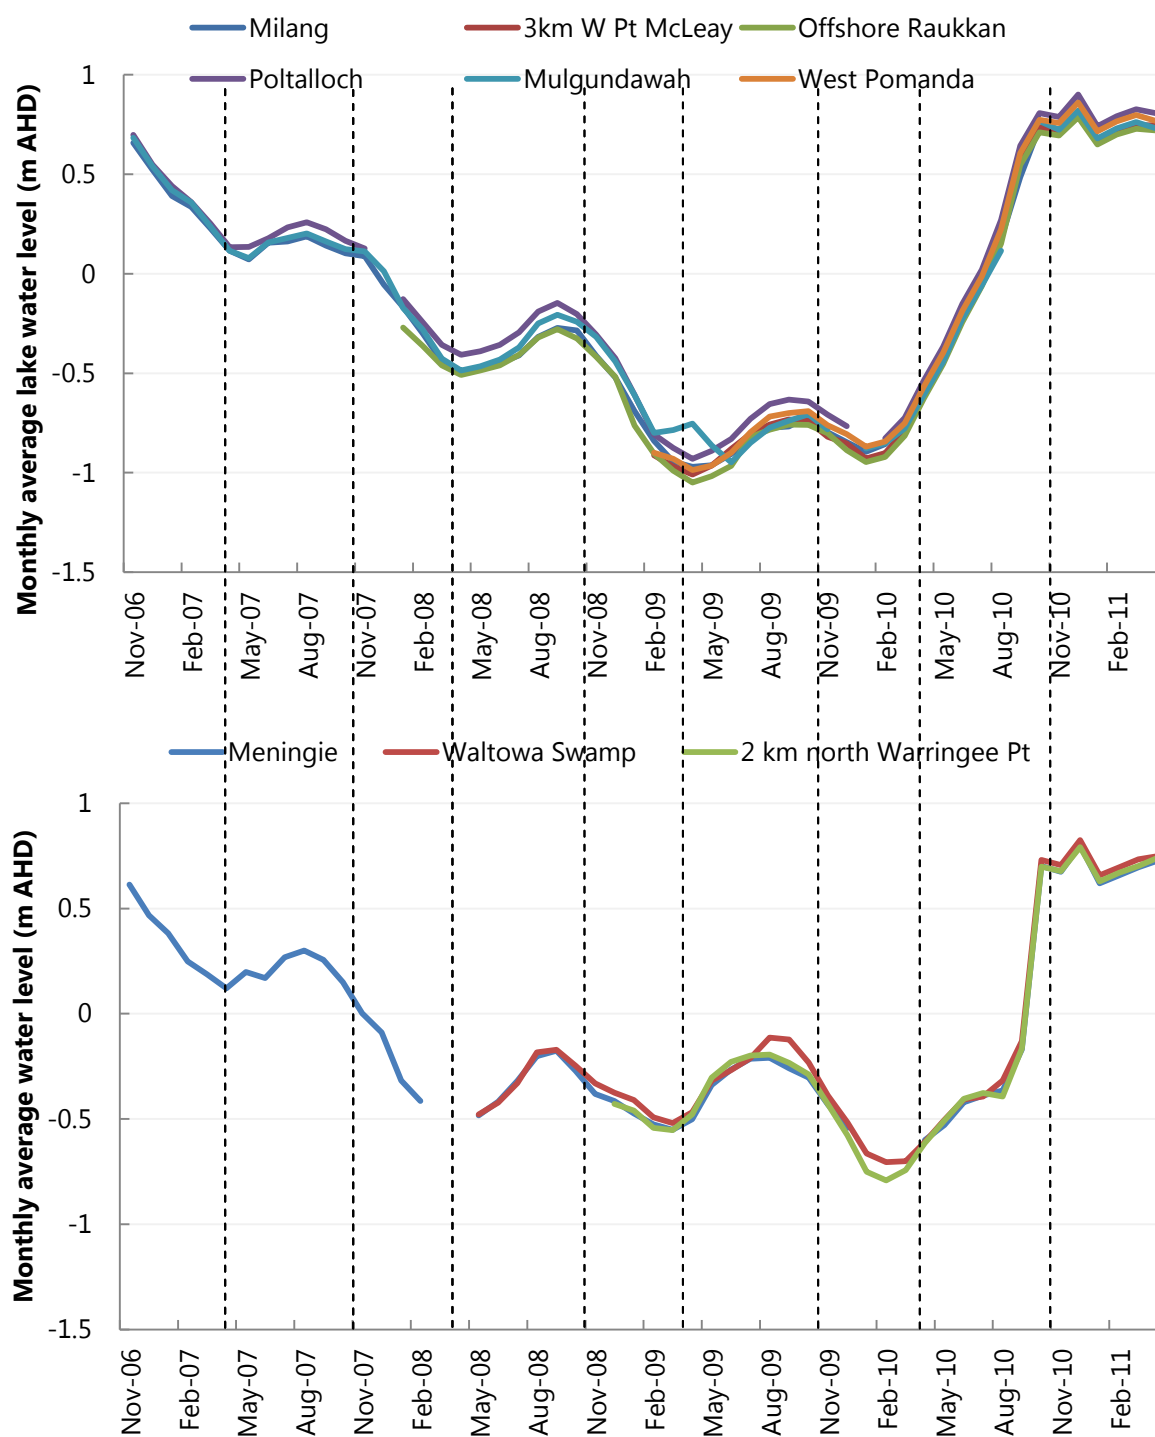
Figure 3-1. Observed monthly lake levels for Lake Alexandrina (top) and Lake Albert (bottom) during erosion monitoring period (monitoring dates indicated by vertical dashed lines)

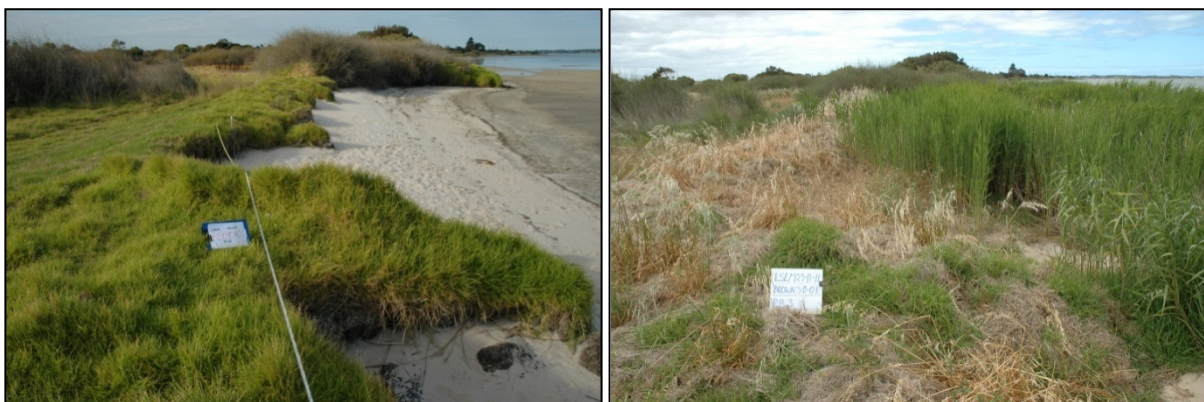
This site experienced minor erosion during the monitoring period, with net erosion at the left (L), centre (C) and right (R) monitoring points found to be 0.25 m, 0 m, and 0.3 m, respectively (average of 0.183 m across the three points). Erosion of 0.4 m and 0.6 m was measured following the April – October 2007 period at L and R, respectively, when the average lake level was 0.209 m AHD, and prevailing winds were from the NNE, WNW, W and S.

However, accretion was also apparent at some other monitoring visits; possible reasons for this include measurement inaccuracy as a result of kikuyu spreading along the bank, sand deposition (0.3 m accretion was observed at R during the April 2008 monitoring visit) and later establishment of the nearshore reed bed. No erosion was observed in April 2011 after lake water levels had returned to normal; in fact, a small amount of accretion was noted, possibly as a result of the phragmites reed bed establishment (Figure 5-1).

Figure 5-1. Browns Beach right photo point in April 2007 (l) and November 2011 (r)

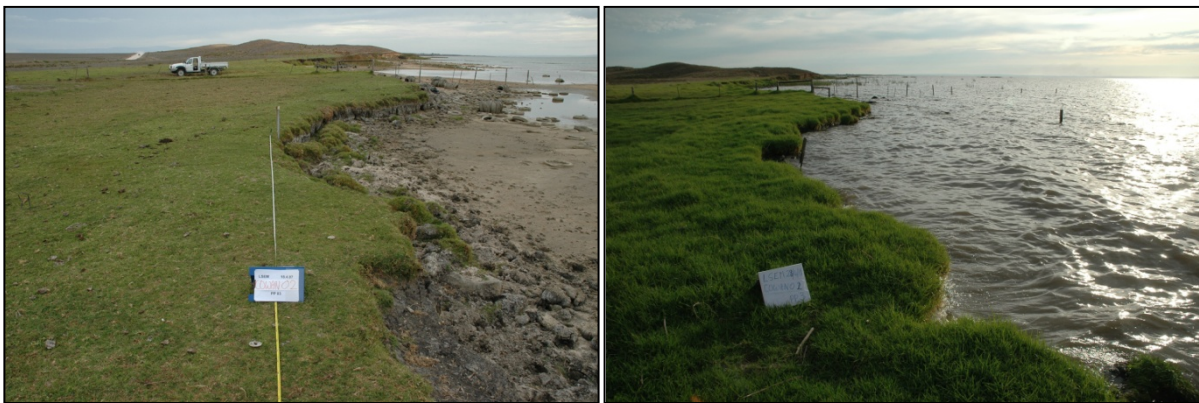
No erosion measurements were made at this site after November 2010. Moderate total shoreline erosion losses of 0.7, 0.2 and 0.8 m were measured at L, C and R, respectively. Minimal erosion was recorded between 2007 and 2009 – most of the shoreline loss was recorded in the November 2010 monitoring visit, immediately after lake levels had returned to normal operating levels after the drought.

Figure 5-2. Cowan02 right photo point in April 2007 (l) and April 2011 (r)

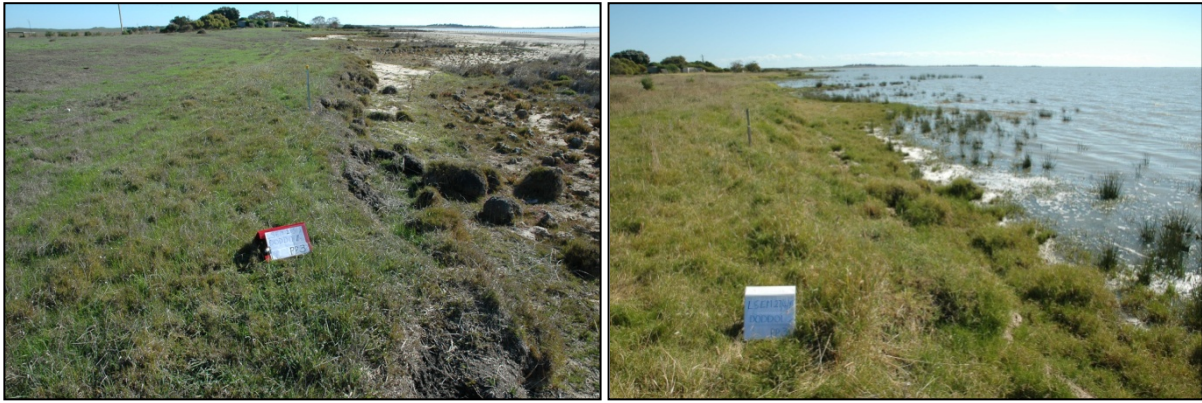
The monitoring site was established in April 2008. Erosion at this site was very minor over the monitoring period, with shoreline losses ranging between 0.1 and 0.2 m across the three measured points (L, C & R). When lake operating levels had returned to normal, bank erosion was only recorded at L and C, whereas the erosion at R occurred when the waterline was well offshore due to the drought and was due to the crumbling of dry bank soil.

Figure 5-3. Dodd01 right photo point in April 2008 (l) and April 2011 (r)

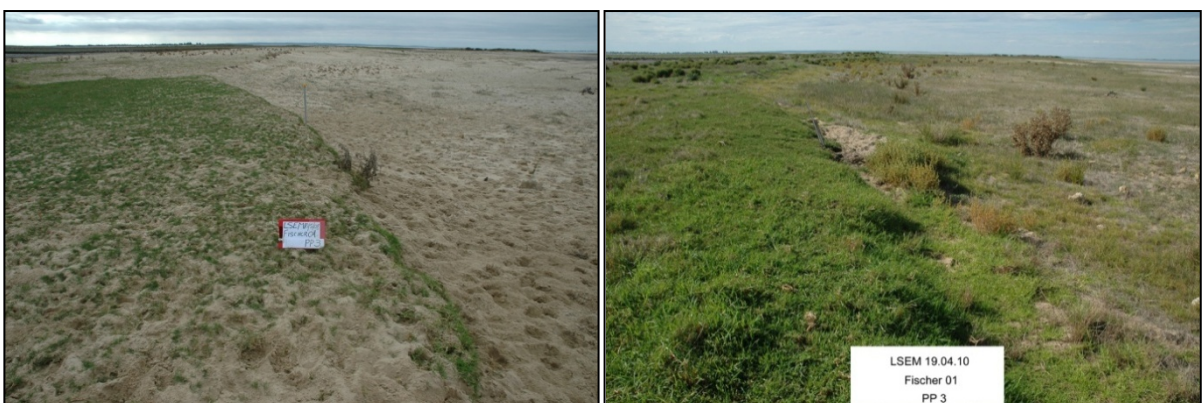
The monitoring site was established in April 2008 with erosion monitoring ceased in 2010 when the monitoring point markers were destroyed by cultivation for cropping. Erosion measurements were undertaken only in November 2008 and April 2009. During this time, lake levels were very low due to the drought and no net erosion occurred. However, some accretion was recorded due to the windblown lakebed sand that was deposited onto the shore. The deposition of aeolian sand from the dry lakebed during 2008 and 2009 is unsurprising since the shoreline directly faces the prevailing wind of the drier summer months (November to March).

Figure 5-4. Fischer01 right photo point in May 2008 (l) and April 2010 (r)

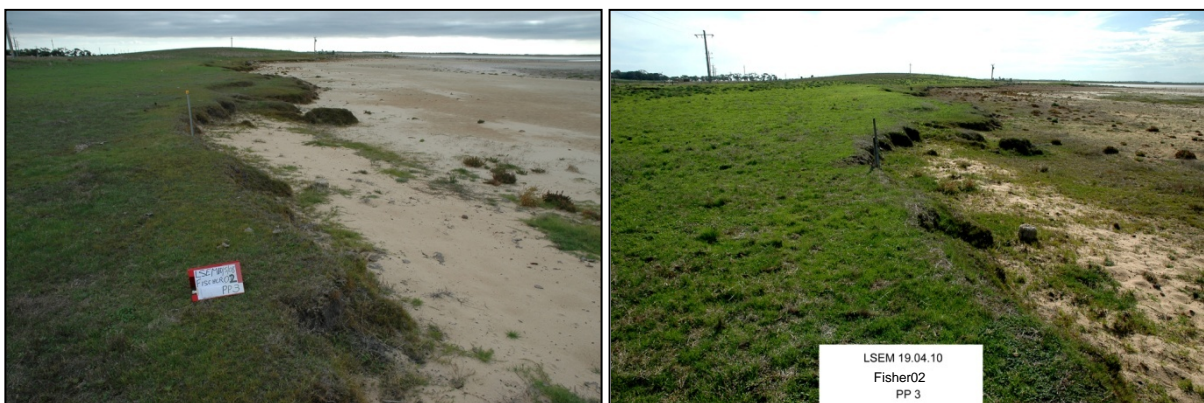
The monitoring site was established in April 2008 with erosion monitoring ceased in 2010 when the monitoring point markers were destroyed by cultivation for cropping. Erosion measurements were undertaken only in November 2008 and April 2009. During this time, lake levels were very low due to the drought and no net erosion occurred.

Figure 5-5. Fischer02 right photo point in May 2008 (l) and April 2010 (r)

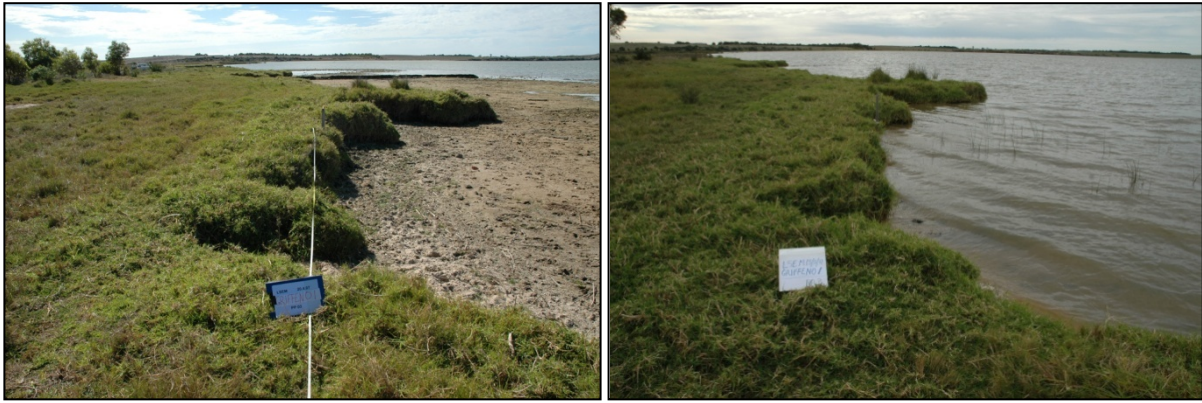
Erosion at this site was moderate. At the April 2007 monitoring visit, 0.5 m of bank loss was observed at the left (L) transect. At the April 2011 monitoring visit, following the return of normal lake levels, further erosion of 0.3, 0.8 and 0.9 m was measured at L, C and R, respectively. The average shoreline loss measured at this site was 0.9 m, with almost all of the erosion occurring during the period when lake levels were at or near normal operating levels. Given the site's south-easterly aspect, it is likely that the prevailing summer-period winds (typically ranging SSW to SSE) were a contributing factor to wave erosion of the shoreline.

Figure 5-6. Griffen01 right photo point in April 2007 (l) and May 2011 (r)

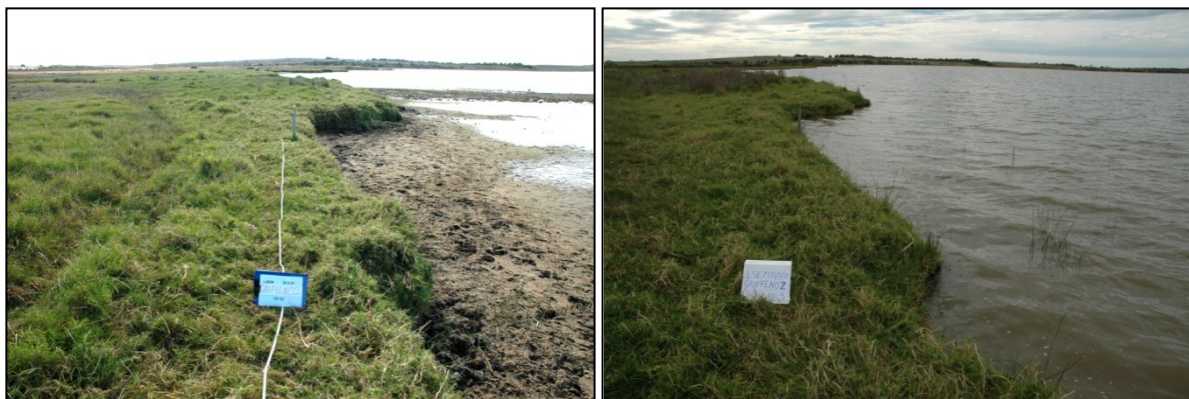
The characteristics of Griffen02 are almost identical to those of Griffen01 (Figure 5-7). Griffen02 is located approximately 80 m NNW of Griffen01, on the northern side of the groyne. Erosion at this site was minor. No erosion was observed at L or C during the monitoring period, however 0.4 m of net shoreline loss was measured at R following the restoration of normal operating lake levels after the drought.

Figure 5-7. Griffen02 right photo point in April 2007 (l) and May 2011 (r)

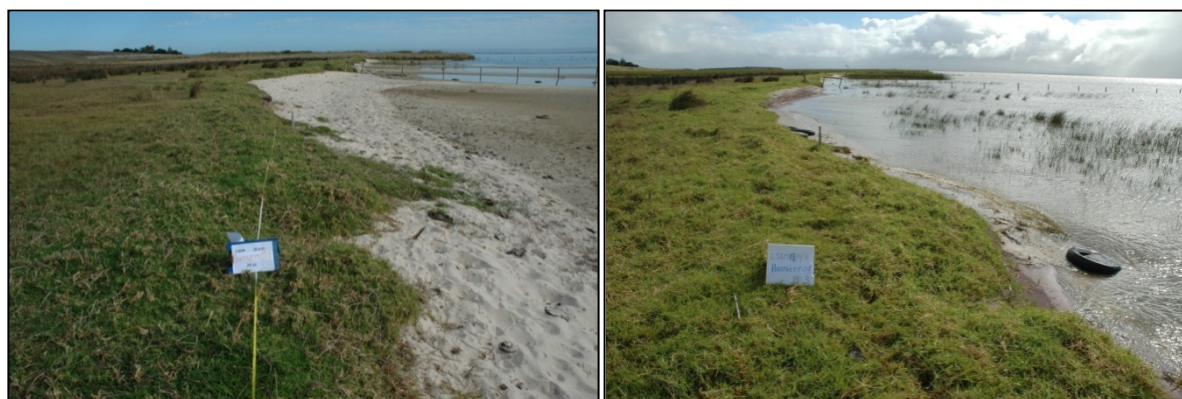
Hartnett is located on an eroded shoreline with a northerly aspect, with a medium erosion risk rating, on the northern side of Point Sturt in Lake Alexandrina. The 0.4 m high shoreline bank consists of Poltalloch soil; it is vegetated with kikuyu and subject to controlled grazing by cattle (Figure 5-8). Some offshore establishment of rushes and other water plants occurred following the restoration of normal lake levels. Soil dispersion was not detected at the surface, but was found to be slight at depth within the soil profile.

No erosion was recorded at this site; in fact net shoreline accretion was observed at all three transects (L, C and R), varying between 0.03 and 0.85 m. The shoreline growth at this site is attributable to the spreading of the kikuyu cover across the sandy beach. Furthermore, the shoreline does not face a commonly-prevailing wind direction (although northerly winds are frequent during some winter (April – October) periods).

Figure 5-8. Hartnett right photo point in April 2007 (l) and May 2011 (r)

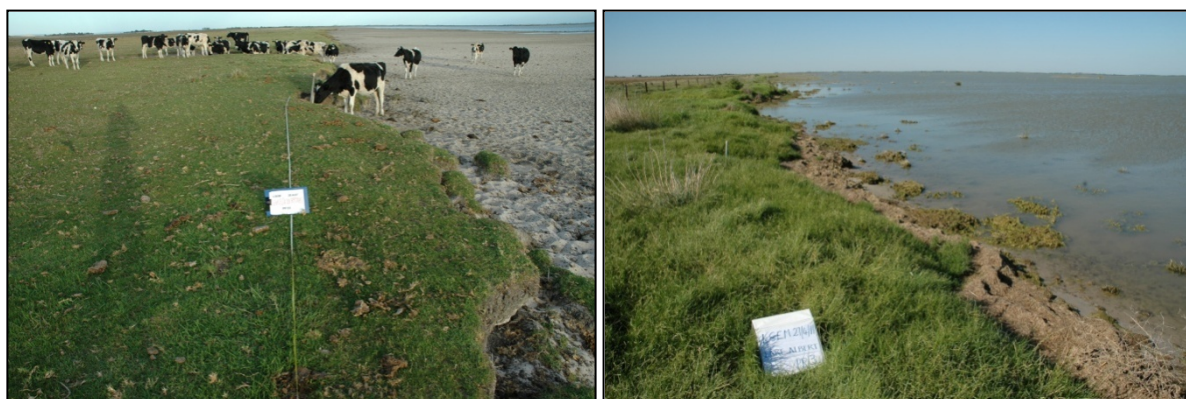
No erosion measurements were taken at this site after November 2010 due to the base marker having been broken off and monitoring pegs having been buried in sand. No erosion was observed following the restoration of normal lake levels after the

drought, presumably due in part to the thick blanket (up to 20 cm deep) of dried algae that was deposited along the shoreline, protecting the bank from physical erosion by water waves. Between setup in November 2006 and April 2009, the net erosion observed was estimated to be 0.7 and 0.5 m at the L and C transects, respectively, whereas net accretion of approximately one m was observed at the R transect.

Figure 5-9. Lake Albert Station right photo point in April 2007 (l) and May 2011 (r)

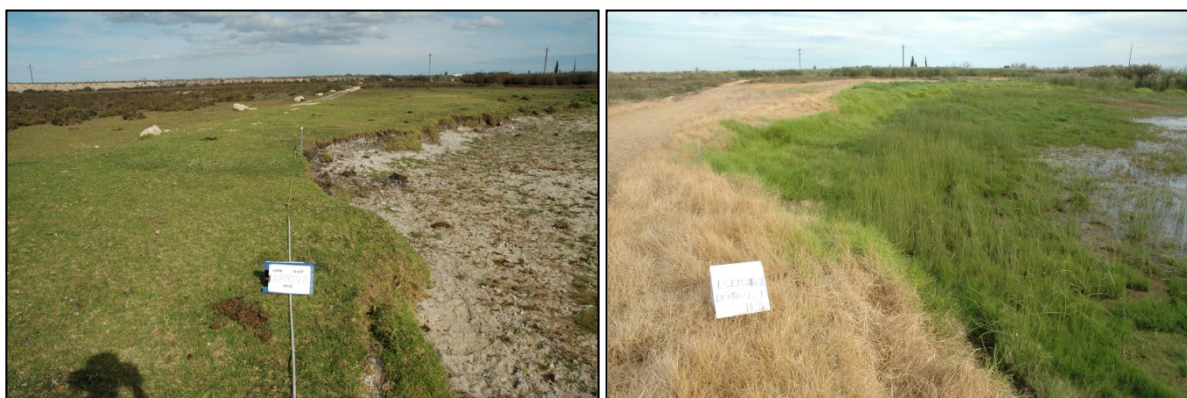
The 0.6 m high Poltalloch soil lake shoreline is vegetated with kikuyu and paspalum and was regularly grazed by cattle until 2010 when exclusion fencing was constructed. When the lake levels were restored to normal levels in late 2010 after the drought, the lake edge was noted to be covered with kikuyu, algae and other plants. The kikuyu was sprayed for weed control in April 2011, as can be seen from Figure 5-10.

Erosion at this site was moderate. However, all erosion during the monitoring period was observed to be a result of crumbling of the dry bank and trampling by cattle. At the time of the site setup, the water level was already too low to produce any water erosion and no erosion was observed after normal lake operating water levels were restored in late 2010. Shoreline loss at this site was 0.95, 0.4 and 0.05 m, measured at L, C and R, respectively.

Figure 5-10. Lighthouse right photo point in April 2007 (l) and April 2011 (r)

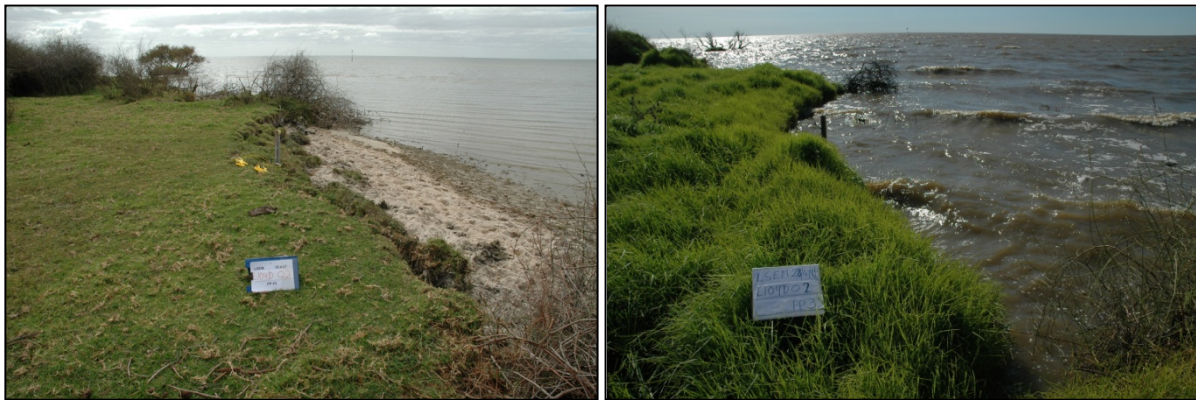
Some of the erosion at this site is attributable to cattle trampling of the dried and cracked bank during the drought period. Overall erosion at this monitoring site was moderate, with shoreline losses of 0.6, 0.9 and 0.35 m respectively, measured at L, C and R. All the erosion at C occurred following the restoration of normal lake operating levels. The site does not directly face a prevailing wind direction. However, due to its location at the entrance of the Narrung Passage, the shoreline is nevertheless likely to be affected by wave and current action due to wind-driven flow between the lakes.

Figure 5-11. Lloyd02 right photo point in April 2007 (l) and April 2011 (r)

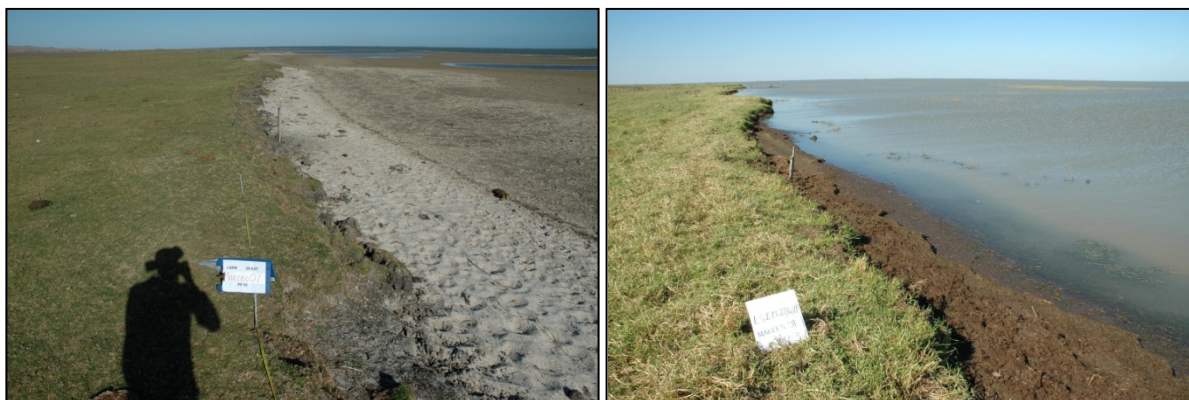
This site directly faces the prevailing wind for the warm months of the year, with a wave fetch up to 17 km. As a result, shoreline losses averaging one m were measured across all transects (L, C and R) within the first few months following setup in November 2006. During 2008, when the dry lakebed was exposed, significant onshore sand drift occurred, with sand being deposited up to 55 m inland of the shoreline. Stock trampling of the dry cracked shoreline contributed to some erosion during the drought. Following the return of normal operating lake levels, a large amount of algae and mulch material was washed onshore (visible in the second photograph in Figure 5-12), protecting the shoreline from significant erosion for at least the first few months.

Erosion at this site was significant, with total shoreline losses of 1.02, 0.97 and 1.12 m measured across L, C and R, respectively, almost all of which occurred during the first few months of monitoring before the waterline had receded well south of the shoreline.

Figure 5-12. Marles right photo point in April 2007 (l) and April 2011 (r)

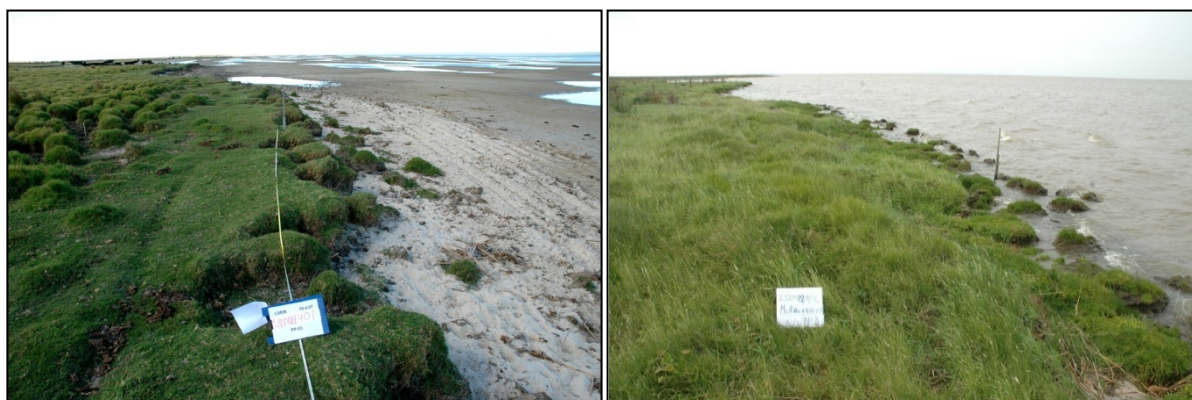
Erosion at this site was significant. Shoreline losses of 2.3, 1.1 and 1.35 m respectively were measured at the L, C and R transects, with practically all of the erosion occurring during the final months of the monitoring period, after normal lake levels were restored.

Figure 5-13. McAnanney right photo point in April 2007 (l) and May 2011 (r)

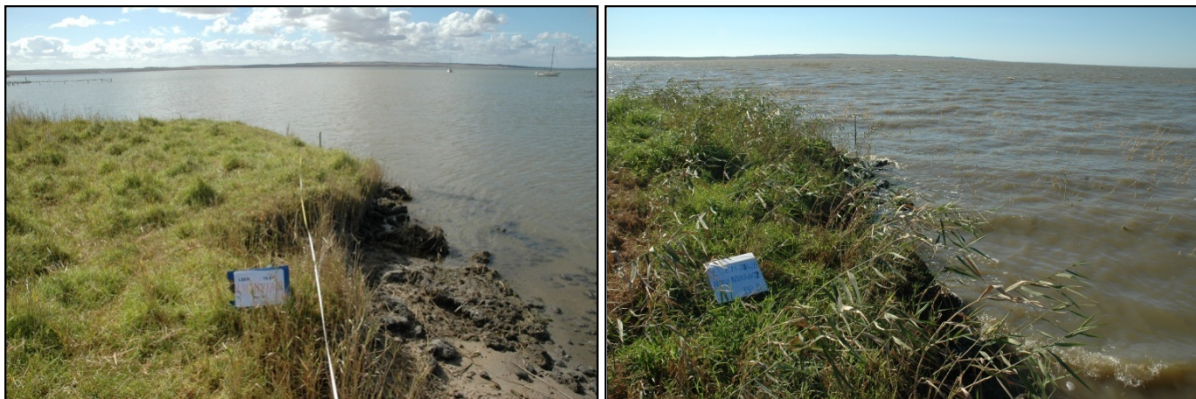
The Nurra Nurra02 monitoring site is located approximately 100 m south of Nurra Nurra01 in Lake Albert. However, the shoreline at this site is very different to that of Nurra Nurra01, consisting of 0.8 m high deep Poltalloch soil bank, vegetated with kikuyu and phragmites (Figure 5-14). Soil dispersion was found to be slight to moderate throughout the soil profile. Some sheep grazing occurred during 2007 and the bank was observed to contain active swamp rat burrows.

Erosion at this site was severe. Although negligible erosion occurred during the initial drought period, significant shoreline losses were observed at the November 2010 and April 2011 monitoring visits, following the restoration of normal lake operating levels. Total erosion losses of 2.1, 2.0 and 1.2 m were measured at the L, C and R transects, respectively. Having a south-easterly aspect, the shoreline does not face a prevailing wind direction.

Figure 5-14. Nurra Nurra02 right photo point in April 2007 (l) and April 2011 (r)

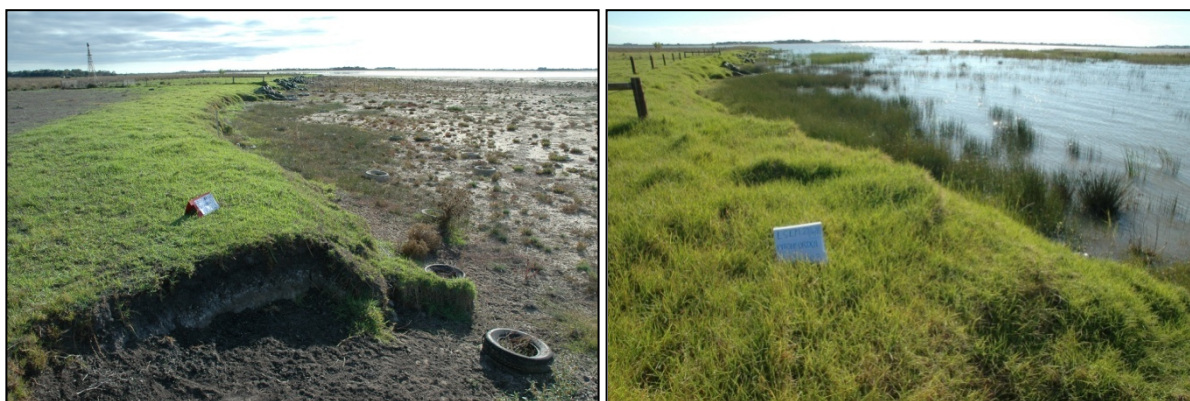
The Pitchford01 monitoring site was established in April 2008 when the waterline was already well offshore due to the drought conditions. No shoreline measurements were taken after November 2010 as the base marker had been removed. The site is located on an eroded western shore of Lake Albert, on the northern side of Rumpley Point. The shoreline has a northerly aspect and a medium erosion risk rating. The shoreline consists of a 0.7 m high Poltalloch soil bank, vegetated with kikuyu and was grazed by cattle until an exclusion fence was constructed in 2010 (Figure 5-15). Following the restoration of normal lake levels, phragmites and rushes rapidly became established up to 80 m offshore.

No erosion was observed at this site.

Figure 5-15. Pitchford01 right photo point in May 2008 (l) and April 2011 (r)

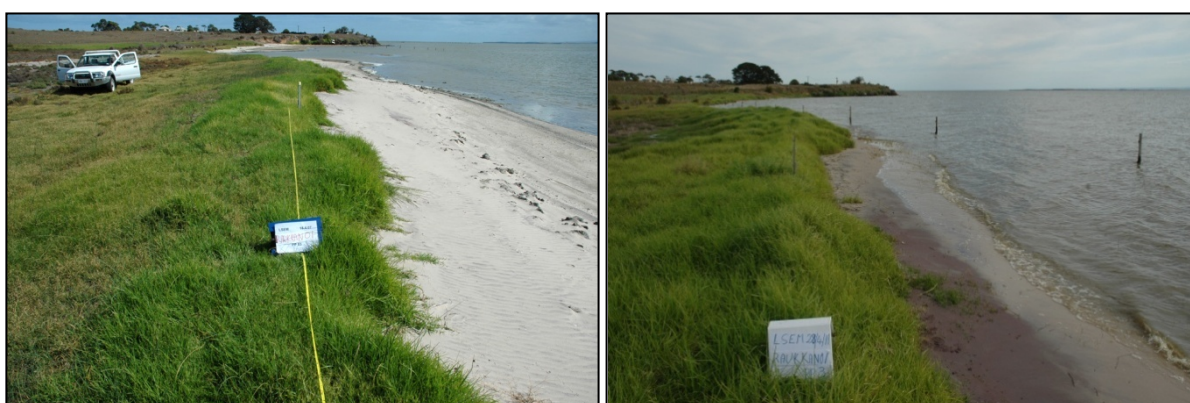
Stock trampling of the foreshore dune caused some erosion during the drought period, but within a few months of the return of normal lake levels, the shoreline had been restored, such that net accretion averaging 0.35 m from the original baseline measurements was observed across all three transects. The shoreline does not face a prevailing wind direction.

Figure 5-16. Raukkan01 right photo point in April 2007 (l) and April 2011 (r)

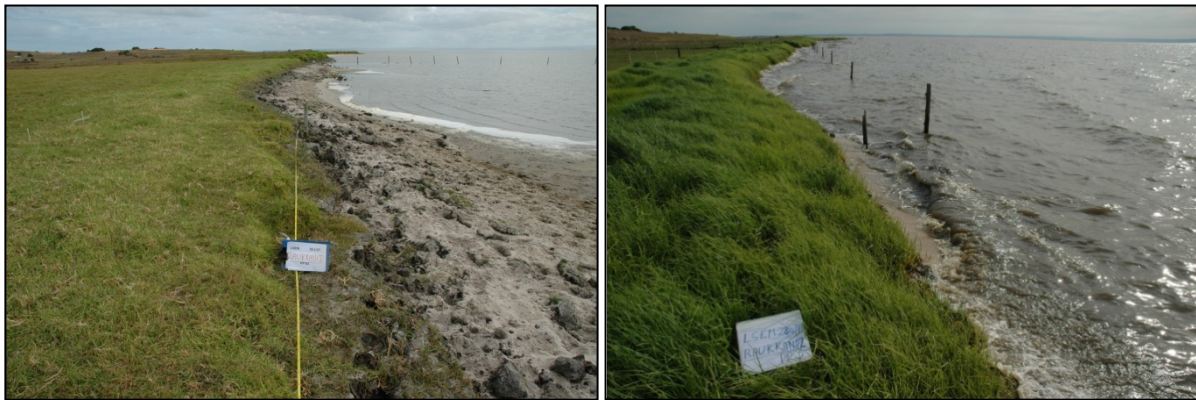
Raukkan02 is located approximately 1.8 km WNW of Raukkan01 and has a northerly aspect. This site lacks the foreshore dune present at Raukkan01, with the result that the lake edge was subject to damage and erosion from a combination of sand drift and stock trampling of the dry and crumbling 0.4 m high Poltalloch soil bank during the drought period (Figure 5-17). With the restoration of normal lake levels, significant erosion occurred across all transects – 1.0, 1.5 and 1.2 m respectively at L, C and R. The shoreline at this monitoring site does not face a prevailing wind.

Figure 5-17. Raukkan02 right photo point in April 2007 (l) and April 2011 (r)

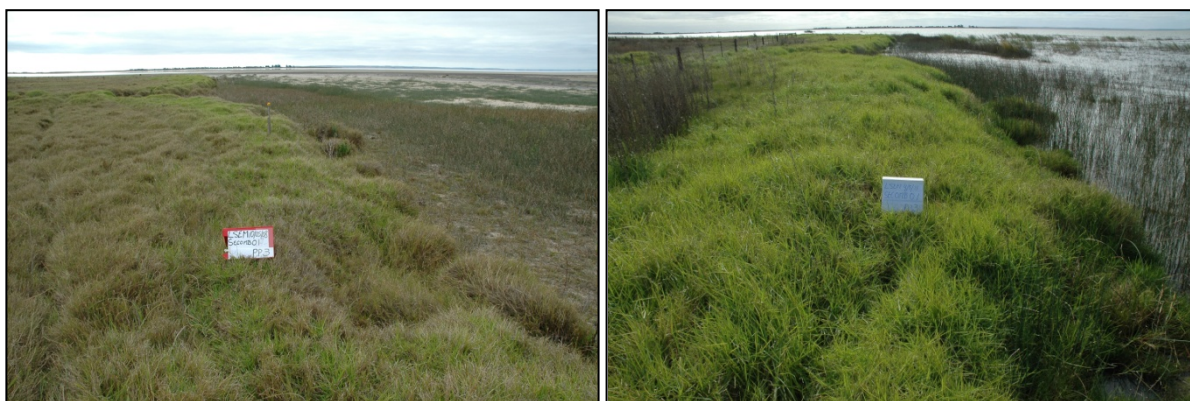
No erosion occurred at this site. Some minor variations in shoreline measurements were noted during 2008 and 2009, but were attributable to changes in the dense kikuyu matting on the lake edge. No erosion occurred following the restoration of normal lake levels. The shoreline does not face a prevailing wind direction.

Figure 5-18. Secomb01 right photo point in May 2008 (l) and May 2011 (r)

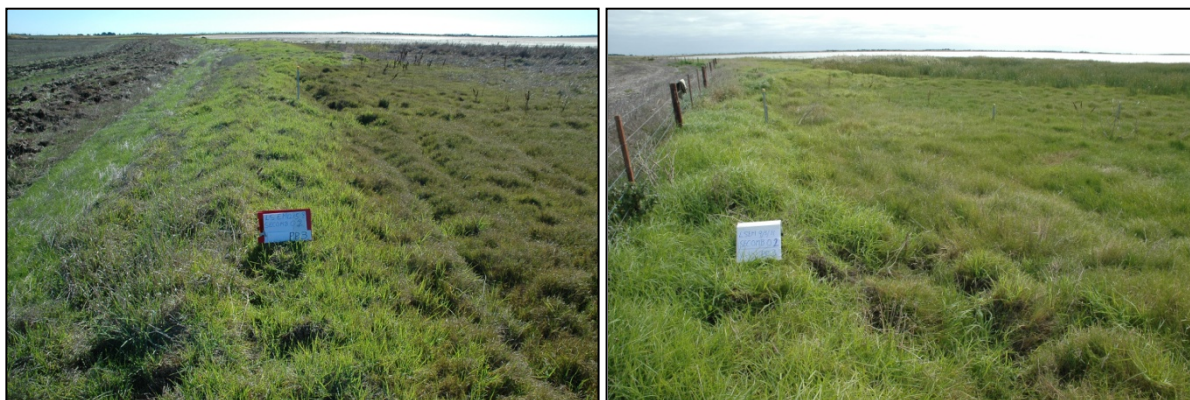
The Secomb02 monitoring site was established in April 2008, approximately 50 m inshore of the bank, which has a self-established reed bed (Figure 5-19). The site is located approximately 360 m north-west of Secomb01 along the south-western shore of Lake Albert. This monitoring site has a north-easterly aspect and is located on a shoreline with a medium erosion risk rating. The shoreline is vegetated with kikuyu, paspalum, typha and phragmites and grazing is excluded.

Figure 5-19. Secomb02 right photo point in May 2008 (l) and May 2011 (r)

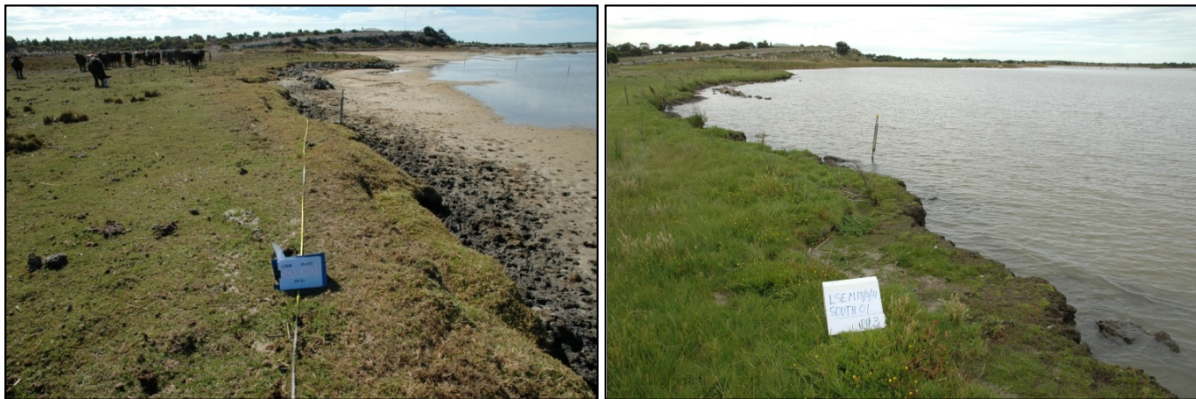
The South monitoring site is located on the eroded south-western shoreline of Point Sturt in Lake Alexandrina and has a south-westerly aspect and a high erosion risk rating. The 0.4 m Paltaloch soil bank is vegetated with paspalum and subject to controlled cattle grazing (Figure 5-20).

Figure 5-20. South right photo point in April 2007 (l) and May 2011 (r)

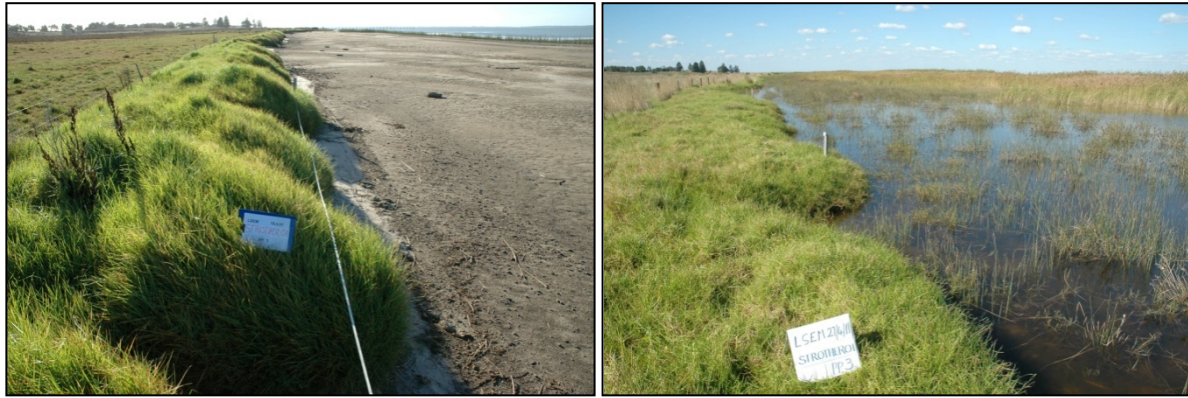
Although this shoreline faces a prevailing wind, erosion at this site was negligible as a result of the established reed bed. Very minor erosion (0.1–0.2 m) occurred at the L and R transects shortly after the monitoring site was set up in November 2006, but no erosion occurred subsequently, even with the return of normal operating lake levels.

Figure 5-21. Strother01 right photo point in April 2007 (l) and April 2011 (r)

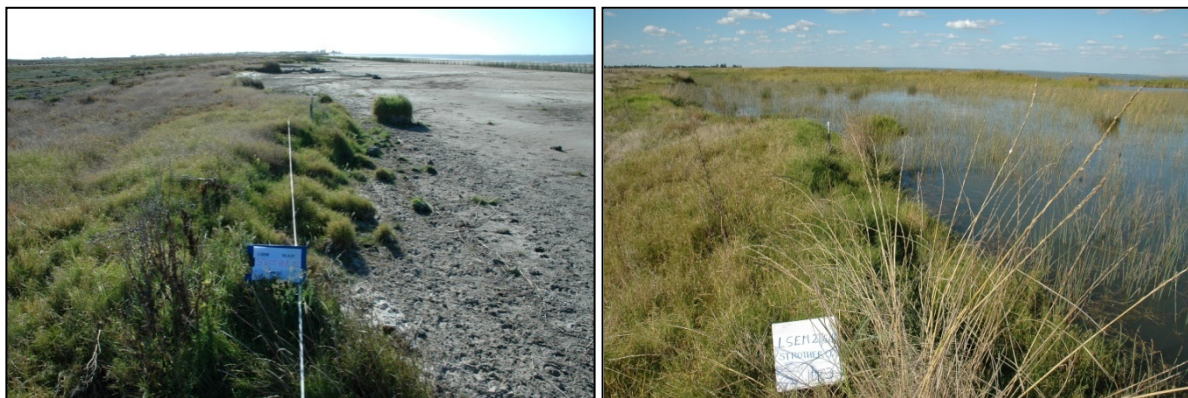
Although this shoreline has exposure to a prevailing wind, erosion at this site was negligible as a result of the established reed bed. Minor erosion (0.15–0.3 m) occurred at the L and R transects shortly after the monitoring site was set up, but no erosion occurred subsequently, even with the return of normal operating lake levels.

Figure 5-22. Strother02 right photo point in April 2007 (l) and April 2011 (r)

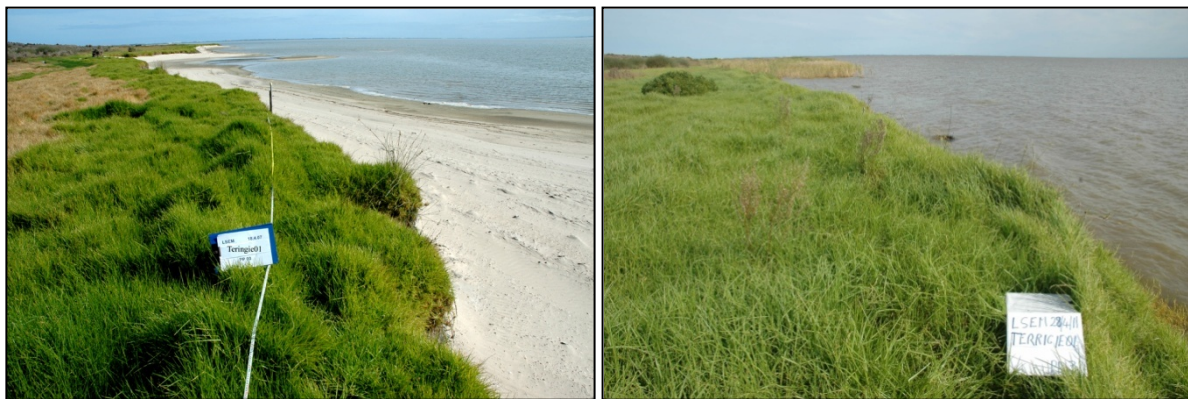
No net erosion occurred at this site. Net shoreline growth of 0.25 and 0.4 m, at the L and R monitoring points respectively, was measured at the April 2011 monitoring visit, with almost all of this occurring after the return of normal lake operating levels.

Figure 5-23. Teringie right photo point in April 2007 (l) and April 2011 (r)

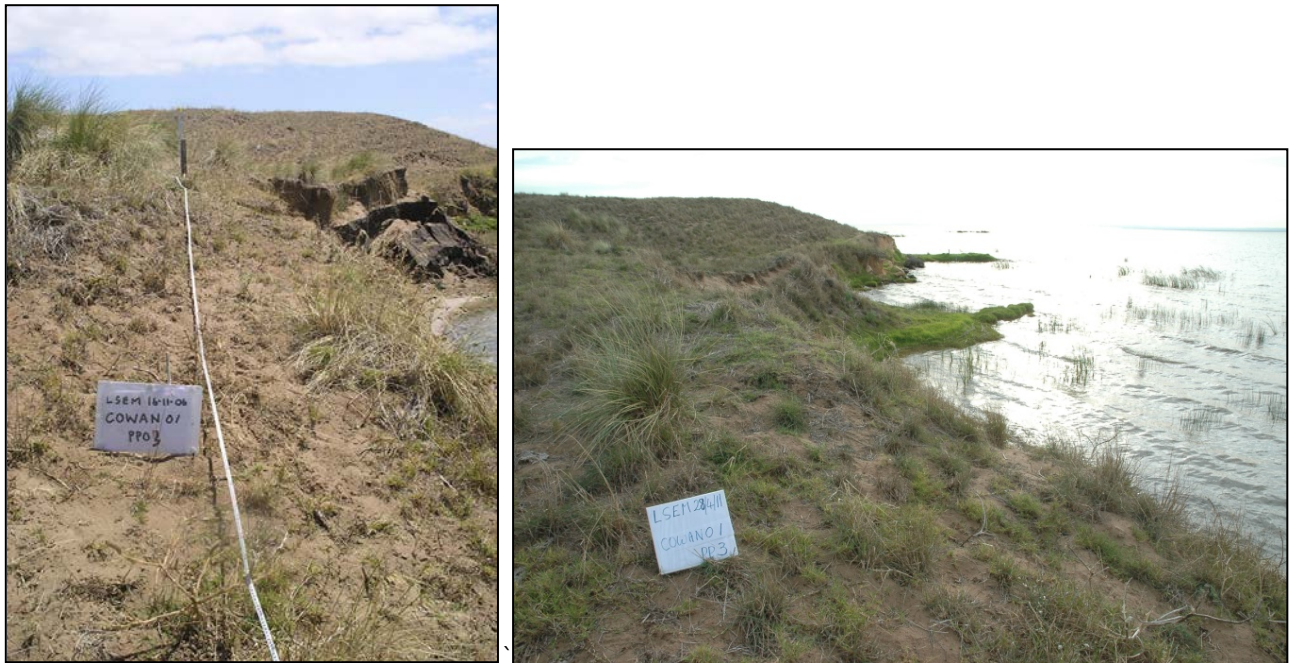
Cowan01 is characterised by a 3 m high sandy cliff face (Figure 5-24). It is located north-east of Pt McLeay in Lake Alexandrina, in a shoreline section with a NNW aspect and high erosion risk rating. Erosion typically occurs at this site as a result of slumping of 0.5–1 m wide sections, due to direct erosion and undercutting of the sand at beach level. As the site is regularly grazed by cattle, the erosion can be exacerbated by stock trampling and breaking of the dune edge. Bundled tyres have been packed against the base of the cliff to the east of the site to try to control the shoreline erosion. The site is vegetated with marram and other grasses and during the drought blue lupins were observed growing on the exposed lake bed.

Figure 5-24. Cowan01 right photo point in November 2006 (l) and April 2011 (r)

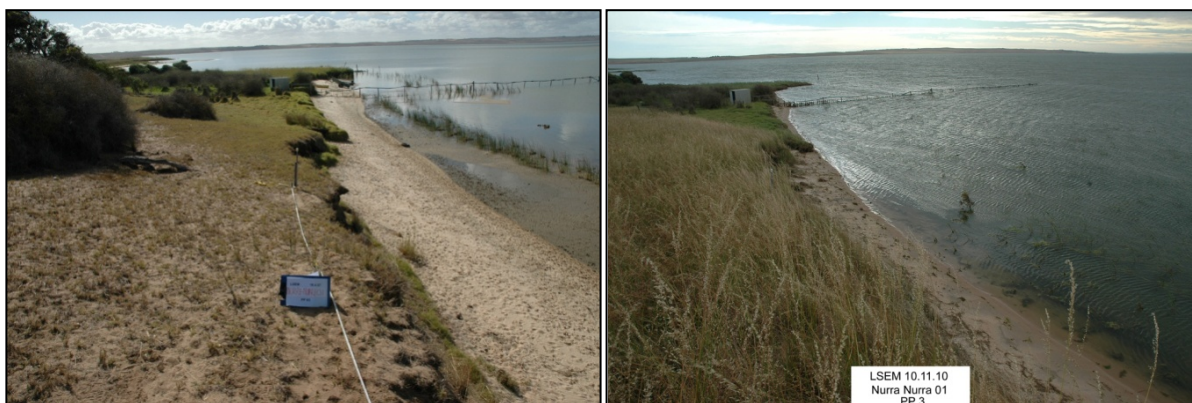
Erosion at this site was relatively minor, with total shoreline losses of 0.35, 0.3 and 0.74 m measured at the L, C and R transects, respectively. Given that cliff slumping occurred even when the water was hundreds of m from the shoreline during the drought, there is little evidence from the limited available data to indicate a direct link between water level and shoreline erosion at this site. No erosion was observed at the April 2011 monitoring visit, when lake levels were at their highest for the monitoring period.

Figure 5-25. Nurra Nurra01 right photo point in April 2007 (l) and November 2010 (r)

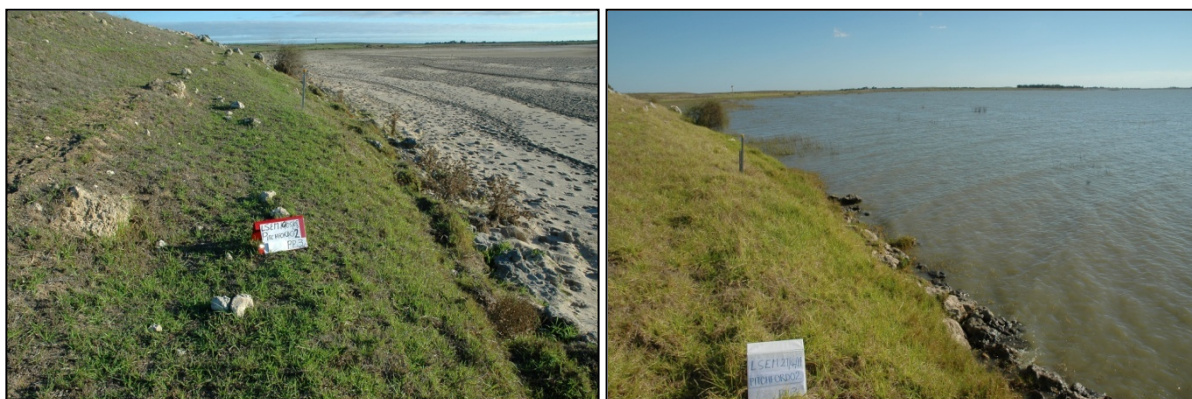
No erosion was observed at this site.

Figure 5-26. Pitchford02 right photo point in May 2008 (l) and April 2011 (r)
