Lakeshore erosion monitoring data analysis

Department of Environment, Water and Natural Resources

May, 2014

DEWNR Technical Note 2014/03

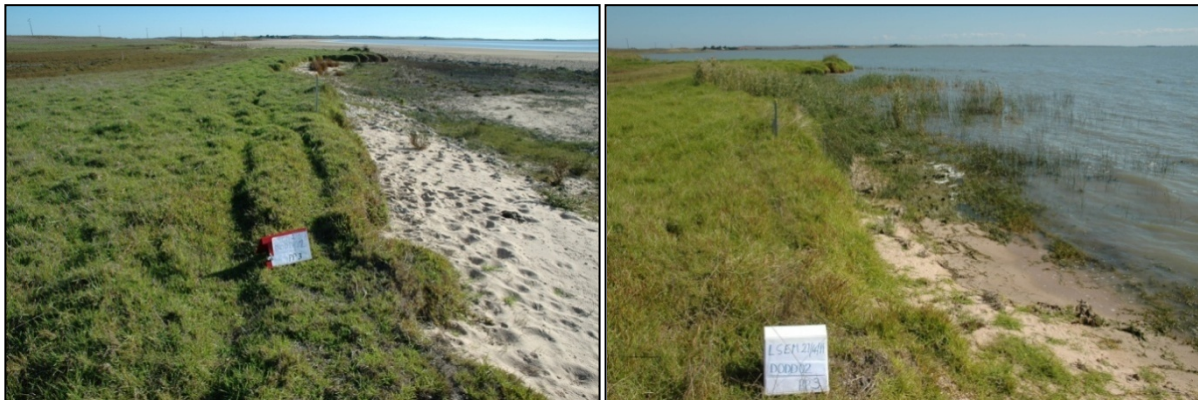
The monitoring site was established in April 2008. No erosion was measured at this site during the monitoring period; in fact slight accretion (0.1 m) was measured at R during the April 2011 monitoring visit.

Figure 5-27. Dodd02 right photo point in May 2008 (l) and April 2011 (r)

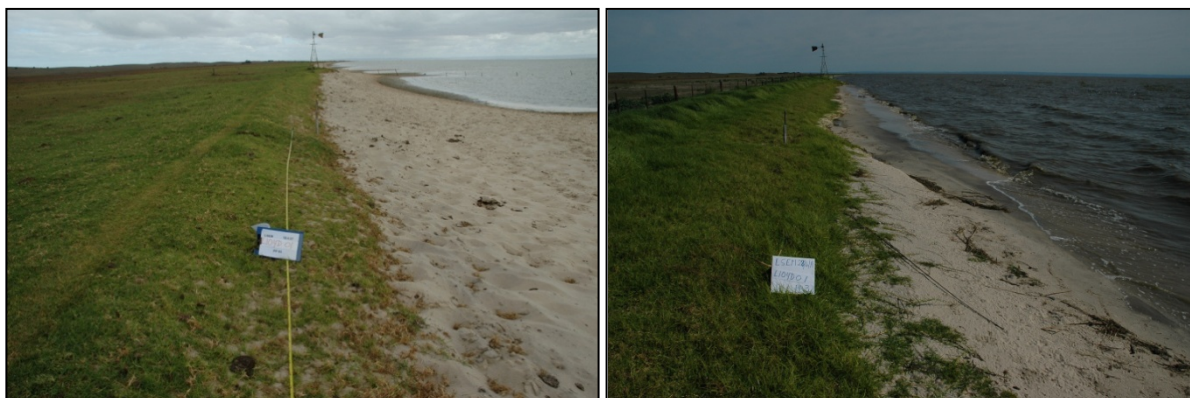
Sand deposition on the shoreline from the exposed lakebed was observed during 2008 and 2009. Shoreline measurements were taken to the edge of the kikuyu cover. The kikuyu retreated during the period when the lake levels were very low, but

returned with the restoration of normal lake levels in 2010. No erosion was observed following the restoration of lake levels. No net erosion occurred at this monitoring site, with shoreline growths of 0.55, 1.1 and 0.65 m recorded at L, C and R, respectively.

Figure 5-28. Lloyd01 right photo point in April 2007 (l) and April 2011 (r)

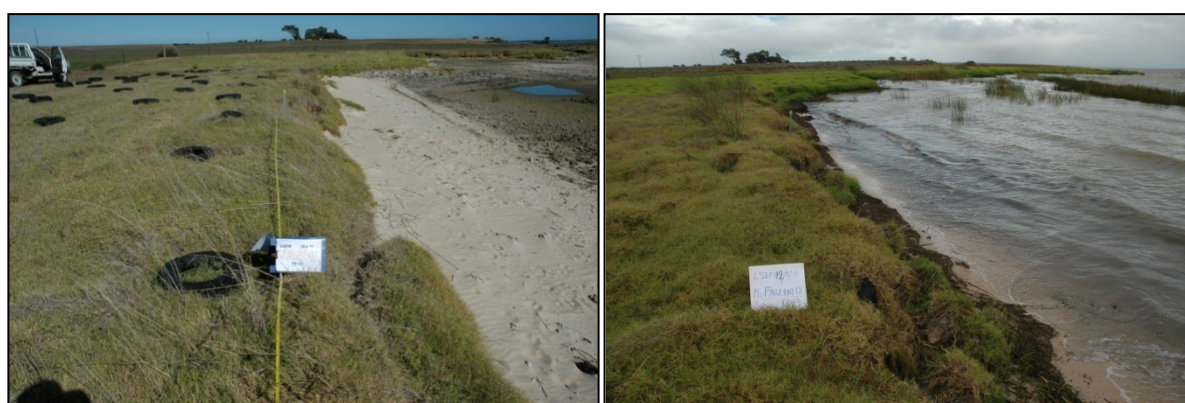
The McFarlane monitoring site is located on the eroded north-eastern shore of Lake Alexandrina opposite Pomanda Point, on a section of shoreline with a westerly aspect and low erosion risk rating. The shoreline consists of a calcareous sand bank, 0.8 m high, overlying a clay soil (Figure 5-29). The shoreline is vegetated with couch grass and protected from grazing by an exclusion fence constructed 20 m from the shoreline. Offshore reed beds were established in early 2007 and regenerated following the return of normal lake levels after the drought.

Figure 5-29. McFarlane right photo point in April 2007 (l) and May 2011 (r)

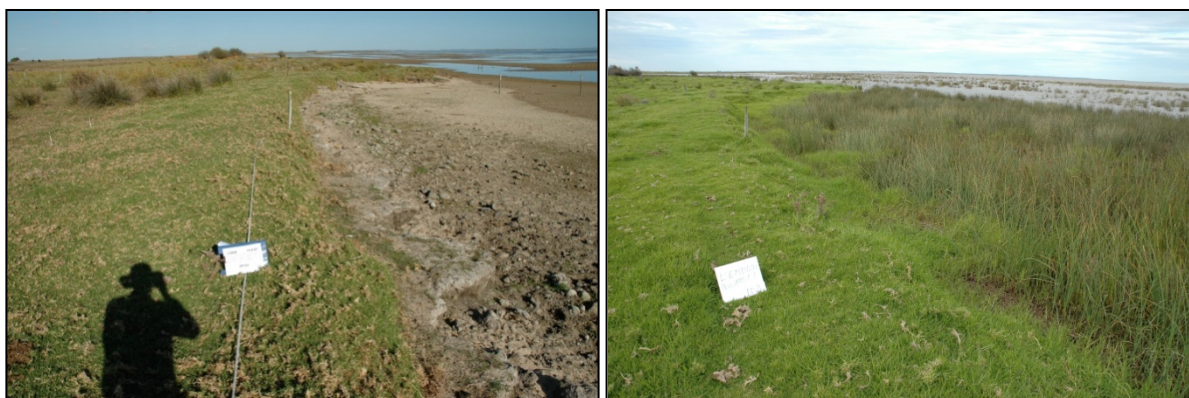
Although this site is exposed to a prevailing wind, no erosion was observed. However some minor erosion of the bank was observed along the L transect during the period that the lakebed was dry, with the waterline located 350 m offshore, due to the trampling of cattle grazing the lakebed. Shoreline growths of 0.6 and 0.2 m, respectively, were measured at the C and R transects.

Figure 5-30. Withers right photo point in April 2007 (l) and May 2011 (r)

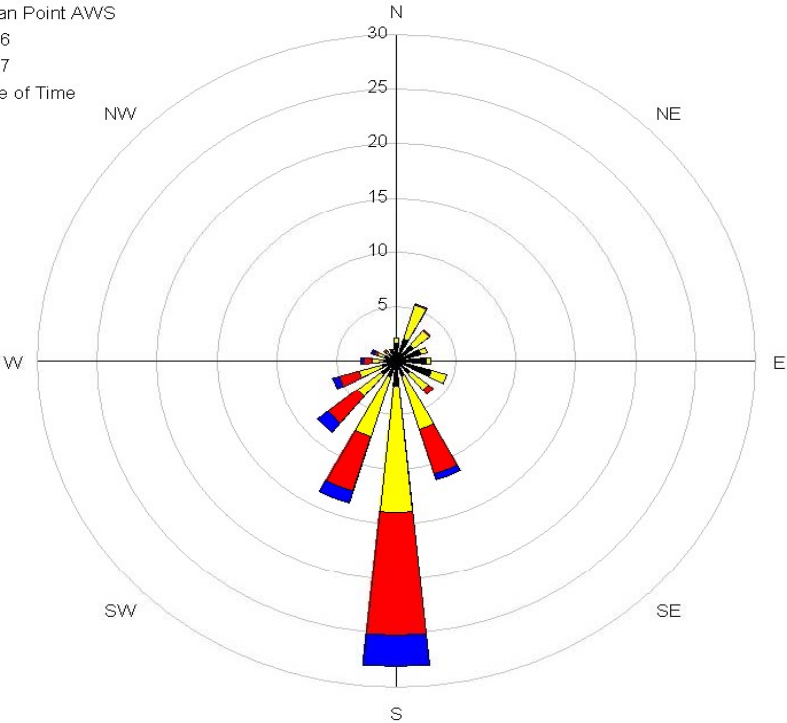
Site A4260603 Pelican Point AWS
Start Time 00:00_01/11/2006
End Time 00:00_01/04/2007
Wind Direction as Percentage of Time

- 0-10.0 km/h
- 10.0-20.0 km/h
- 20.0-30.0 km/h
- >30.0 km/h

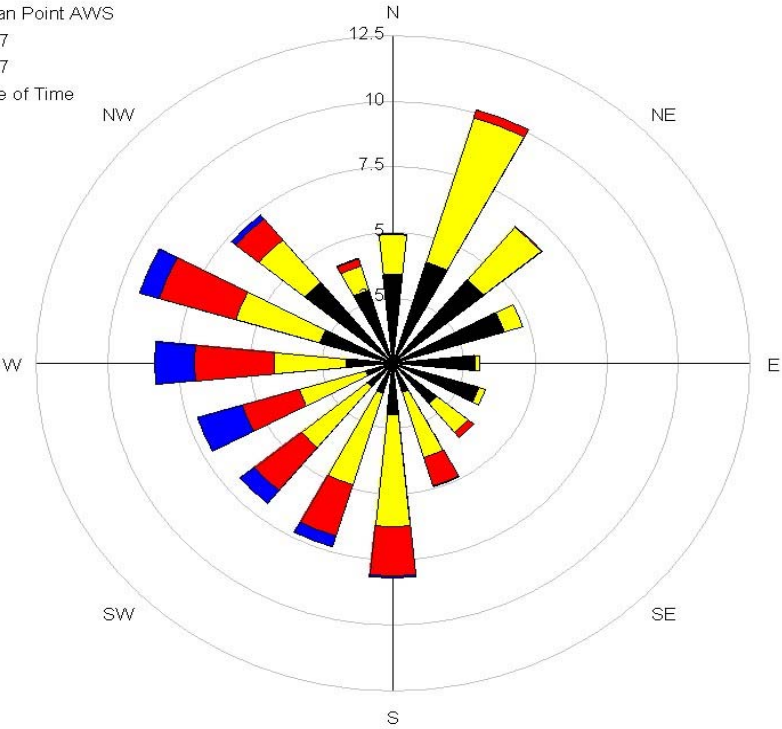
Site A4260603 Pelican Point AWS
Start Time 00:00_01/04/2007
End Time 00:00_01/11/2007
Wind Direction as Percentage of Time

- 0-10.0 km/h
- 10.0-20.0 km/h
- 20.0-30.0 km/h
- >30.0 km/h

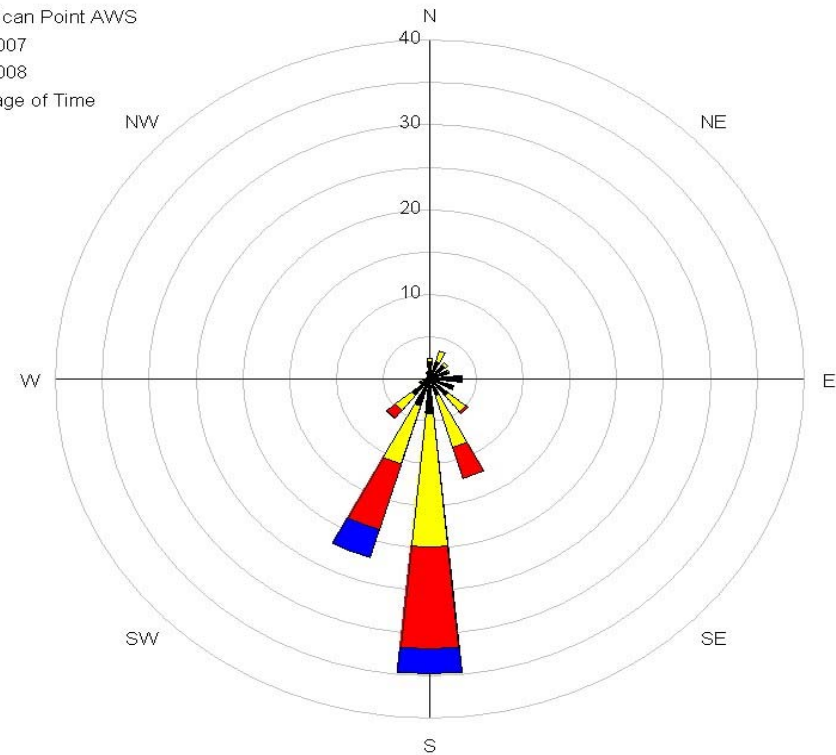
Wind Direction as Percentage of Time

- 0-10.0 km/h
- 10.0-20.0 km/h
- 20.0-30.0 km/h
- >30.0 km/h

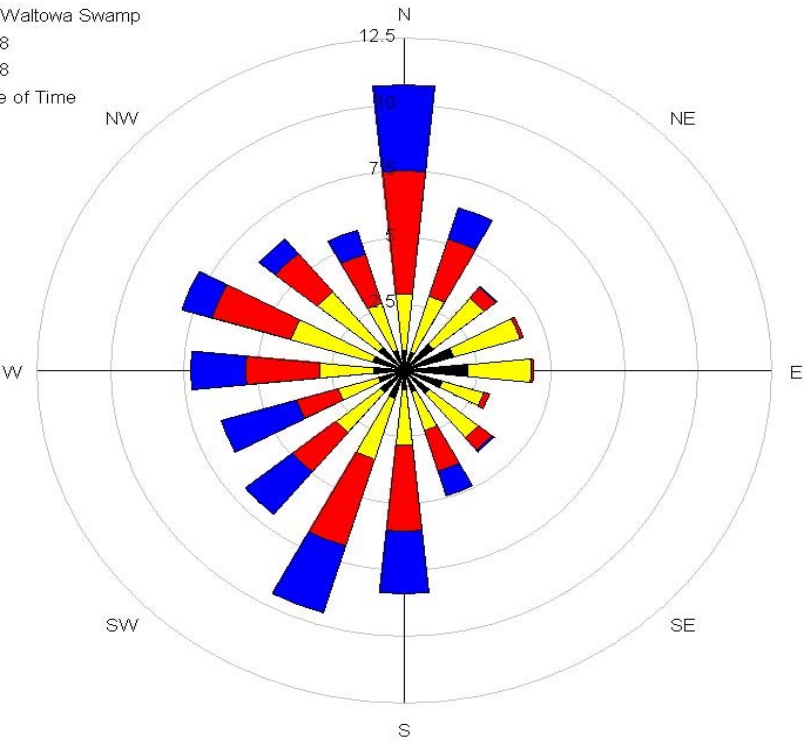
Wind Direction as Percentage of Time

- 0-10.0 km/h
- 10.0-20.0 km/h
- 20.0-30.0 km/h
- >30.0 km/h

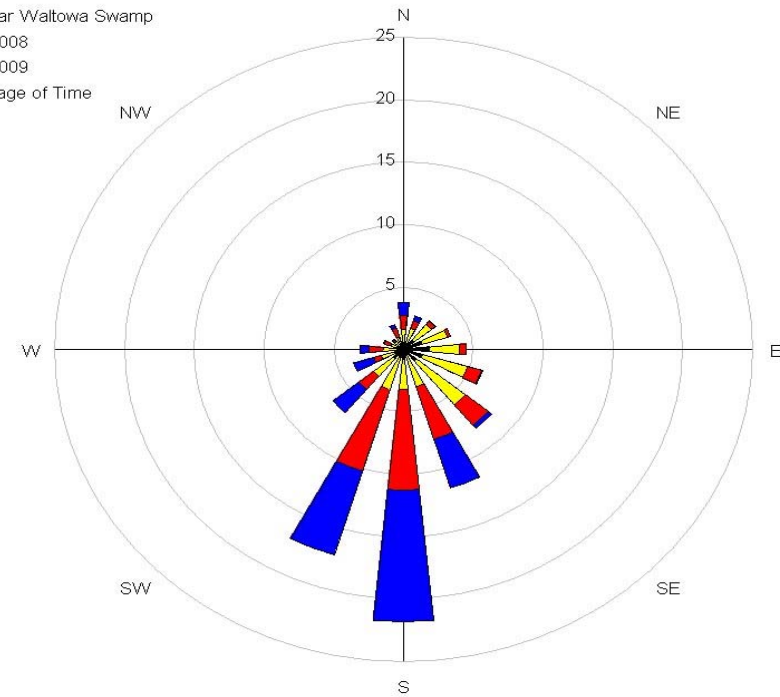
Site A4261153 Near Waltowa Swamp
 Start Time 00:00_01/11/2008
 End Time 00:00_01/04/2009
 Wind Direction as Percentage of Time

0-10.0 km/h
 10.0-20.0 km/h
 20.0-30.0 km/h
 >30.0 km/h

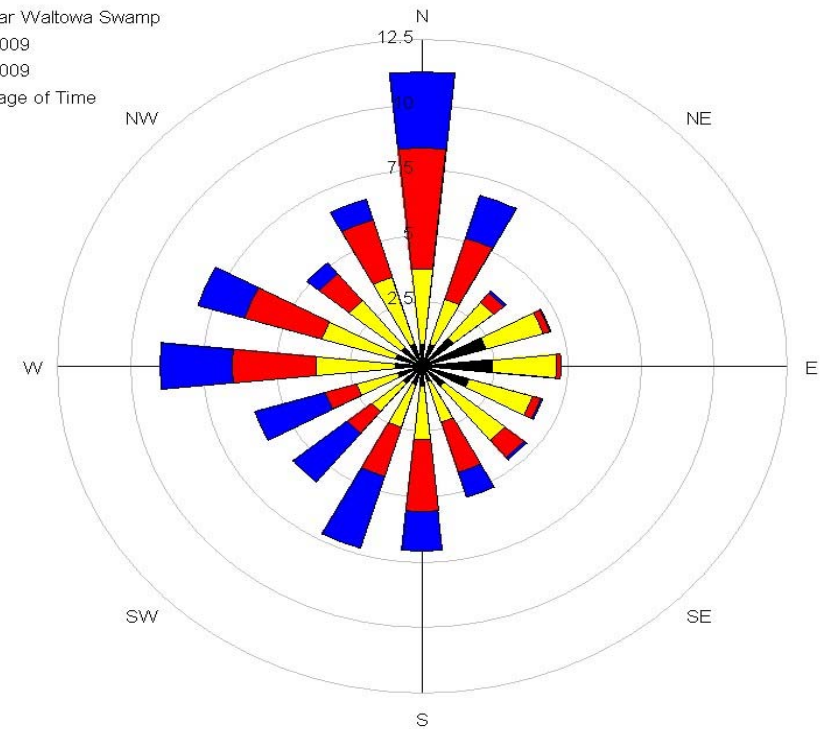
Wind Direction as Percentage of Time

- 0-10.0 km/h
- 10.0-20.0 km/h
- 20.0-30.0 km/h
- >30.0 km/h

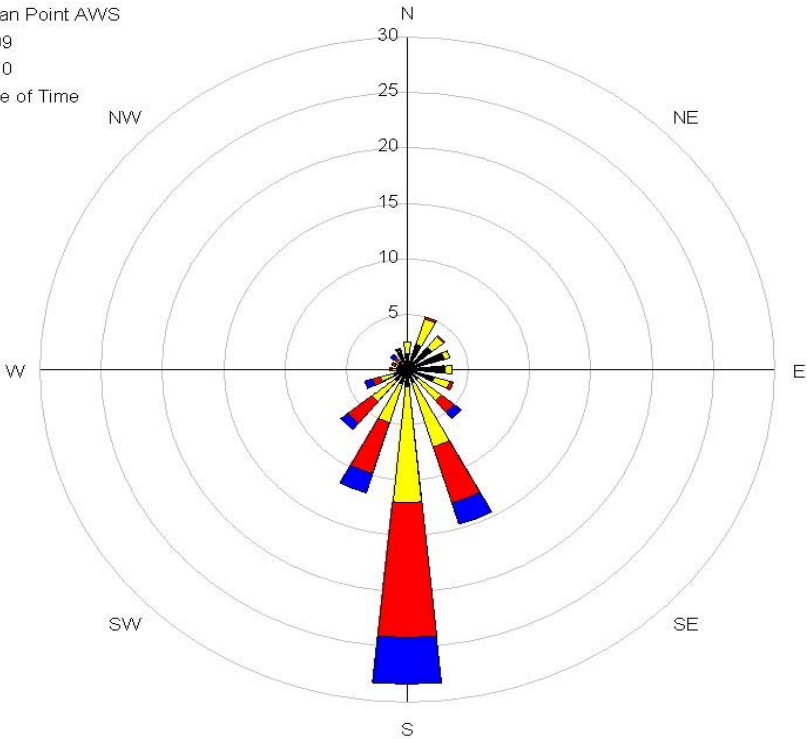
Wind Direction as Percentage of Time

- 0-10.0 km/h
- 10.0-20.0 km/h
- 20.0-30.0 km/h
- >30.0 km/h

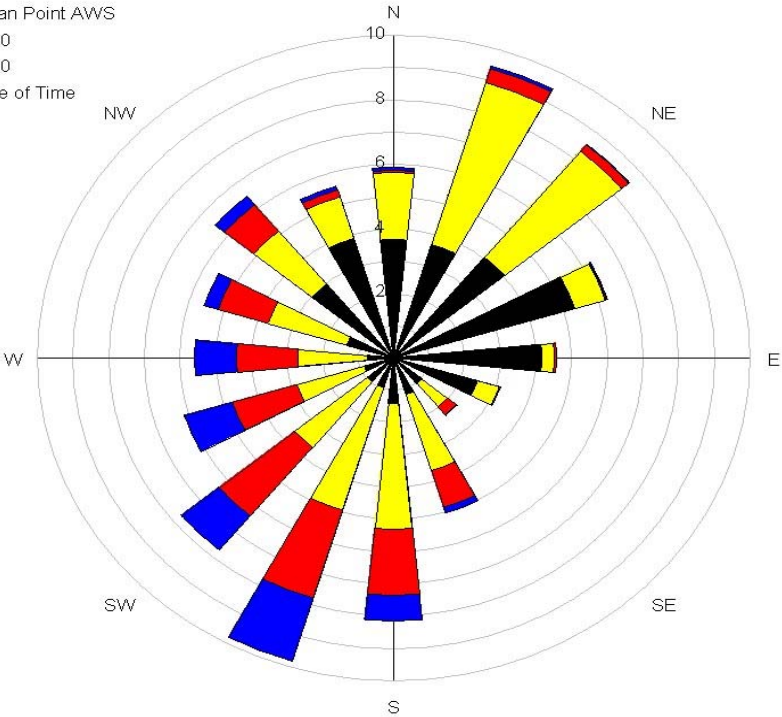
Site A4260603 Pelican Point AWS
Start Time 00:00_01/04/2010
End Time 00:00_01/11/2010
Wind Direction as Percentage of Time
0-10.0 km/h
10.0-20.0 km/h
20.0-30.0 km/h
>30.0 km/h

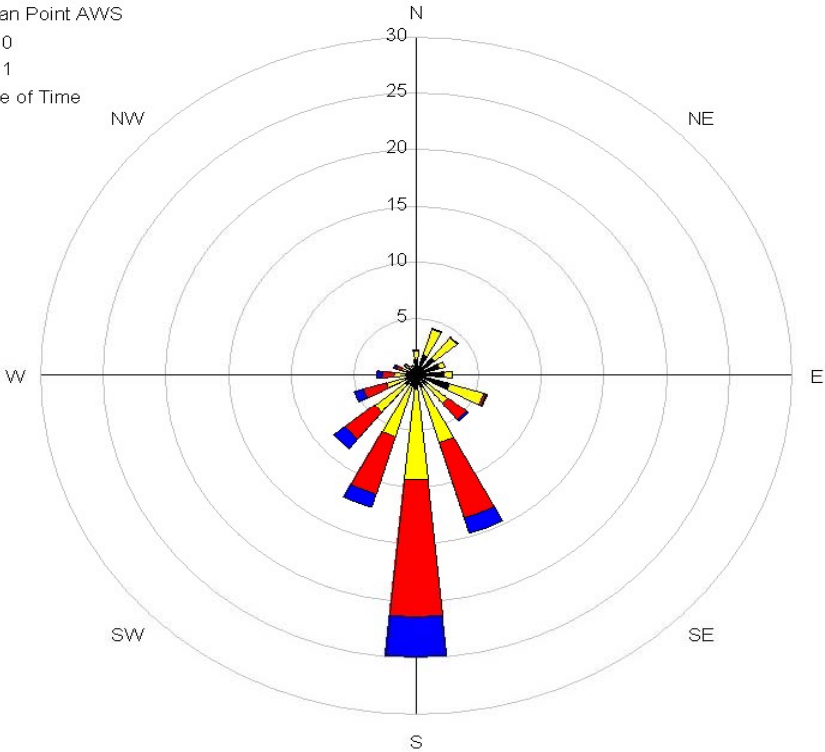
Wind Direction as Percentage of Time

- 0-10.0 km/h
- 10.0-20.0 km/h
- 20.0-30.0 km/h
- >30.0 km/h
