Hydrogeological assessment of Hookina Spring (Pungka Pudahanha), Flinders Ranges

DEWNR Technical note 2015/13

Steve Barnett, Lauren Houthuysen and Tahnae Ditton
Department of Environment, Water and Natural Resources

September, 2015

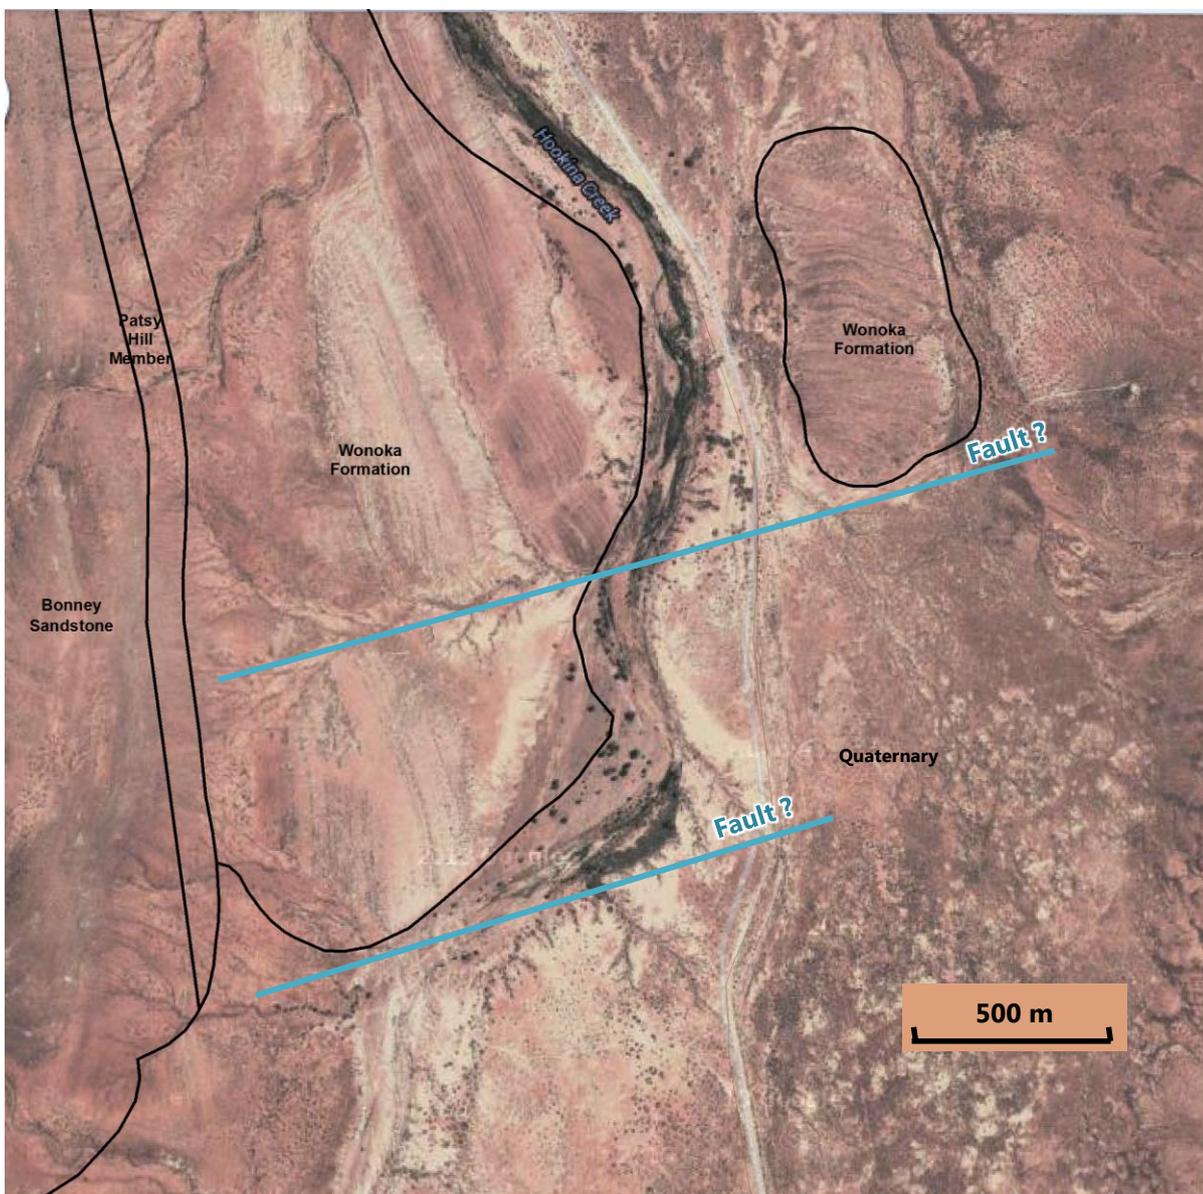
Figure 2. Geology and source of springs

Figure 2 shows the area where the spring commences together with the mapped 1:100 000 geology. The geological outcrops appear to be much more complex than the published geology suggests. The occurrence of lush vegetation coincides with two south-west to north-east trending faults that seem to control the direction of Hookina Creek and a tributary. This suggests that faulting may provide a conduit for groundwater discharge from deeper aquifers, which appear from Figure 2 to be the Wonoka Formation or possibly the Bonney Sandstone.

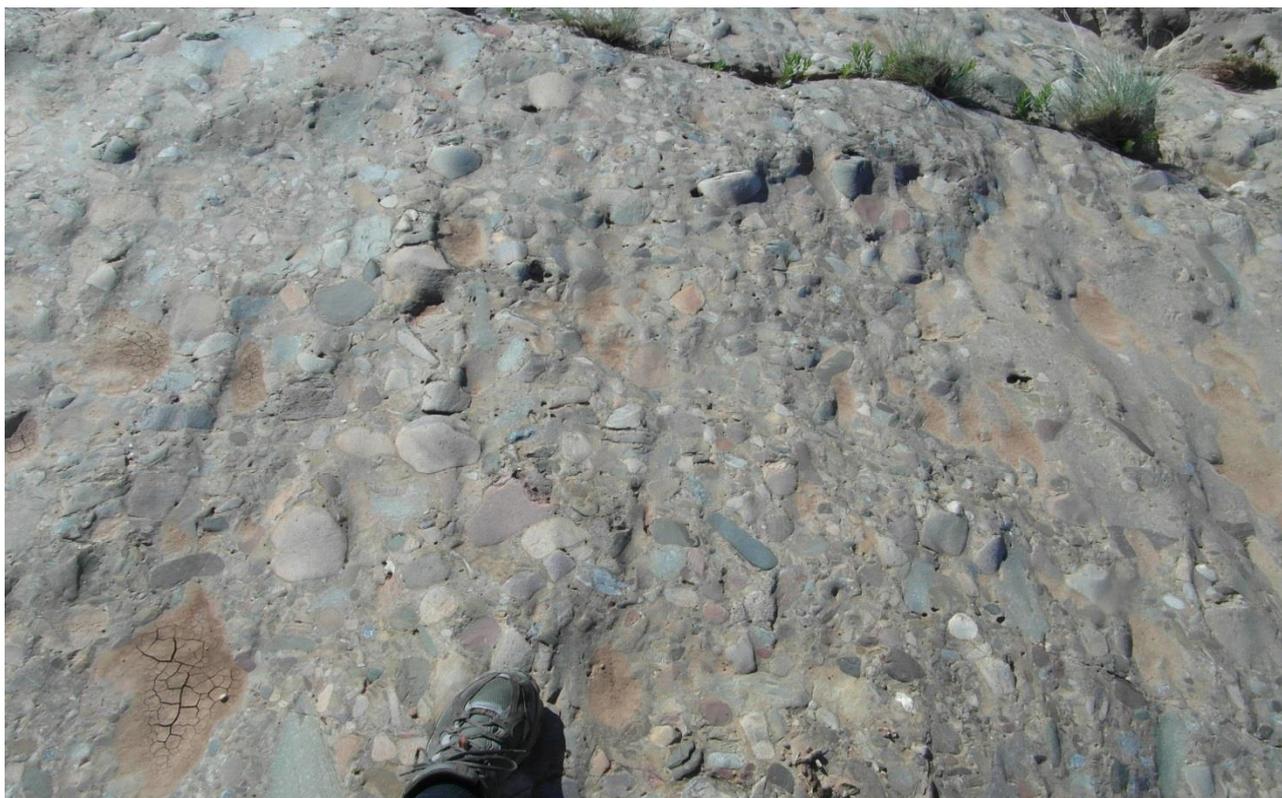
Figure 3. Cemented conglomerate deposited in the creek bed

An indicator that this groundwater discharge has been occurring for a considerable period of time is the presence of a very hard, cemented conglomerate in the creek bed, which appears just downstream of where the first signs of discharge were observed (Fig. 3). The conglomerate consists of rounded cobbles (of various rock types) in an off-white calcareous cement, which was probably formed by the evaporation of groundwater discharged from the spring in the creek bed.

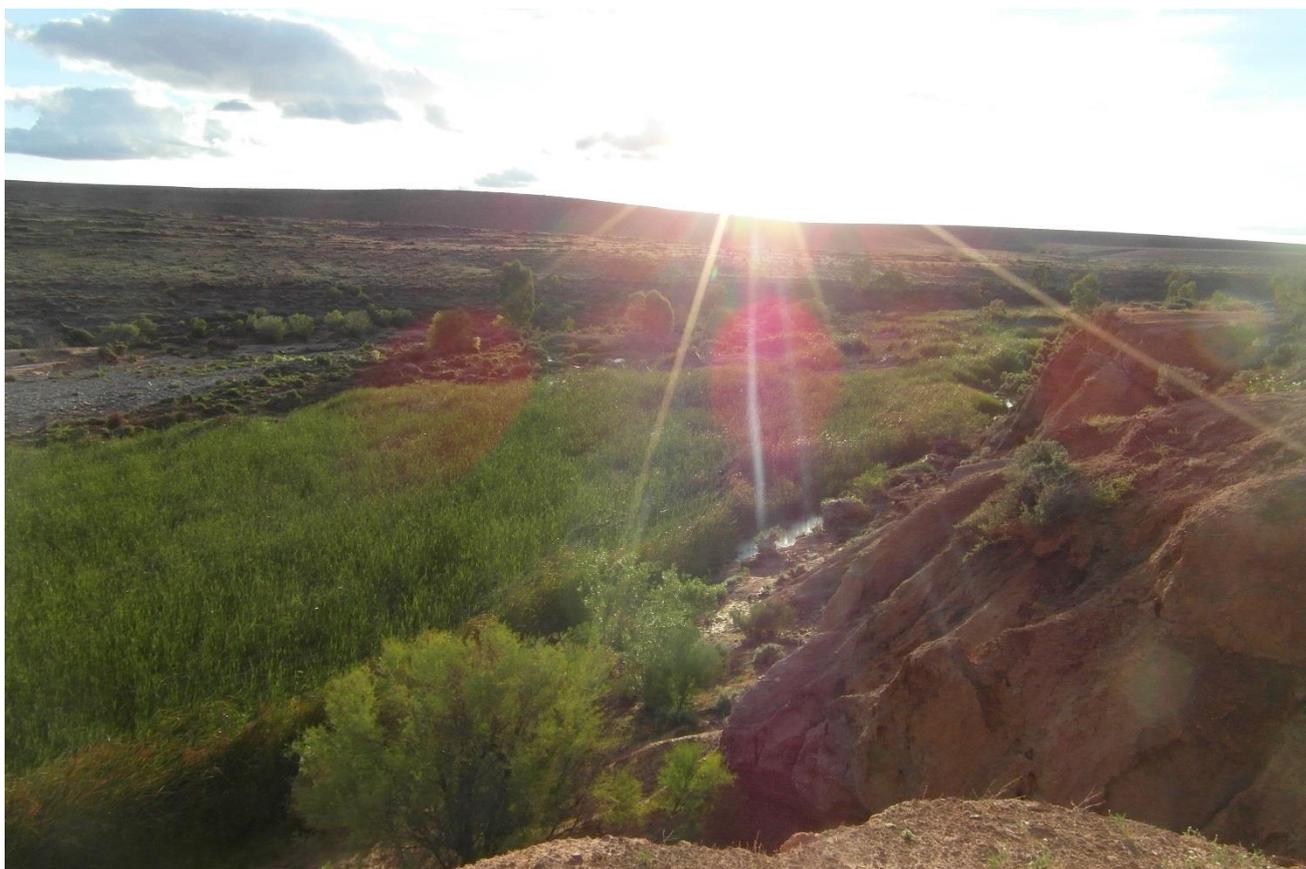
Figure 4. Creek bed covered in reeds

For most of the eight kilometre length of creek where permanent flow occurs, the creek bed is mostly covered by reeds (Fig. 4). About 1.8 km from the spring source, some large waterholes have formed probably as a result of scouring of the creek bed during rare flood events that occur every 10–15 years or so. The largest of these is about 3 m deep, with an observed estimated discharge from the downstream end of 1–2 L/sec. Figure 4 also shows how the creek has been incised about 10–15 m into the generally fine grained Quaternary outwash sediments.

- Downcutting of the creek bed into the Quaternary sediments (visible in Figs 4 and 6) also suggests local uplift.

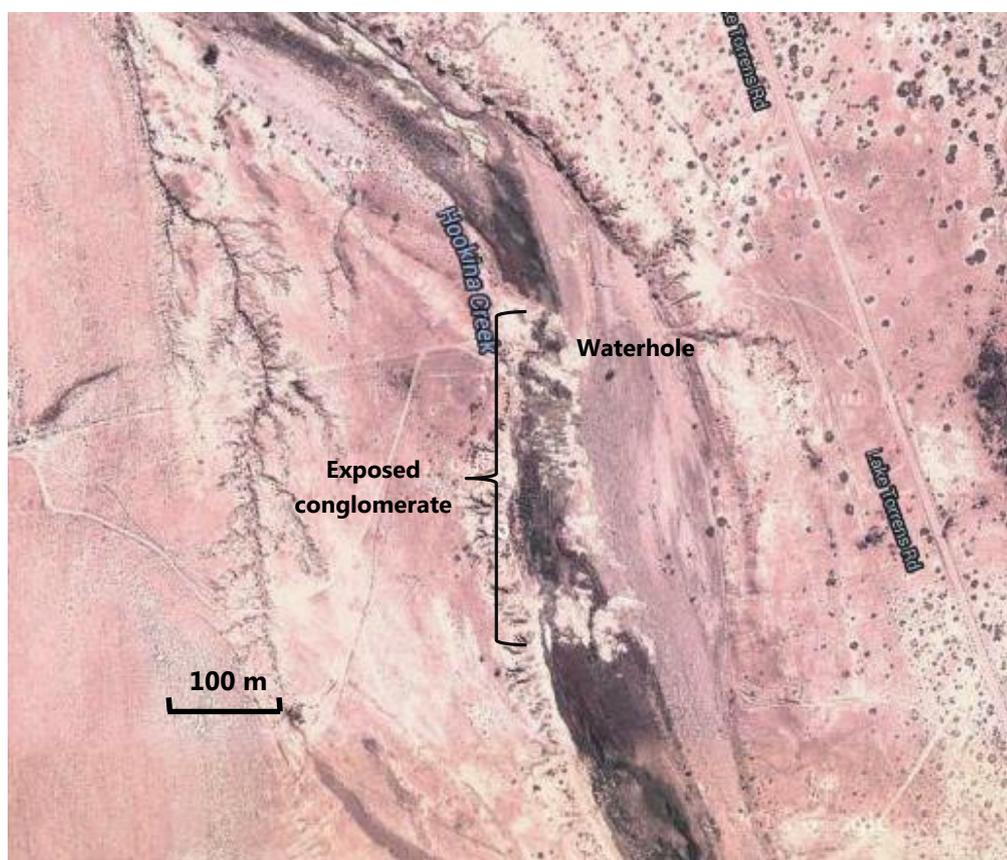
Figure 5. Hookina Spring and area of exposed conglomerate

The main access to the spring occurs about five kilometres downstream from the source (Fig. 5). Here, the reed beds have been removed, exposing a significant area of the cemented conglomerate over which the creek flows. This is also the location of an offtake for stock supplies. The flow appears to have progressively increased downstream and has been recently gauged by DEWNR to flow at 20 L/sec at this location, with no obvious point source providing the additional flow.

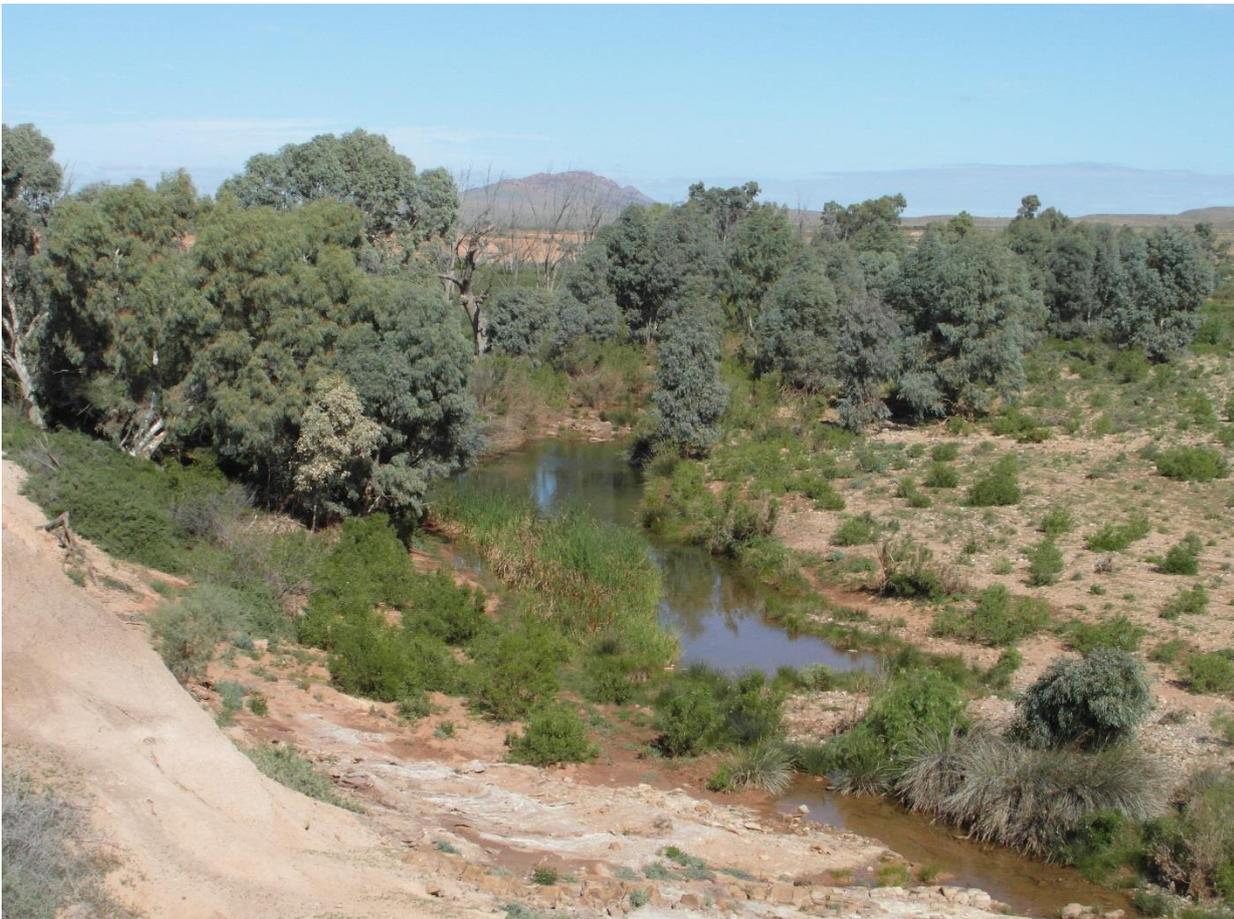
Figure 6. Hookina Spring waterhole chosen for sampling

Water samples were collected in the field to help determine the source of the spring water. The absence of a discrete source and poor accessibility along Hookina Creek complicated the process. The first sizeable and accessible waterhole was selected for sampling (Fig. 6). An equipped stock well (Bobby Creek Bore, well 6534-110) located 6 km south of the springs was also sampled. Figure 1 shows the location of the sampling sites. These were collected for laboratory analysis of cations, anions, metals and carbon isotopes. The carbon-14 activity of dissolved inorganic carbon (DIC) in groundwater, expressed as percent modern carbon (pMC), can be a very useful tool for estimating groundwater residence times in the range 500–25 000 years.

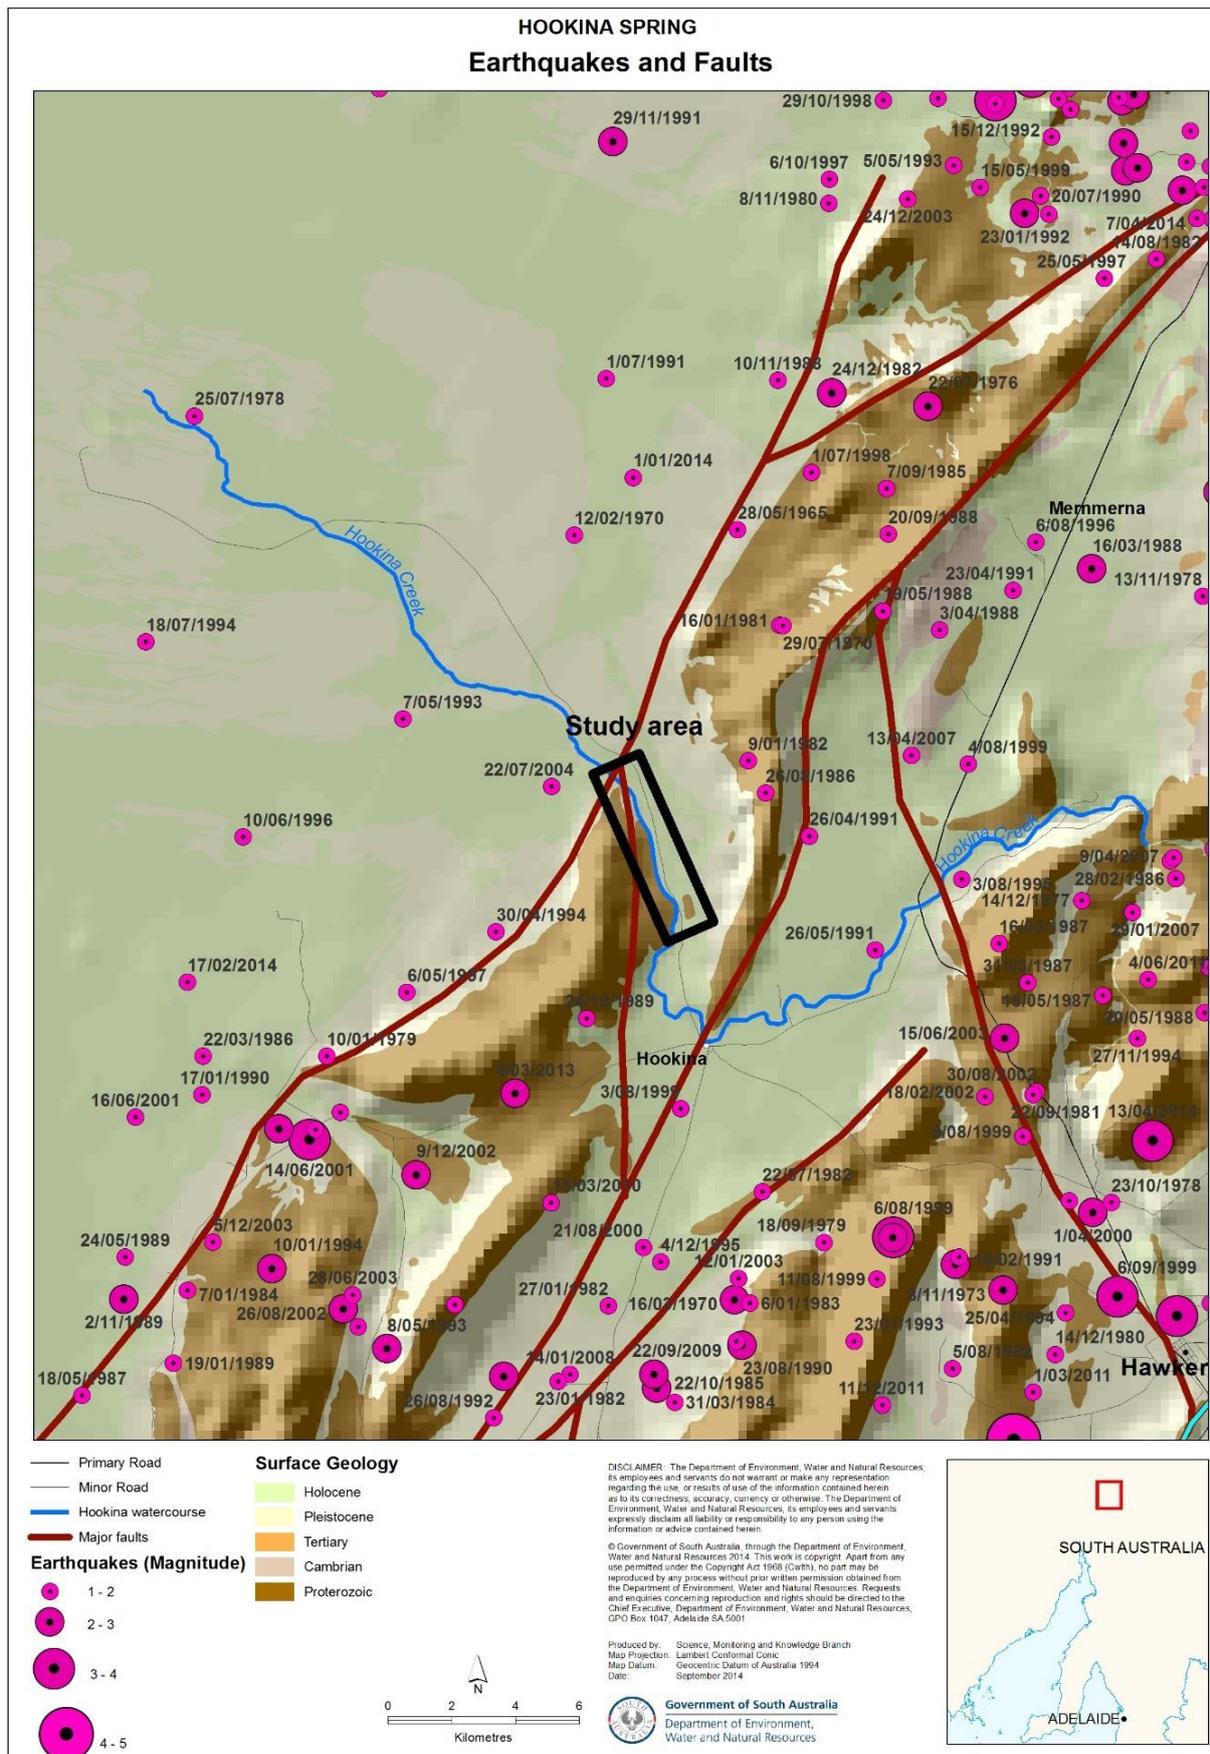
Figure 7. Seismic activity and major faults in the Hookina Spring area

Hookina Spring lies on the western margin of the Flinders Ranges where some of the most significant faults, although not exposed, have caused very major displacements of various rock units (Preiss, 1999). Figure 7 shows some of the major faults that have been interpreted from aeromagnetic survey data. Uplift is likely to have continued over the past 40 million years and there is much evidence to suggest that this process is continuing in the present day as outlined below:

- Earth tremors are felt regularly, with anecdotal evidence from a traditional landowner reporting a large bubble emerging from the waterhole during one such tremor. A map of epicentres recorded by the network of seismographs maintained by the Geological Survey (Department of State Development) in Figure 7 shows that a number of smaller earthquakes have occurred in the area.

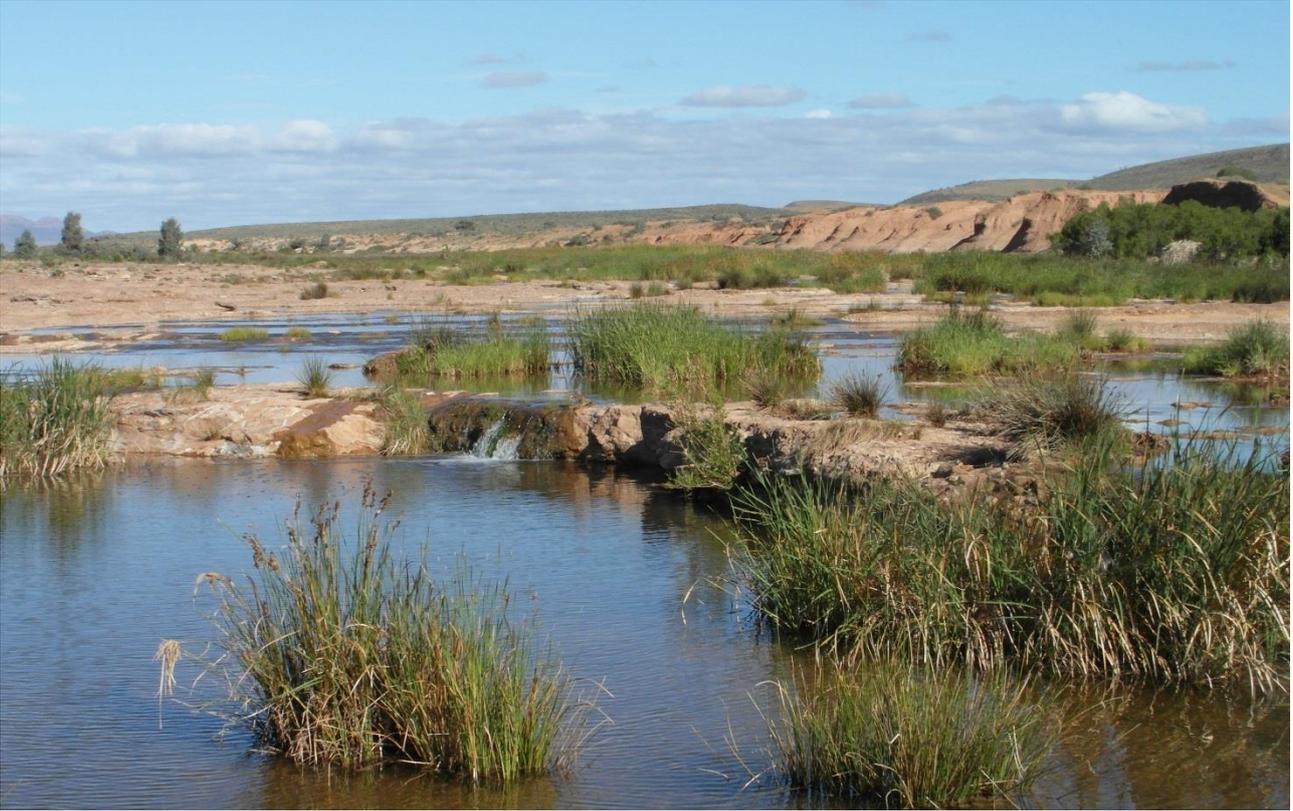
Figure 8. Upward displacement of the creek bed conglomerate

- The area of exposed conglomerate at the Pungka Pudanha waterhole (Fig. 8) has resulted from local vertical displacement or uplift. The conglomerate exhibits fracturing with some vegetation growing within the fractures (Fig. 9). There are also more recent fresh fractures infilled with splinters of conglomerate.

- Anecdotal evidence from traditional landowners indicates there is less water in the waterhole and that the deep pools seem shallower. This is consistent with the floor of the waterhole being uplifted while the water level in the waterhole remains constant.

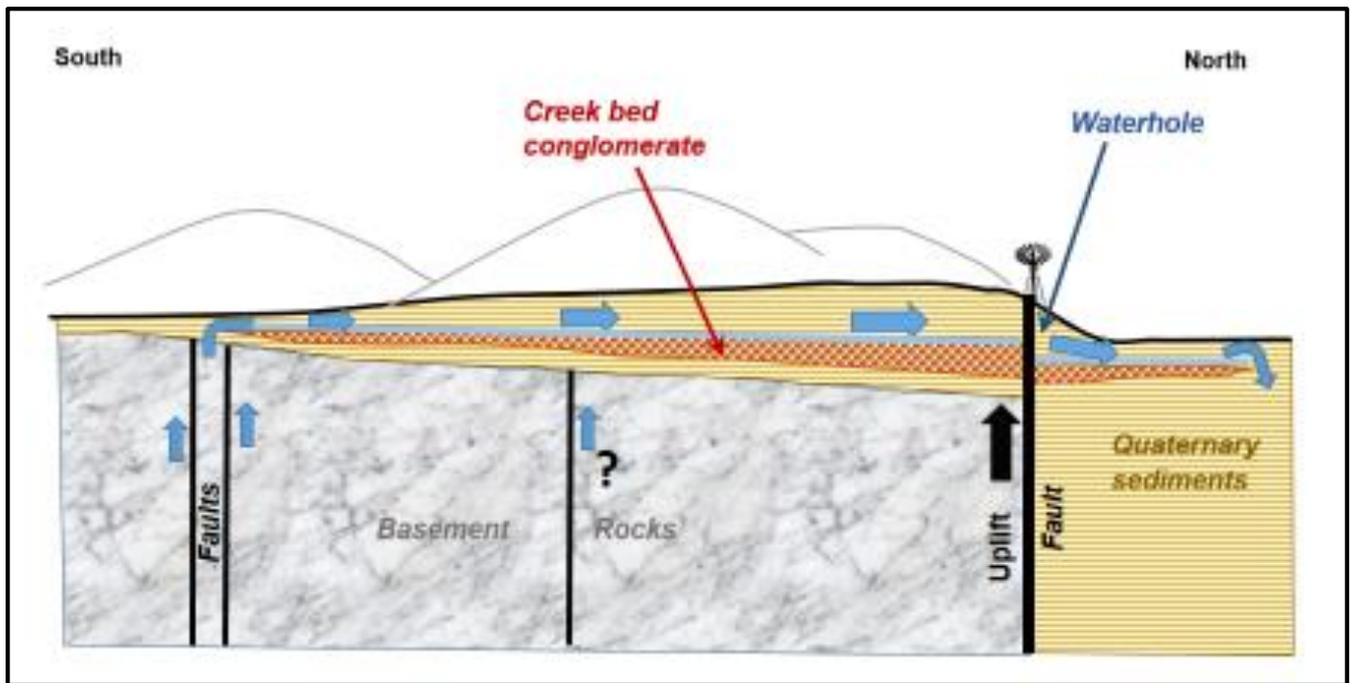
Figure 10. Schematic section along Hookina Creek

Figure 10 presents a south to north schematic section along Hookina Creek which displays these features and the postulated flow processes.

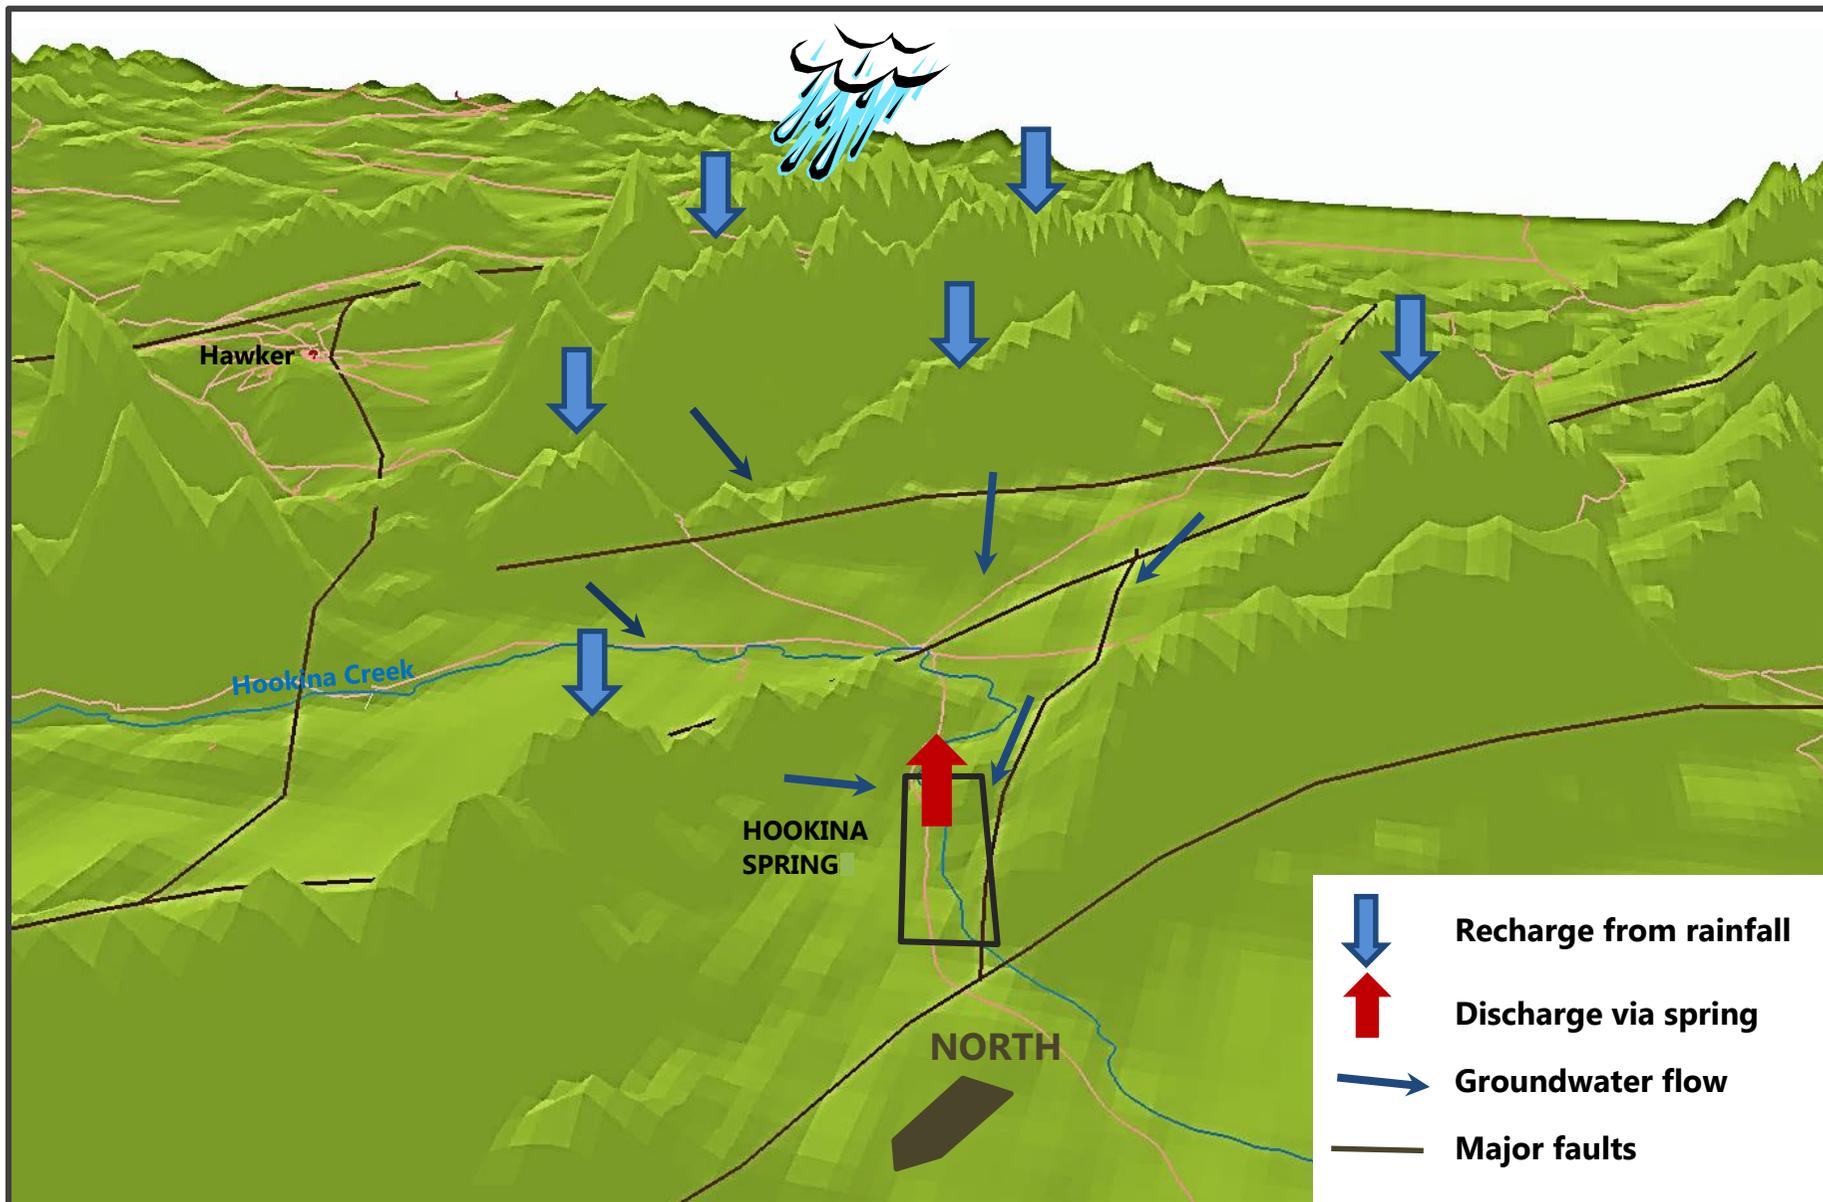
Figure 11. Visualisation of groundwater flow processes

The evidence strongly suggests that "mountain block recharge" may be the source of water for Hookina Spring. Rainfall falling on the Yappala and Elder Ranges to the east has slowly infiltrated down into the fractured rock aquifers (Fig. 11). The lack of vegetation and soil cover on the ranges would enhance such recharge. Groundwater within these aquifers flows under gravity toward the lowest point in the landscape which happens to be Hookina Creek at ~140 m AHD. The extensive faulting in the area as shown in Figure 7 has most likely facilitated regional groundwater flow toward the discharge area, as well as providing the mechanism for discharge in the creek bed as discussed earlier.
