# Geomorphology of the Thomson River, Queensland: overview and comparison with Cooper Creek

DEWNR Technical report 2015/52

A Report to the Department of Environment, Water and Natural  
Resources, South Australia; Lake Eyre Basin River Monitoring Project

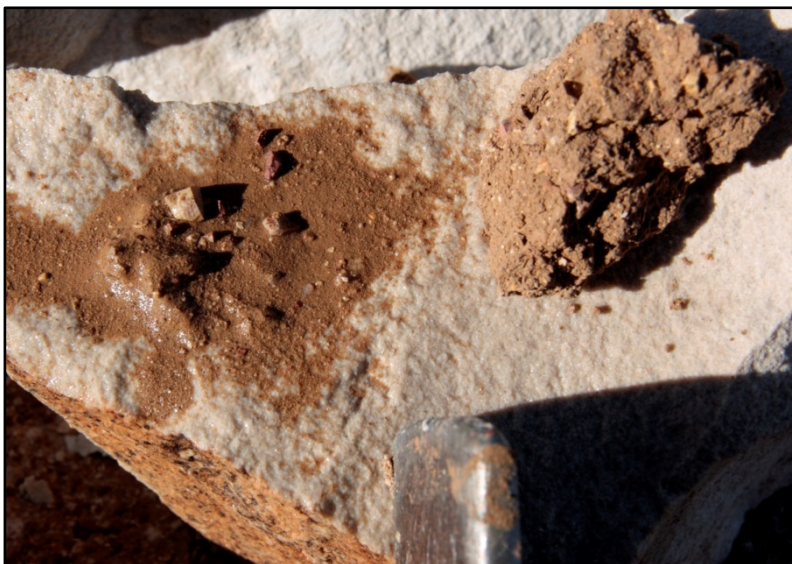
Fig. 2 Wetted vertic soils slake to aggregates.

Mud aggregate sediments are a characteristic feature of the Cooper/Thomson system: they are robust under transport, and their pellet grain size ranges from coarse silt to coarse sand (Maroulis and Nanson 1996). Viewed in the field during documentation of sediment type, the mud aggregate sediments appear to contain much more sand than they really do. Gently pouring water onto a clod of dry Cooper Creek mud causes it to rapidly break down into its component aggregates, but the aggregates themselves remain intact: only very little clay is released into suspension (Gibling et al. 1998). Vigorous treatment is required to dismantle mud aggregates into their primary grains (see Wakelin-King and Webb 2007a). For the purposes of estimating sediment composition during this project's field work, any dark-coloured or dusty sandy sediment was wetted to see if it would slake to aggregates (Fig. 2), and then the slurry mashed with a fingertip to destroy the aggregates and reveal the relative abundances of mud and sand.

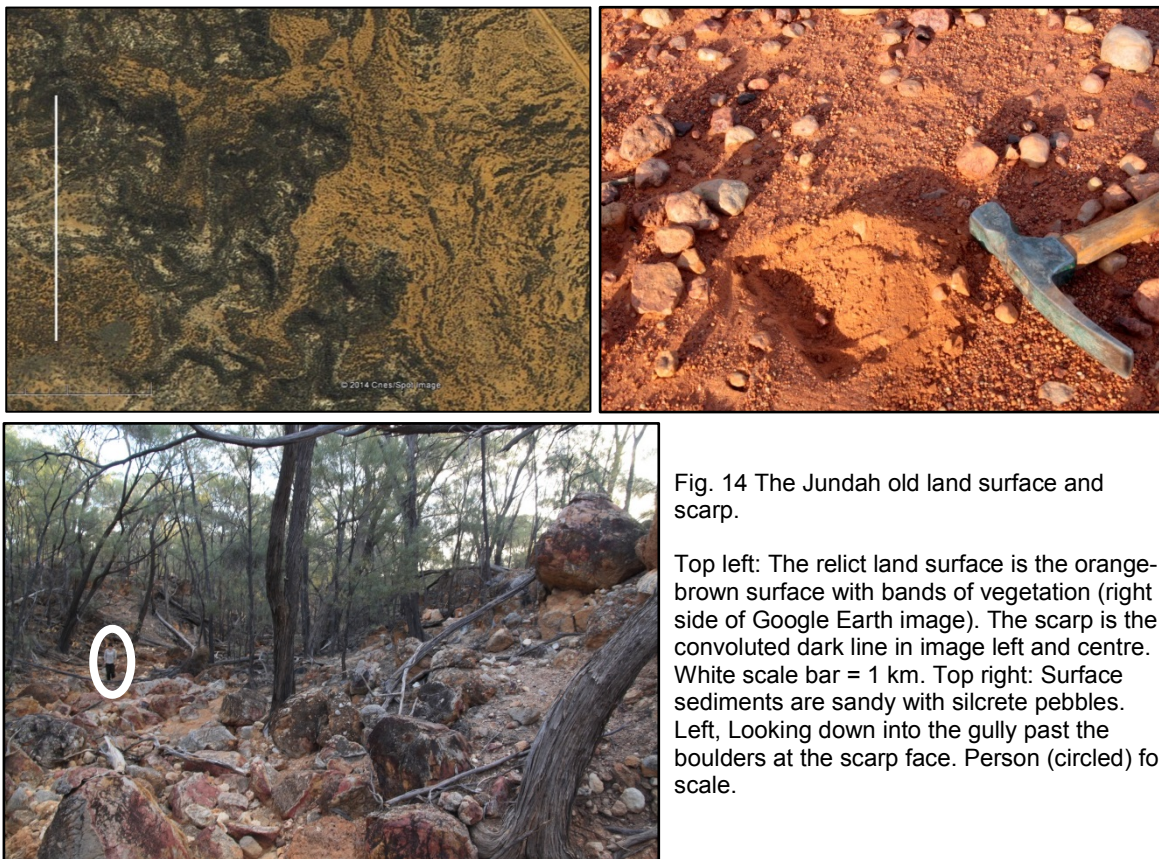
Fig. 14 The Jundah old land surface and scarp.

Banded vegetation indicates that a hillslope's drainage occurs as unchannelised sheetflow (as opposed to creeks or streams). The slope operates interactively with the vegetation communities such that rain shed from the bare interband is intercepted by the vegetated band (Wakelin-King 1999). Where the banding is intact and functioning well, banded vegetation slopes are good at intercepting rainfall; they are productive ecosystems. They are vulnerable to erosion (especially channel incision along water lanes, see Wakelin-King 1999), or devegetation which reduces the efficiency of the water-trapping vegetation bands.

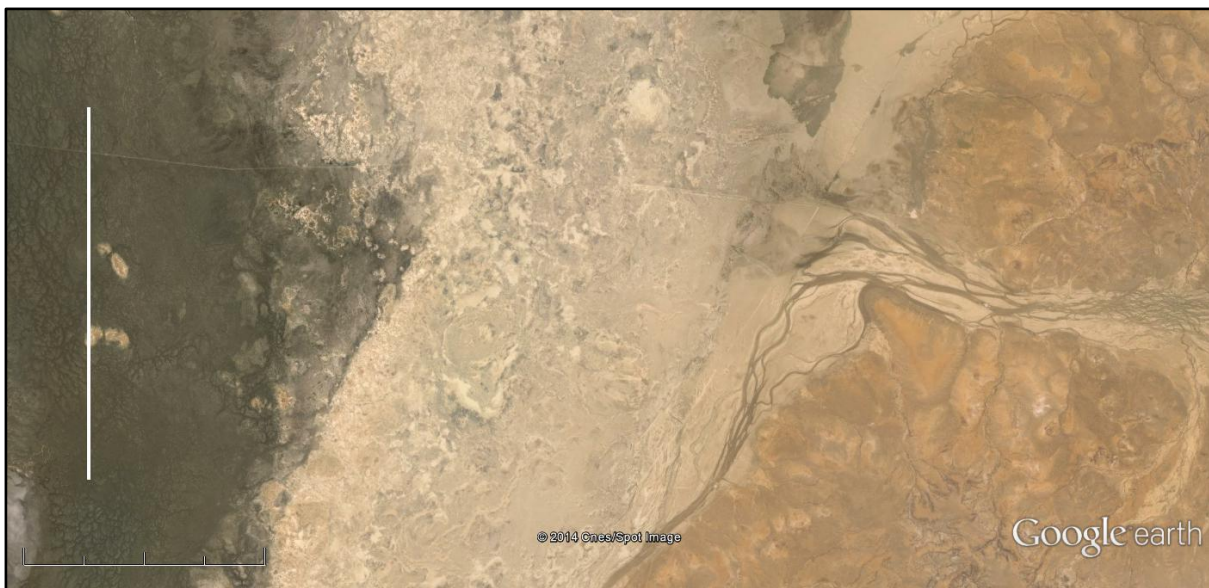
Fig. 15 Pale sands accumulating along the Cooper Plain's eastern side.

Although these sandy splays are accumulating within the valley of the Cooper Plain, they could be considered as valley-margin because the present-day creek is not constrained by them and rarely interacts with them.

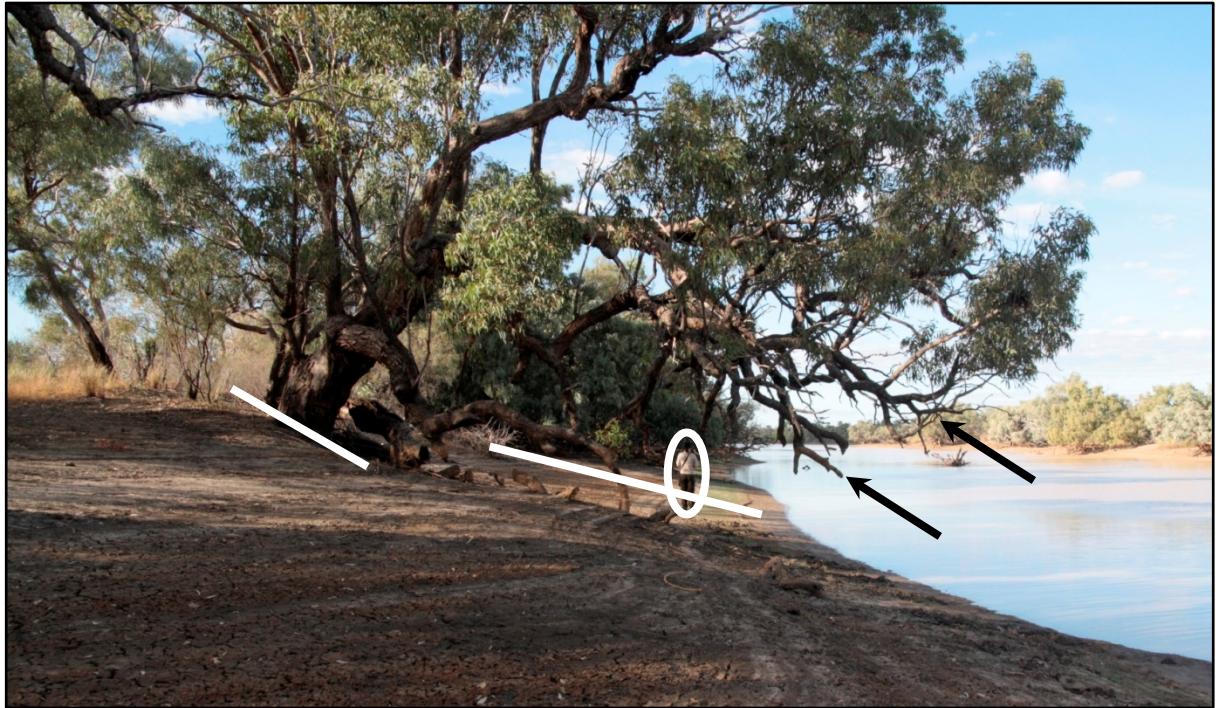
Fig. 21 Galina Waterhole bank.

Channels' and waterholes' most characteristic feature are their banks of cohesive muds. Banks are clearly defined by topography and vegetation, making channels easy to distinguish on Google Earth images and "bankfull" clear on the ground. There is usually a sharp break of slope at the bank lip, a moderate to moderately steep slope at the upper bank which grades to a gentle slope at the lower bank (Fig. 21). Some banks are moderately steep down to the water level (a more gentle lower bank possibly concealed beneath the water). Some banks are relatively steep, especially those of sinuous small channels. In some small channels, the two-element nature of the bank slope can be resolved into the steep upper bank (which may be erosional in origin), and a lower bank-attached bar with an almost-flat upper surface and a more steep foreset (Fig. 22).

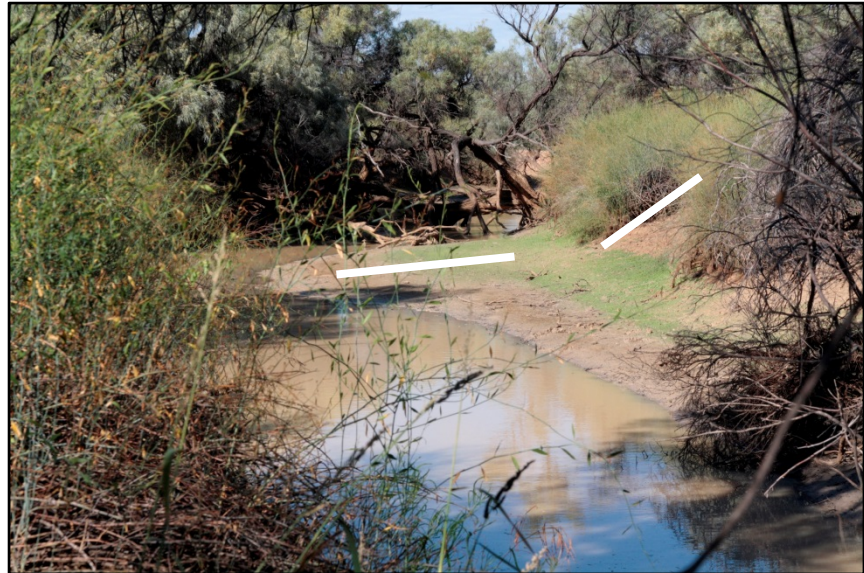
This small channel feeds into Galina Waterhole. White lines show approximate bank slope. Dense lignum in foreground left, and on upper bank slope (right, near steeper white line).

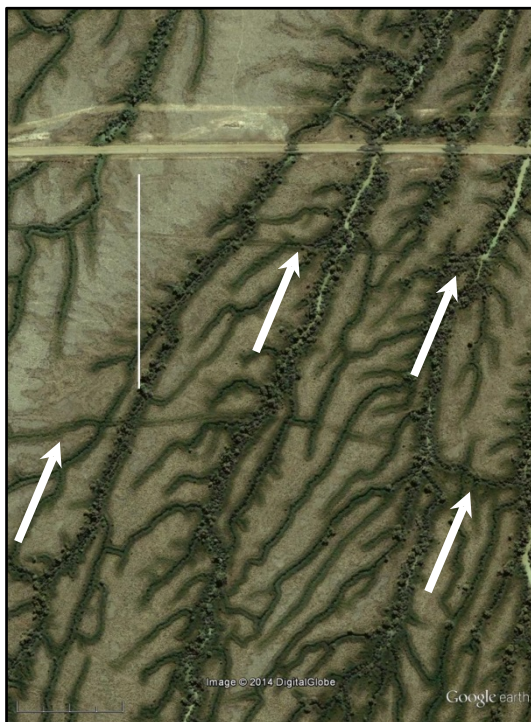
Fig. 23 Ex-roads acting as swamp channels.

Where roads cut across swamp channels, the lowered road surface becomes a focus for inundation and may in time begin to act like a swamp channel. Google Earth images show these former roads cross-cutting the trend of natural swamp channels (Fig. 23), some showing the double line that indicates bank-top lignum. In some cases, the new swamp channels divert flow from one swamp channel to another. There is no observable tendency for such flow diversions to be more effective in streamwise direction, and (unusually for roads crossing active rivers) road surfaces do not seem to be developing gullying or erosion. These observations are supporting evidence of the very low-energy nature of flood flows in these areas.

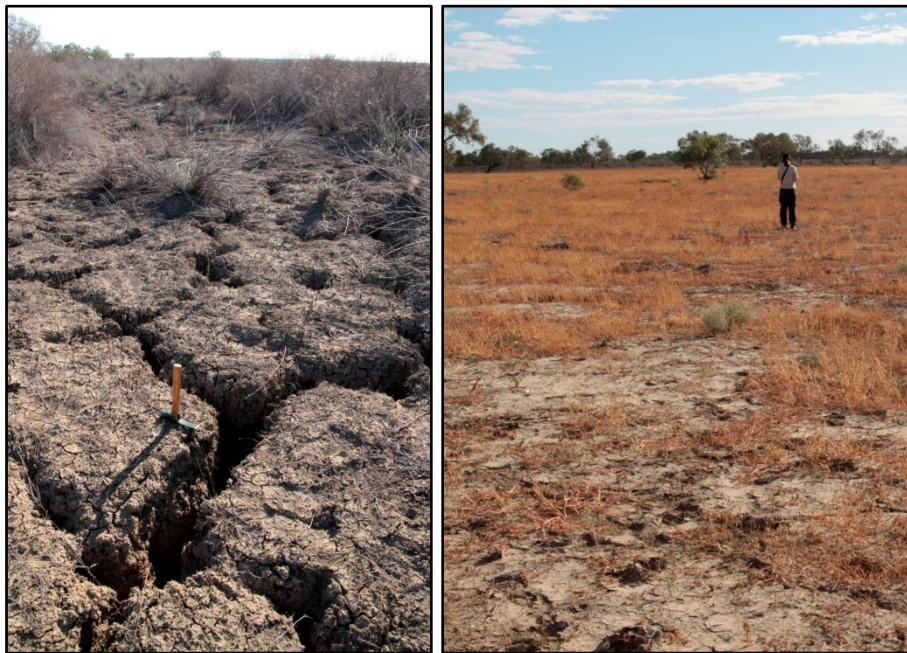
Fig. 25 Gilgai features in floodplain sediments.

The floodplain sediments in these reaches are dark grey mud aggregates, showing gilgai features (macropores, gilgai depressions, heaved surface, and either multiple cracking or self-mulching). The degree of gilgai feature development correlates with the degree to which the area is likely to be inundated: elevated floodplain bars display much less gilgai than swamp channels (Fig. 25). Most of the floodplain muds contain little sand; where present, its grain size is fine sand. Mud from a large and relatively elevated floodplain bar north of Windorah (just downvalley of the Thomson/Barcoo confluence) has a greater proportion of sand. It displays multiple cracking but no heave or deep crabholes; whether this lesser degree of gilgai features is due to elevation or sediment composition is not clear from this site.

Left, large deep macropore cracks in a swampy floodway swale, Durham Downs reaches, hammer for scale. Lignum grows along the swale edges but not in its centre. Right, small macropores are present on an elevated floodplain bar near Galina Waterhole in the Durham Downs reaches, person for scale.

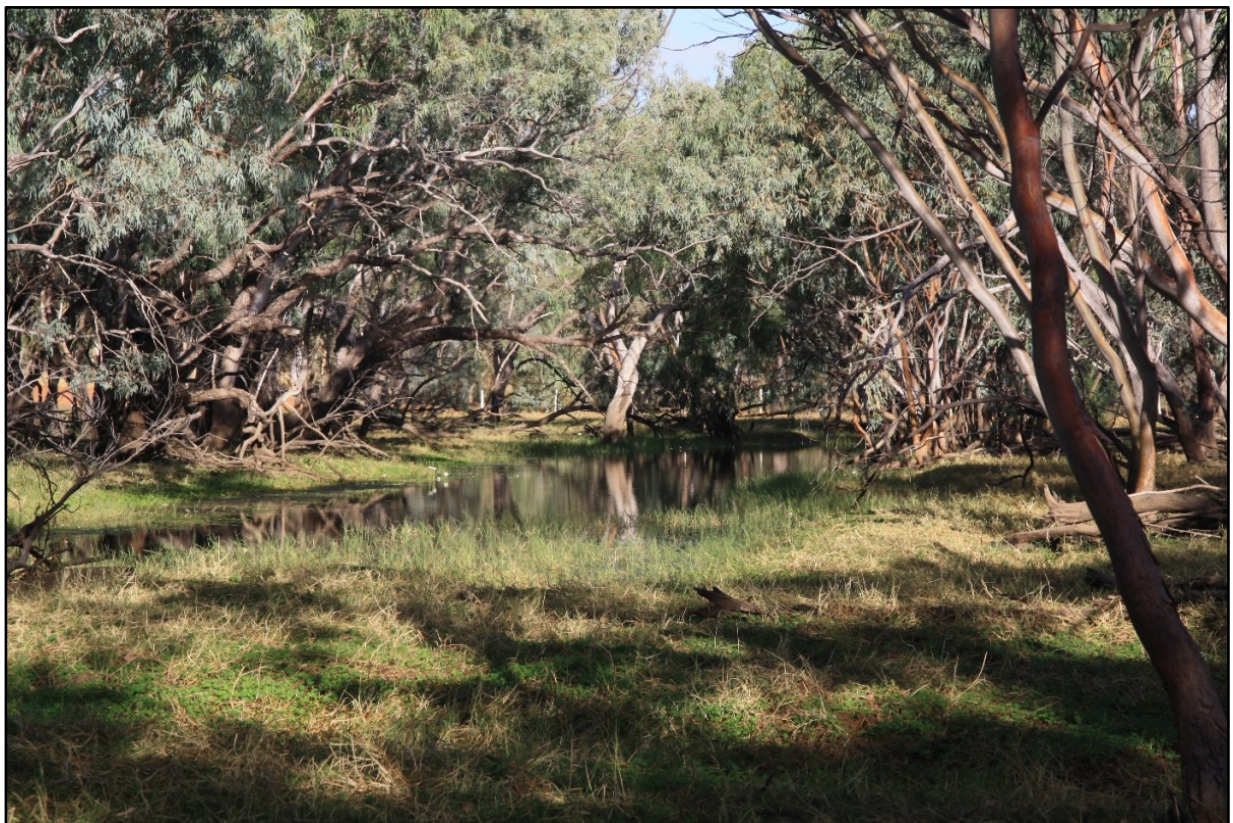
Fig. 28 The swamp west of Lake Dunn.

muds of the Thomson River and Cooper Creek. The sediments were obscured by standing water and dense vegetation, and within the timeframe it was not possible to make any further examination. The valley-margin hillslopes flanking the linear marsh were observed to be red-brown sand and silt.

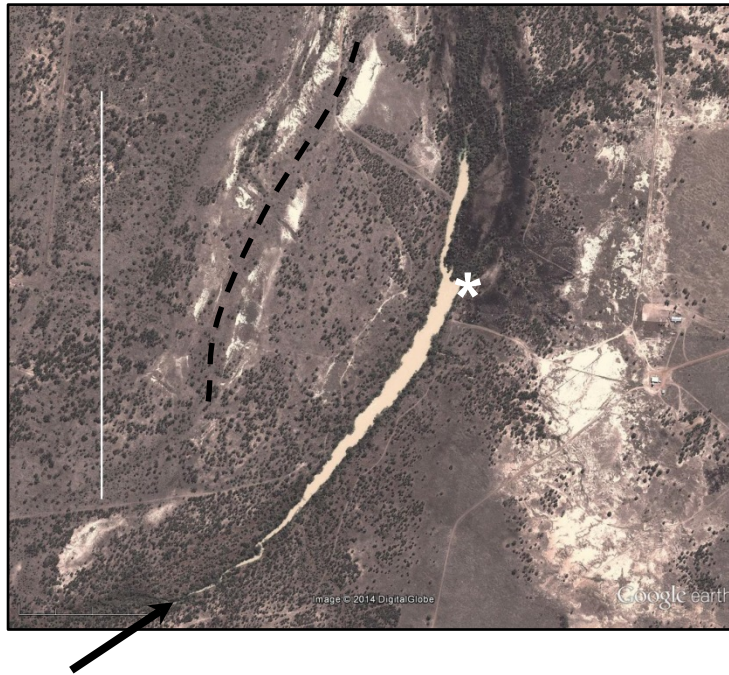
Fig. 32 Waterhole in upper Aramac Creek.

The waterholes' planforms are similar to others in Cooper Creek and the Thomson River: a narrower upstream channel widens to become the waterhole; the waterhole finishes abruptly in the downvalley terminal splay in which the single waterhole channel becomes multiple smaller channels.

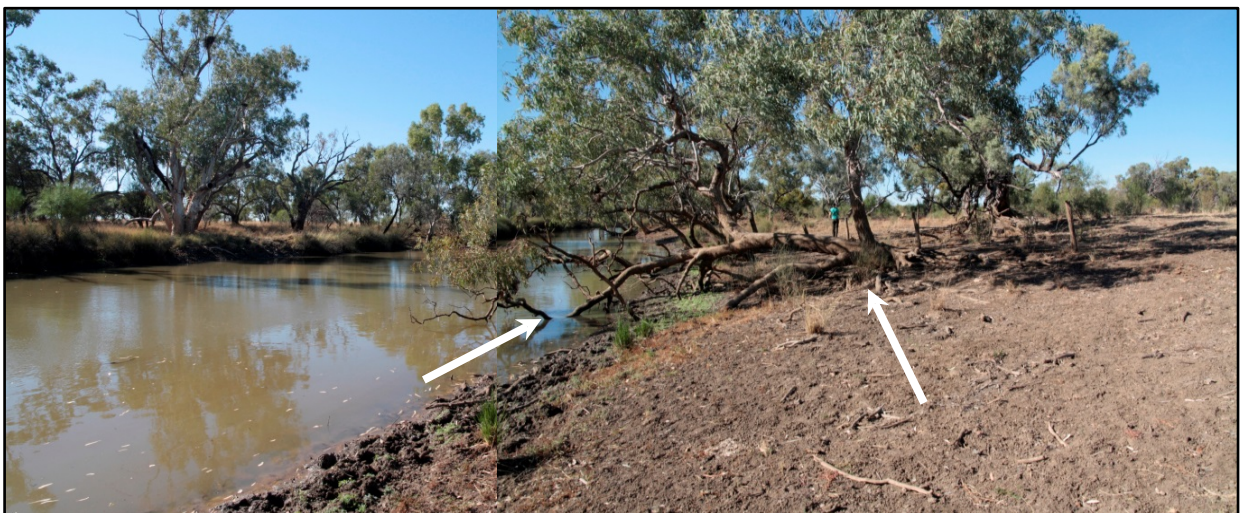
Fig. 33 A waterhole on upper Aramac Creek.

In other respects these waterholes are dissimilar. In many places along the river valley the gidgea scrub is extremely dense. The waterholes have shallow very gently-sloping banks, in which the riparian trees are set well back from the water's edge. The waterline (as expressed by water level and lignum line) is high with respect to the riparian tree bases and the overhanging limbs (Fig. 33).

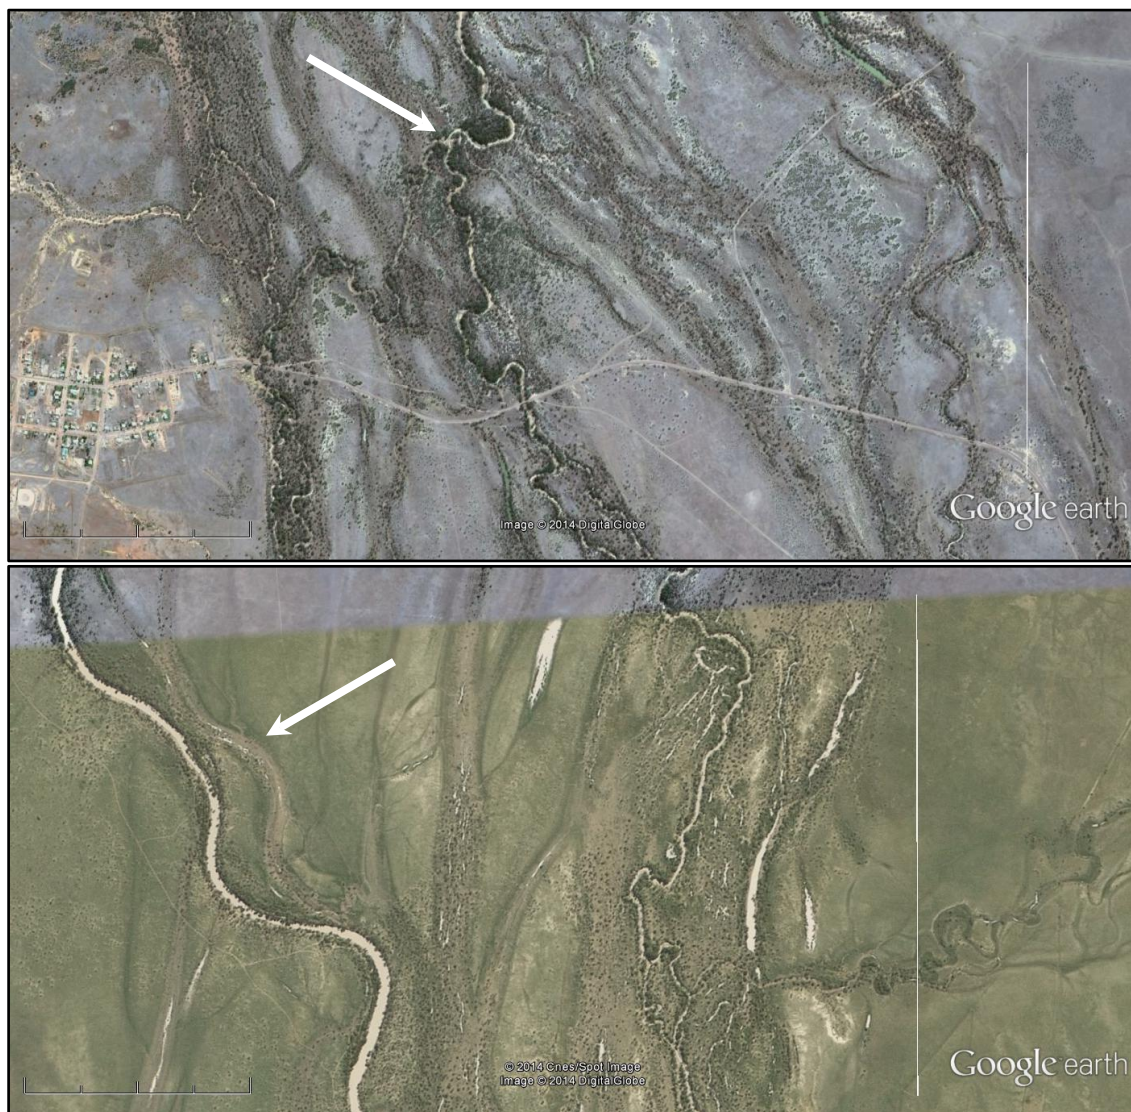
Fig. 34 Channels and floodways of the Thomson River at Muttaborra.

The upper Thomson River A is flanked on the west by low hills of sandstone outcrop partially overlain by vertic soils, and on the east by low rises of vertic soils (Fig. 30). The river valley does not appear to be constrained by the hills (c.f. section 4.7), although it is not possible within the scope of this project to be definitive.

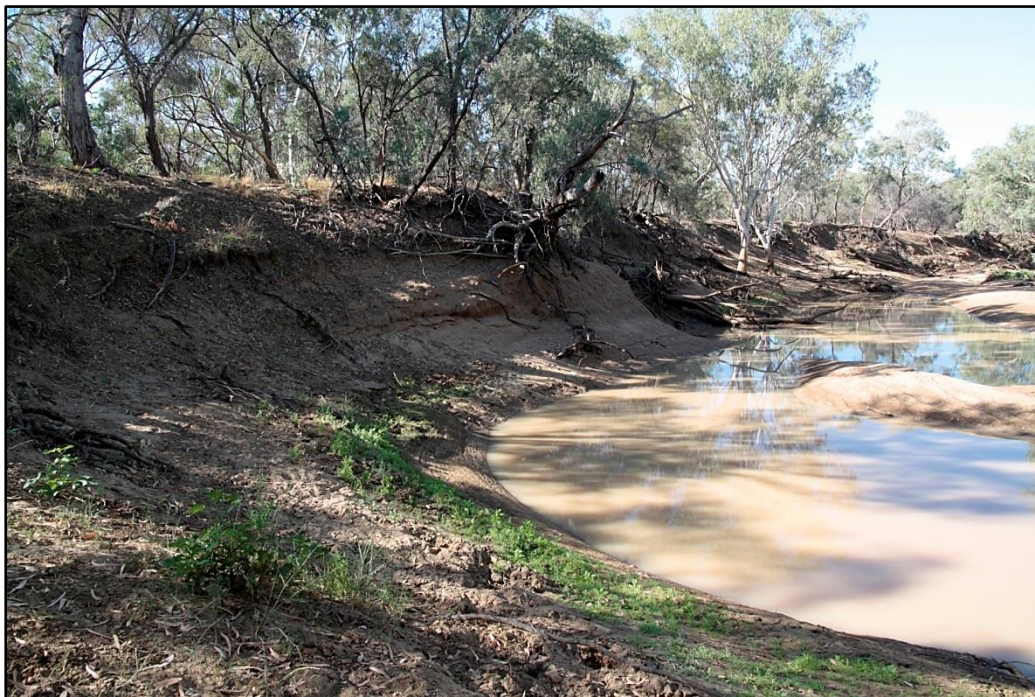
Fig. 35 Looking downstream at the sinuous Thomson channel, Muttaborra.

The anabranch connecting the Thomson channel to the Landsborough channel showed similar characteristics, however indicators of flow direction (bedform orientation, erosion patterns) were ambiguous.

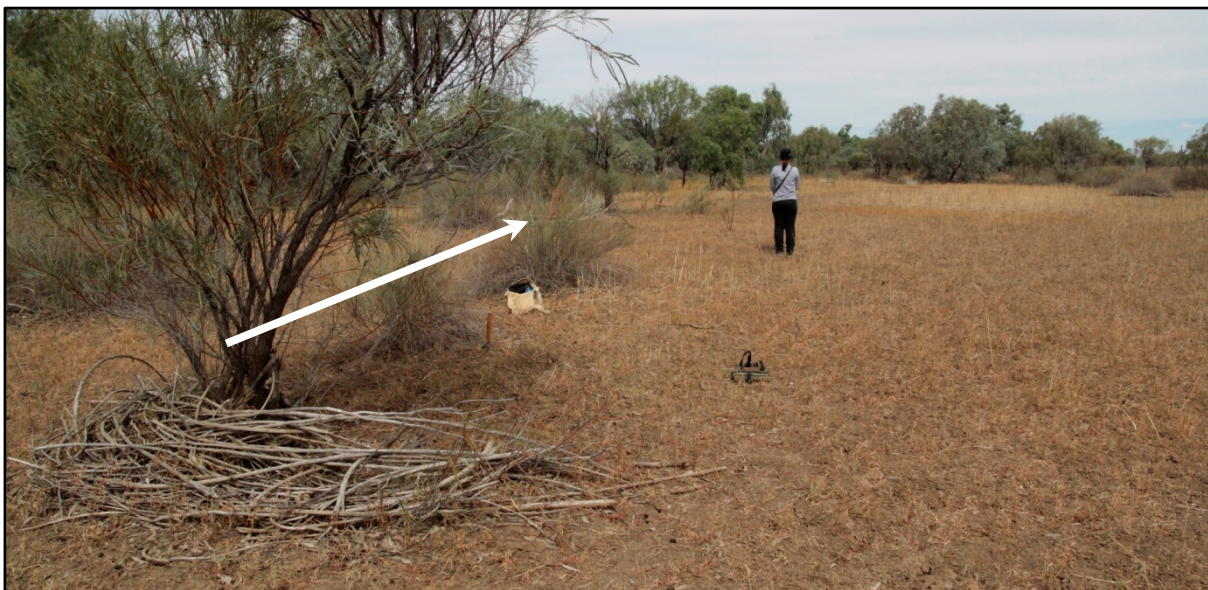
Fig. 37 Floodplain bar (right), floodway swale (left), and shadow bar ridge (arrow) with flood debris.

Floodplain bars have broad planar tops with minor gilgai features, are poorly vegetated, and may have flood debris at the break of slope (Fig. 37). Floodways are moderately densely vegetated and are of lower elevation. By visual estimate, the bar-floodway elevation difference is greater than is the case in the Cooper Plain. Most floodways are broad open swales, but some have a more distinct channel-like form and are likely to be a gradational to discontinuous channels in both form and process. In places, shadow bars behind floodway vegetation encourage germination and survival of other plants, so streamwise ridges of plants and sediment mounds are created. Where floodways host small channels, the floodway surface near the channels is likely to be sculpted into numerous small swales.

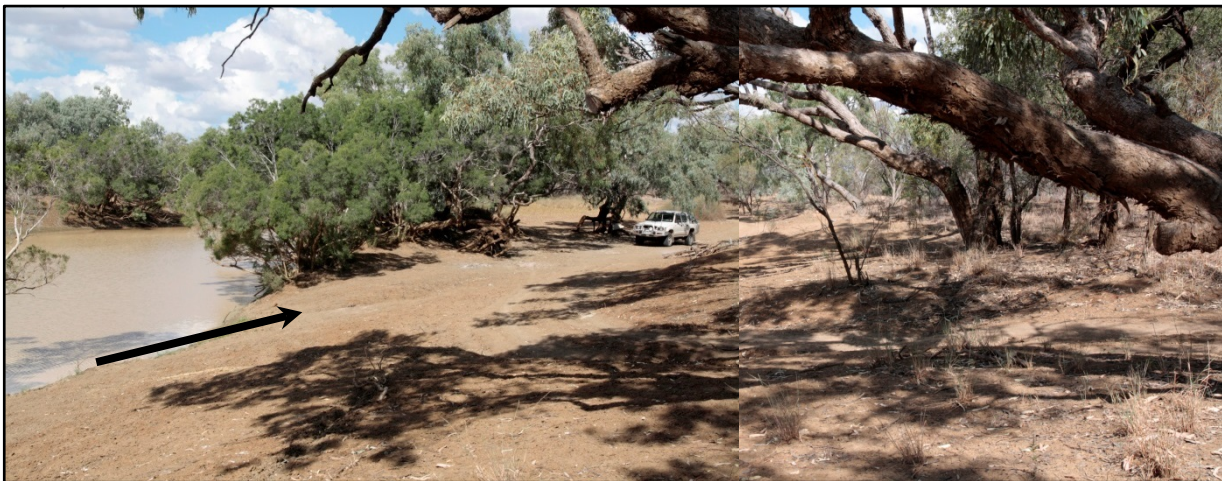
Fig. 38 Camoola Waterhole bank with an inflow/outflow channel (arrowed).

Channel and waterhole bank slopes vary from moderate to steep. The steepest slopes are in areas of geomorphic activity (anabranch nodes or sinuous small channels) where bank retreat is part of channel development. Indications of geomorphic activity included bank retreat exposing riparian tree roots, sediment deposition on bank tops and bank slopes, and small scour holes around riparian tree trunks. Many bank tops showed small swales or channels where floodwaters flowed from the floodplain into the channel, or from the channel out onto the floodplain, or both. In some places these in/outflow areas were expressed as sculpted bank tops and exposed tree roots, whereas in others more definite channels were developed (Fig. 38).

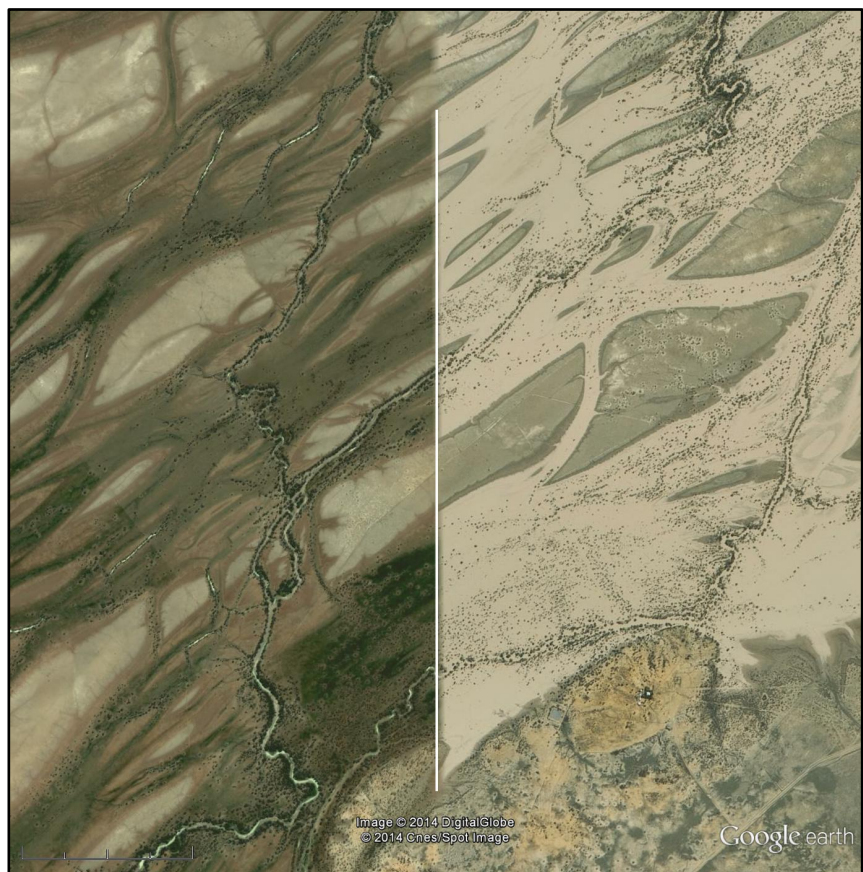
Photo right, the river in flood; photo left, the river with water in the channels but not in the floodways. Google Earth image, central white scale bar = 4 km.
