Morambro Creek and Nyroca Channel PWCs and Morambro Creek PSWA

Surface water status report
2014

Government of South Australia
Department of Environment,
Water and Natural Resources

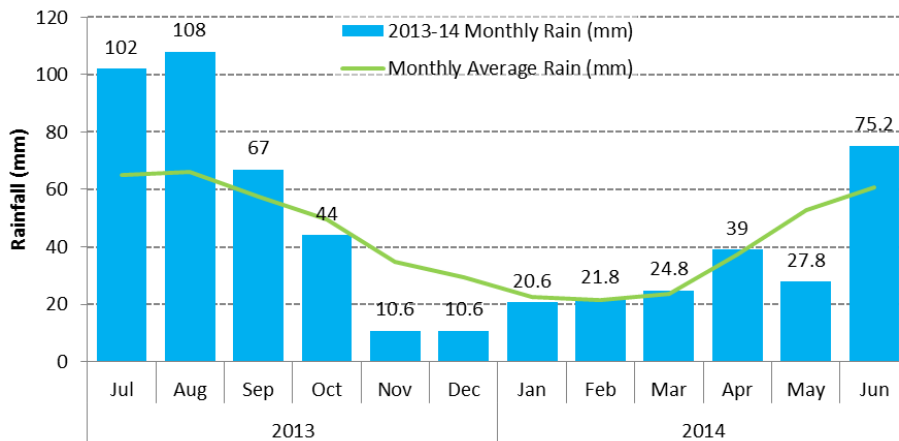
Figure 3. Monthly rainfalls at Frances (M026007)

Frances Bureau of Meteorology (BoM) rainfall station received an above average rainfall of 551 mm in 2013–14 in comparison to its long-term average of 521 mm (Figure 3). Above average rainfall was experienced in 7 months, predominantly the winter months of June, July and August across 2013–14. The months of October to January all received below average rainfall.

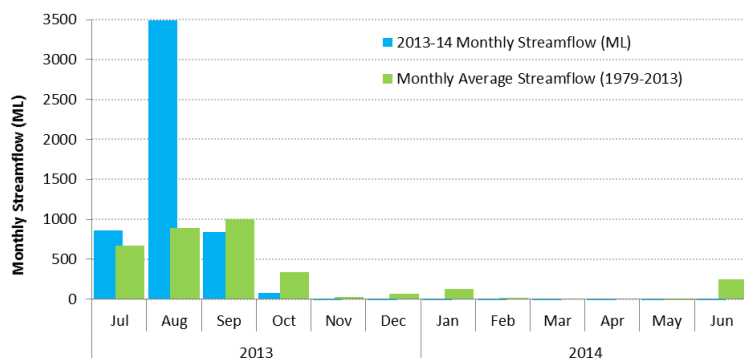
Figure 4. Monthly streamflow at Morambro Creek (A2390531)

Morambro Creek at Bordertown–Naracoorte Road Bridge gauging station (A2390531) experienced an above-average annual streamflow of 5271 megalitres (ML) for 2013–14 (55% higher than the 3392 ML long-term average). The monthly breakdown of streamflow for 2013–14 (Figure 4) highlights that the months of July and August received well above average streamflow, with August alone receiving 66% of the annual total. No streamflow was recorded from November to June.

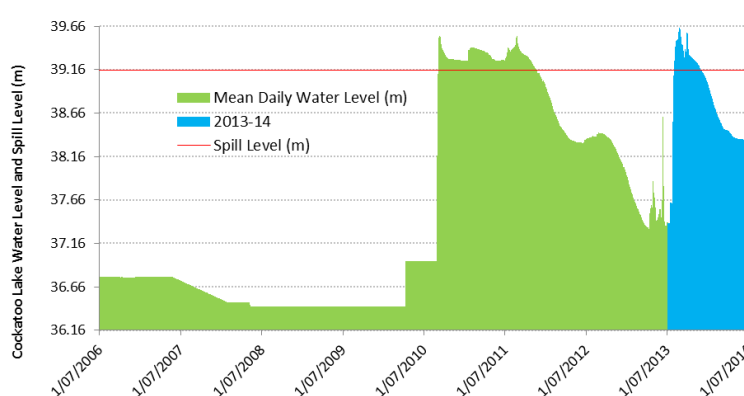
Figure 5. Water level at Cockatoo Lake (A2391074)

The Cockatoo Lake monitoring station (A2391074) is approximately 15 km downstream of the Morambro Creek gauging station and monitors water level only. The estimated base level of the lake is 36.16 m AHD, with a spill level of 39.15 m AHD. Spill from Cockatoo Lake flows along Nyroca Channel for approximately 30 km and ultimately discharges into the Marcollat Watercourse. Cockatoo Lake exceeded capacity for 122 days (33% of total days) from late July to late November during 2013–14 (Figure 5) but then started to drawdown in the second half of the year due to reduced streamflow in Morambro Creek.

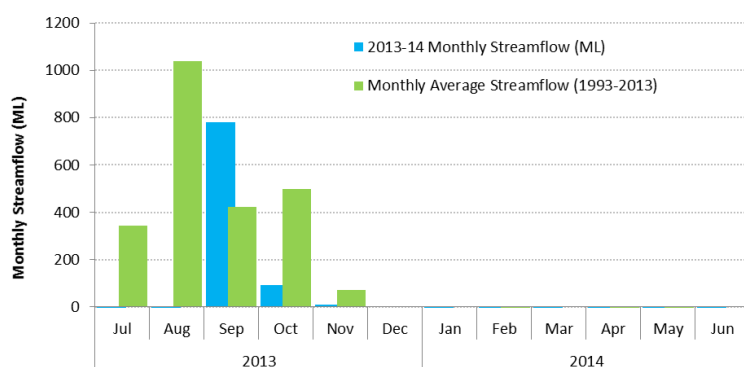
Figure 6. Monthly streamflow at Jip Jip Weir (A2391023)

Jip Jip Weir (A2391023) is located at the downstream end of the Marcollat Watercourse, downstream of a regulator for the Marcollat system. This surface water monitoring site is located outside of the PA and is not used to determine the surface water status, however flows recorded at Jip Jip Weir affect the taking of water from the PA. Jip Jip Weir received 884 ML of streamflow in 2013–14 (Figure 6) after receiving no streamflow the previous year.

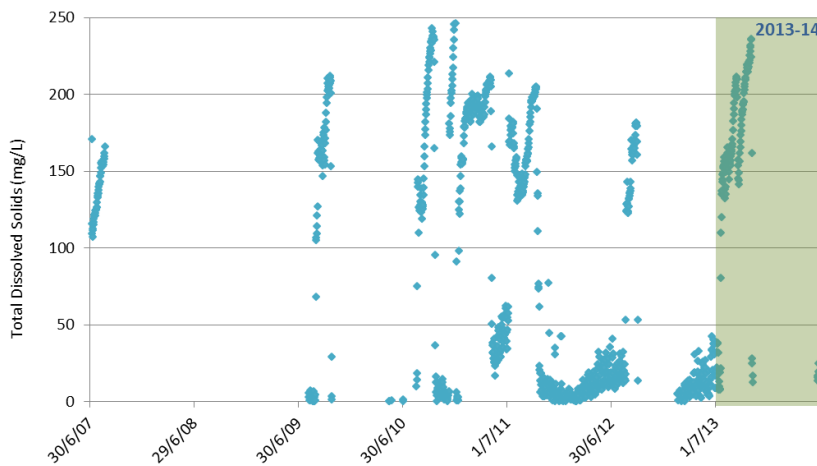
Figure 7. Salinity data at Morambro Creek from 2007–2013

Due to the ephemeral nature of Morambro Creek, streamflow is generated in response to heavy rainfall and is short lived, resulting in large data gaps when the stream is dry. Salinity data suggests that streamflow is consistently very fresh, with all data less than 250 mg/L Total Dissolved Solids (Figure 7). The range of salinity for 2013–14 is slightly higher than the previous year but still very fresh.
