# Morambro Creek and Nyroca Channel PWCs and Morambro Creek PSWA

2015 Surface water status report

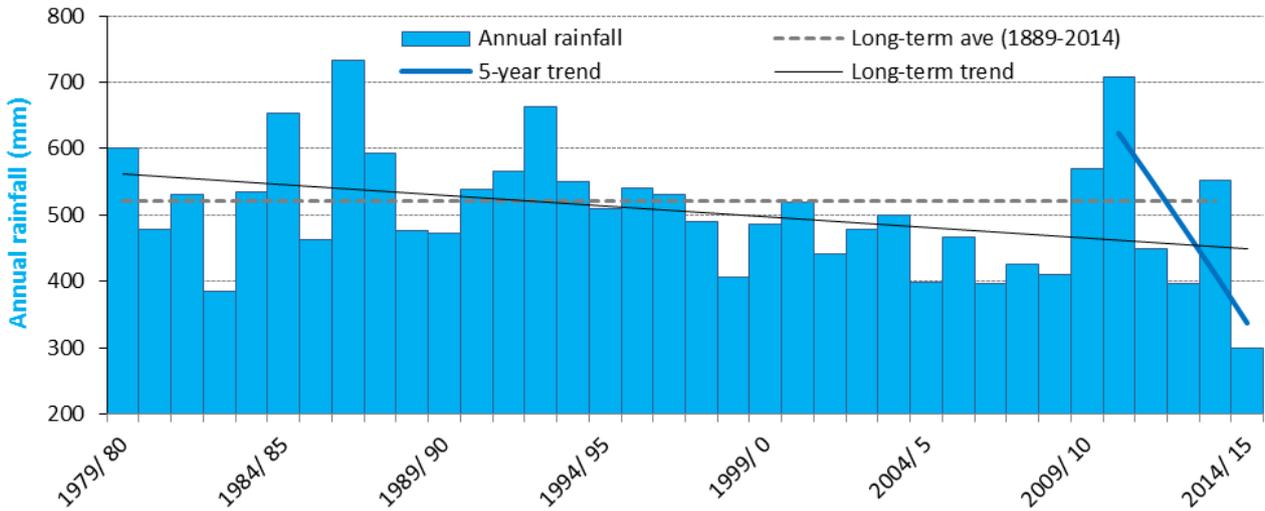
Figure 1. Annual rainfall (mm) for the 1979–80 to 2014–15 water-use years (July–June), the long-term trend and long-term average annual rainfall, and the short-term trend for the past five-years recorded at Frances rainfall station (M026007)

The Frances rainfall station (M026007) is located along the eastern-edge of the Morambro Creek PA where annual rainfall totalled 299 mm in the 2014–15 water-use year, 222 mm below the long-term average annual rainfall (Fig. 1). Last year's rainfall was the lowest of the past 36 years at the Frances rainfall station (the period which aligns with the period of available streamflow data). During the 12 months to June 2015, only two months (January and May) had above average rainfall, with the winter and spring months of July to November recording below average rainfall during the last water year. The spatial distribution of rainfall for the past five-years shows average annual rainfall below the long-term average throughout the majority of the PA, with the exception of the eastern region and the southern boundary where the five-year rainfall average was more comparable to the long-term average (Fig. 3). The spatial distribution of rainfall for 2014–15 shows well below average rainfall across the entire PA.

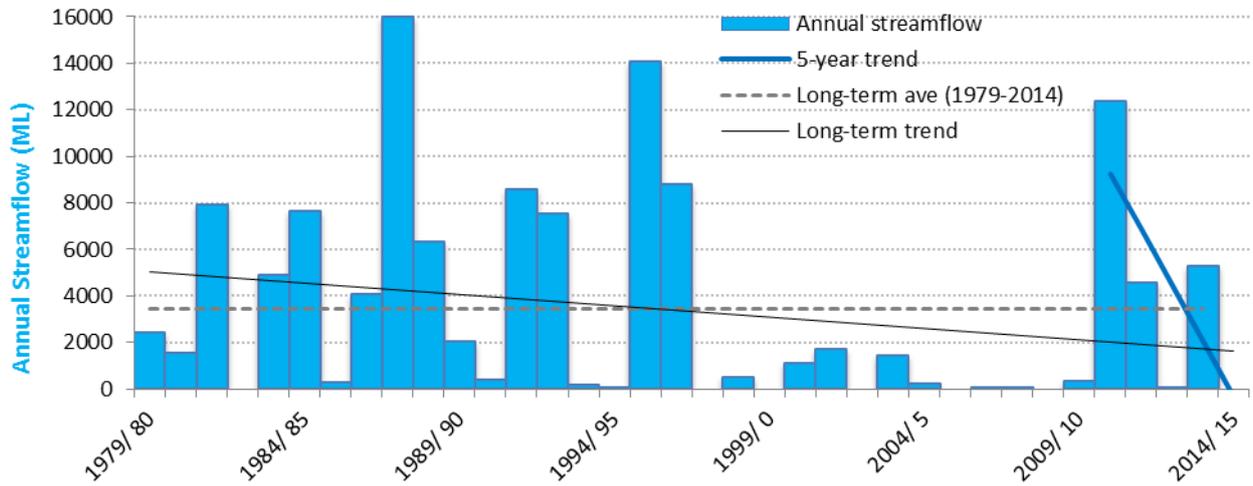
Figure 2. Annual streamflow (ML) for the 1979–80 to 2014–15 water-use years (July–June), the long-term trend and long-term average annual streamflow, and the short-term trend for the past five-years recorded at Morambro Creek gauging station (A2390531)

The Morambro Creek gauging station (A2390531) at Bordertown-Naracoorte Road Bridge is the sole streamflow gauging station located within the PA. Annual streamflow recorded at Morambro Creek gauging station was 0 ML in the 2014-15 water-use year, the seventh time no flow has been observed since 1979, and ranks in the 0–25<sup>th</sup> percentile (%ile) range of streamflow over the period of record. As a comparison, the station has a long-term average annual streamflow of 3442 ML and recorded a flow of 5271 ML in 2013-14 (Fig. 2). Located approximately 15 km downstream of the Morambro Creek gauging station is the Cockatoo Lake monitoring station which received no flow from Morambro Creek in 2014–15 and measured a lake water level drop of over 1 m, from 38.4 m AHD to 37.2 m AHD during this period. The spill level of Cockatoo Lake into the Nyroca Channel is 39.15 m AHD and as water level was below this level no flow entered the Nyroca Channel.

The annual streamflow volume recorded at Morambro Creek from 1979 to 2015 (Fig. 2) indicates a long-term declining trend, with less frequent years of above average streamflow since 1997 compared to the preceding two decades. This declining trend correlates with the predominantly below-average rainfall recorded in the Morambro Creek PA since 1997.

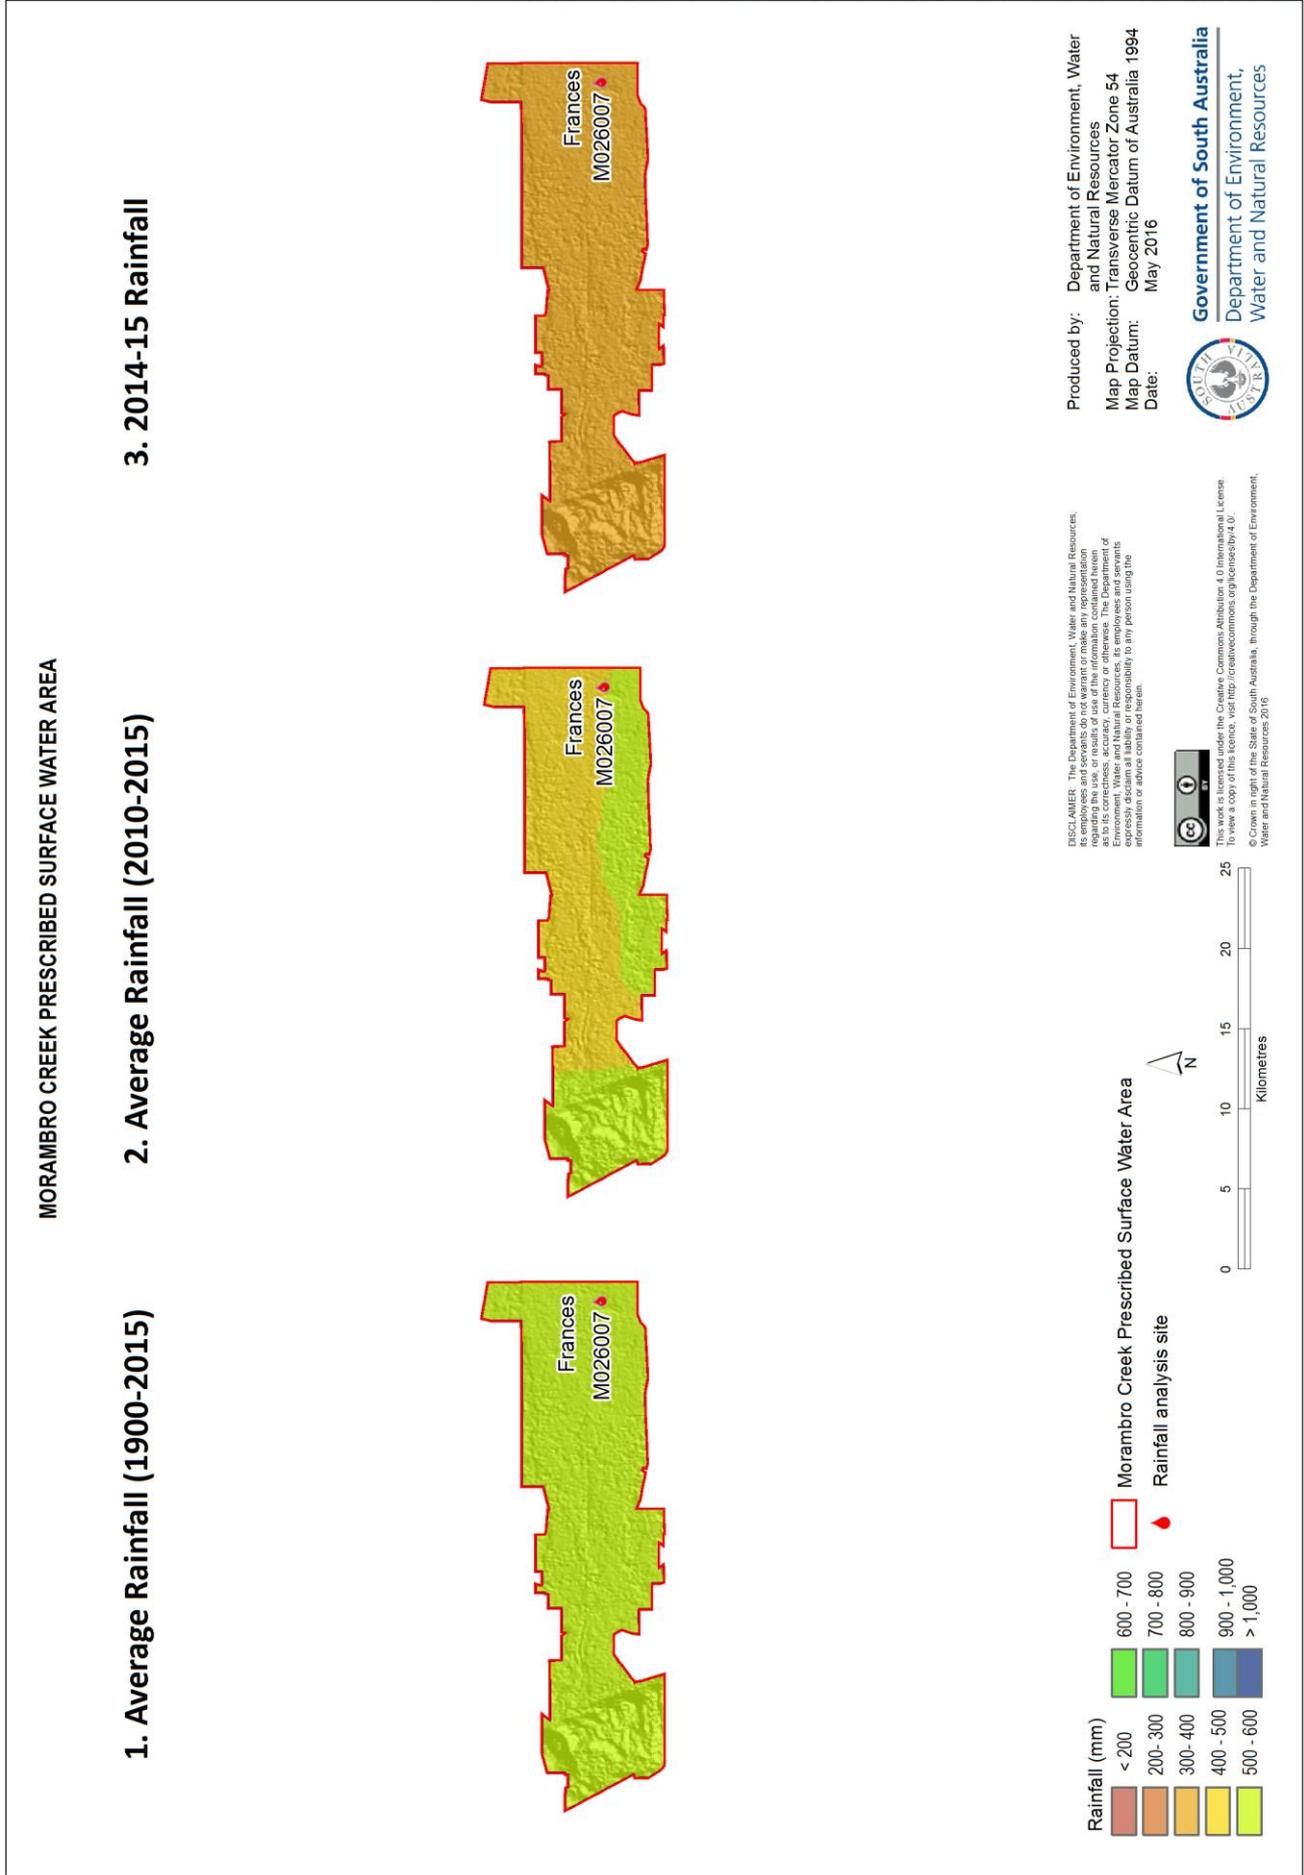
Figure 3. (1) Long-term and (2) five-year average annual rainfall and (3) annual rainfall for the 2014–15 water-use year in the Morambro Creek PSWA

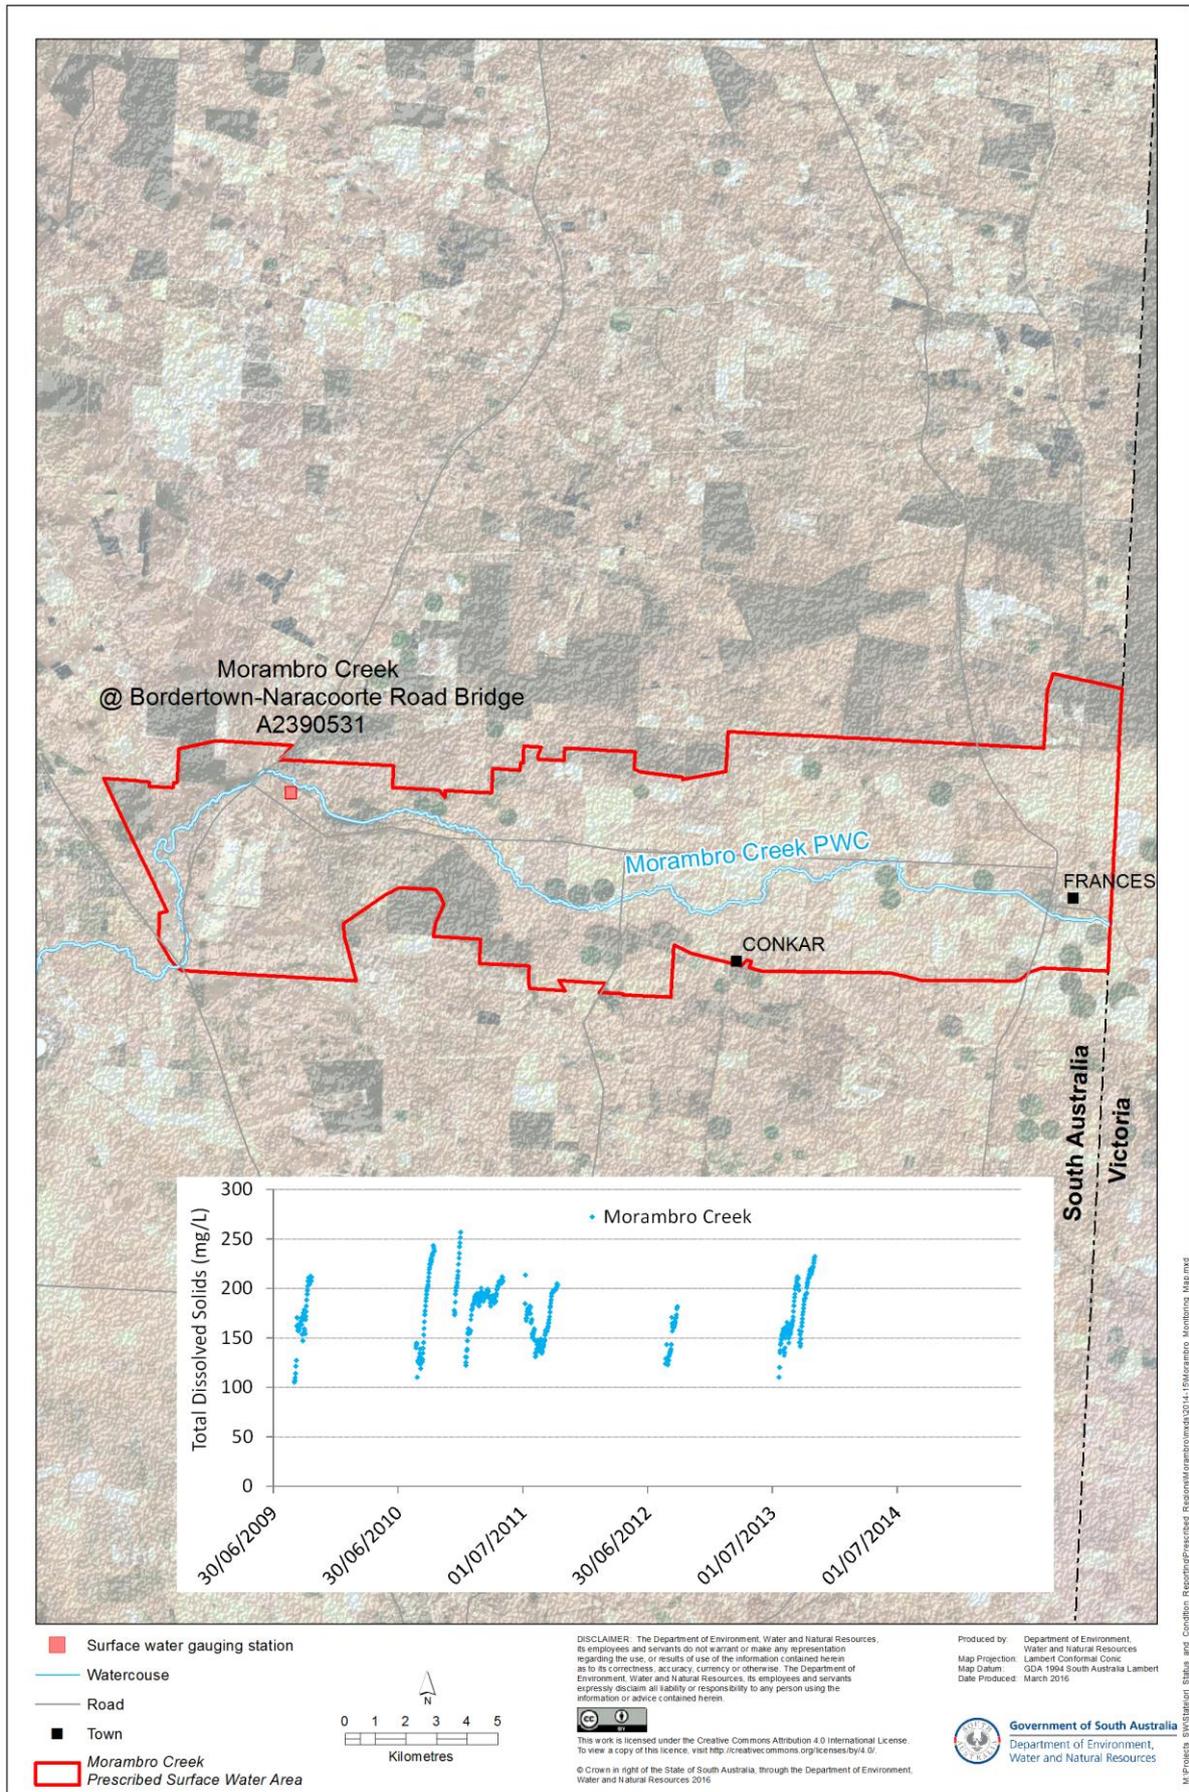
Figure 4. Surface water gauging station in the Morambro Creek PA and salinity data (TDS mg/L) for the 2009-10 to 2014-15 water use years at Morambro Creek at Bordertown-Naracoorte Road Bridge (A2390531) gauging station

Due to the ephemeral nature of Morambro Creek and the streamflow generated being short lived in response to heavy rainfall, there are large data gaps in salinity data when the stream is dry. Salinity data is unavailable for the 2014-15 water year as there was no streamflow during this period. However, during times of streamflow the Morambro Creek gauging station provides a reliable indication of salinity (TDS) with data recorded generally being less than 250 mg/L TDS, indicating a very fresh section of watercourse (Fig. 4).
