SA River Murray Flow Report

Report #2/2025

Issued 12:00 pm 10 January 2025

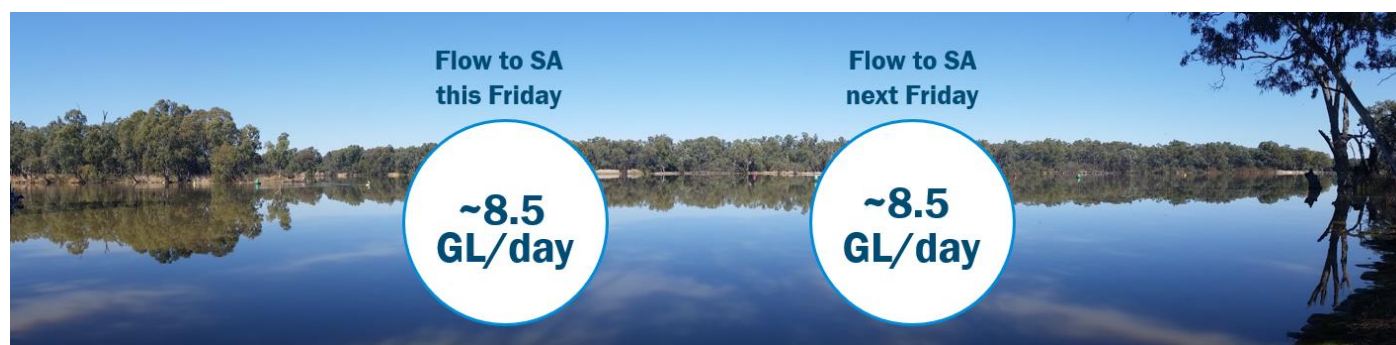
The flow at the South Australian border is approximately 8.5 GL/day and is expected to remain at approximately 8.5 GL/day over the coming week, **depending on river operations**.

The current flow at the South Australian border includes the full January Entitlement Flow (7 GL/day), along with water for the environment, interstate trade adjustments and adjustment for deferred entitlement flows, which are stored and accumulated for critical human water needs during dry periods.

The flow over Lock 1 this Friday will be approximately 6 GL/day, but flow is expected to increase to approximately 6 GL/day by next Friday. It is important to note that flow forecasts in this advice are based on the information available at the time of preparation. Advice may change as new gauging information becomes available or due to rainfall events or changed operations upstream.
