Prioritising springs of
ecological significance in
the Flinders Ranges

Prioritising springs of ecological significance in the Flinders Ranges

Report DWLBC 2009/16

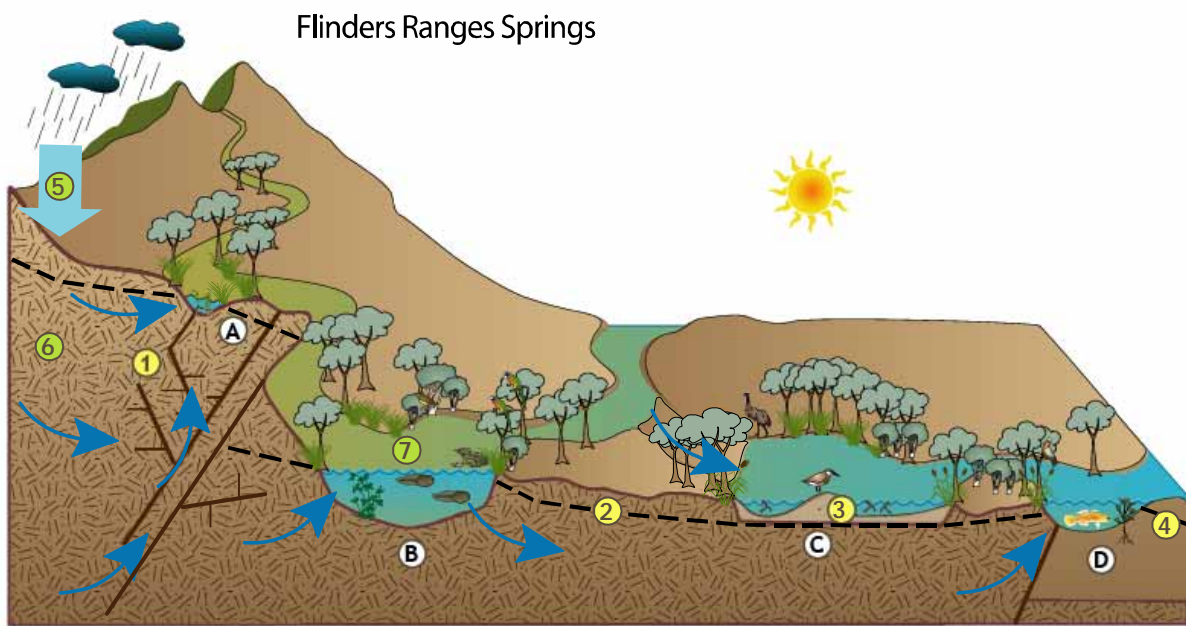
Spring types

Four distinct hydrogeological processes can be distinguished that determine springs hydrological function in the Flinders Ranges. These (Figure 4) are summarised as:

- A. Fractured Rock: water follows rock fractures, which may lead to the surface. These fracture features flow after rainfall events.
- B. Groundwater Discharge: where groundwater from a deeper aquifer is expressed at the surface; these are usually permanent features.
- C. Sub-surface Flow: whereby a stream disappears underground and is expressed at the surface; these may also be permanent features.
- D. Fault-line: when groundwater travels along a fault line and intersects a streambed and water is expressed at the surface

- (A) Fractured Rock (B) Groundwater Discharge (C) Sub-surface Flow (D) Fault Line

- A - Fractured Rock: water follows rock fractures, which may lead to the surface. These fracture features often mimic rainfall events.
 B - Groundwater Discharge: where groundwater from an underlying aquifer is expressed at the surface, these are usually permanent features.
 C - Sub-surface Flow: whereby a stream disappears underground and is expressed at the surface when the sediment type is very porous.
 D - Fault Line: when groundwater travels along a fault line and intersects a streambed and water be expressed at the surface.

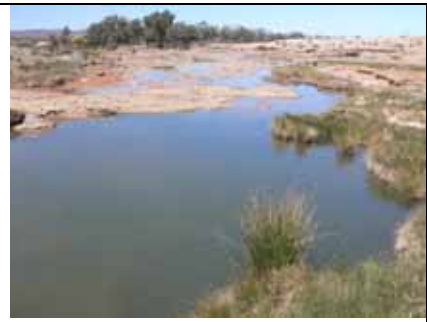
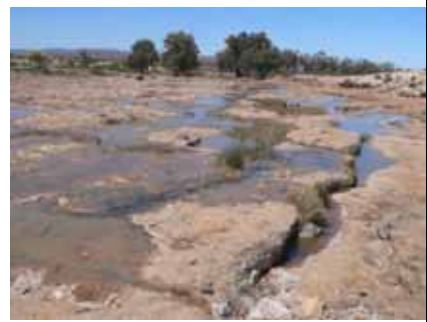
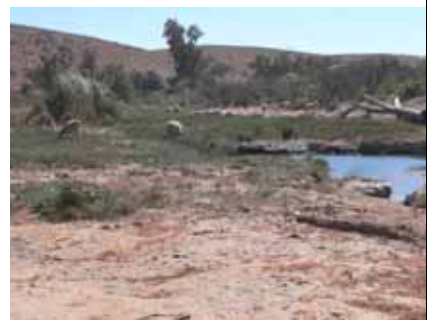
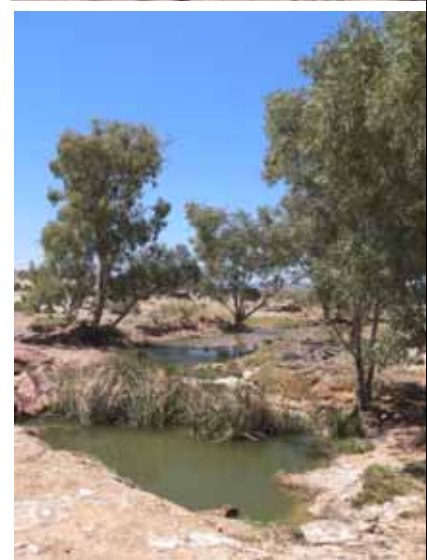
Depth: at time of visit, various depth of pools with the deepest being ~1.5 m and the shallow riffle zone being <0.2 m deep.

These pools are part of the Puttapa Spring system.
Photos taken in October 2008 by Mel White.

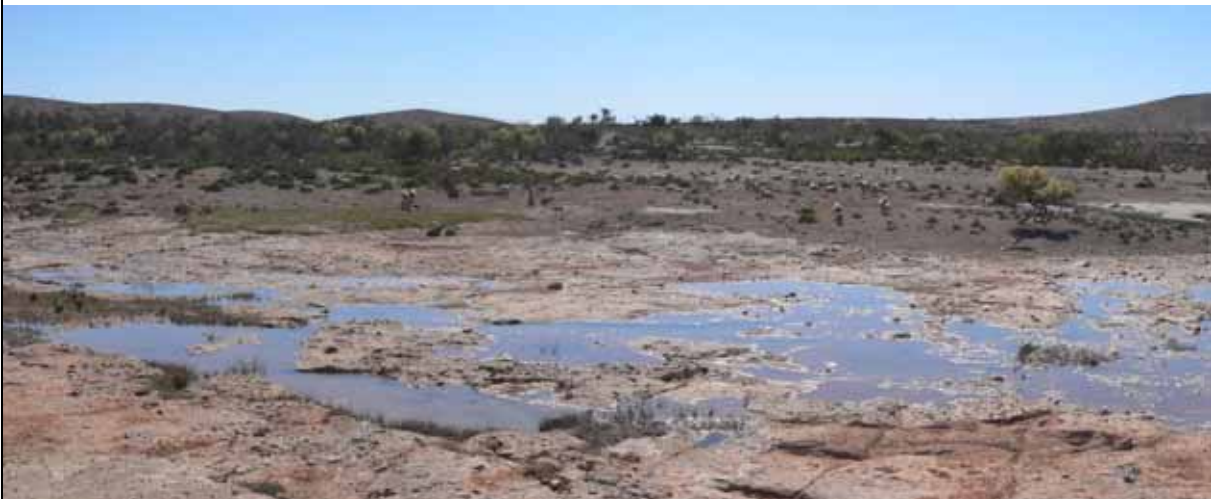
Photograph of the shallow pool section of Puttapa Spring, with stock seen on the banks. Being a shallow crossing that is highly used by stock, little vegetation exists along the spring edge in this section. October 2008 (Mel White).

HIGH: Based on the springs HIGH restoration potential, its hydrological permanence in being a key aquatic refuge for the sub-catchment, and it being a unique large wetland feature.

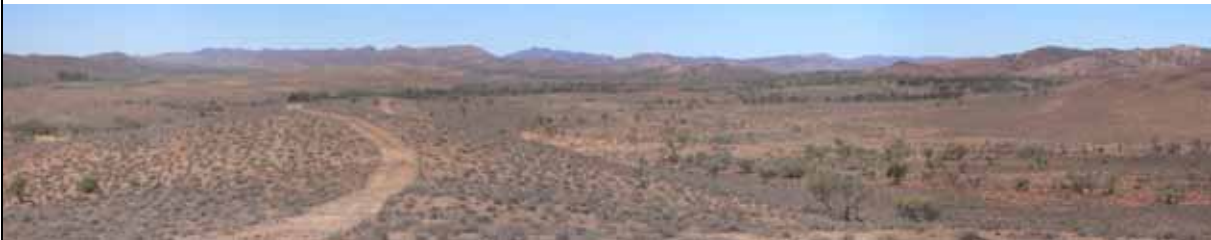
Photograph of the range where the unnamed/unmapped spring exists. The track leads to the spring which is located in a creek line at the bottom of the hill. October 2008 (Mel White).

LOW: Based on the springs low restoration potential and the low significance as a 'key aquatic refuge'

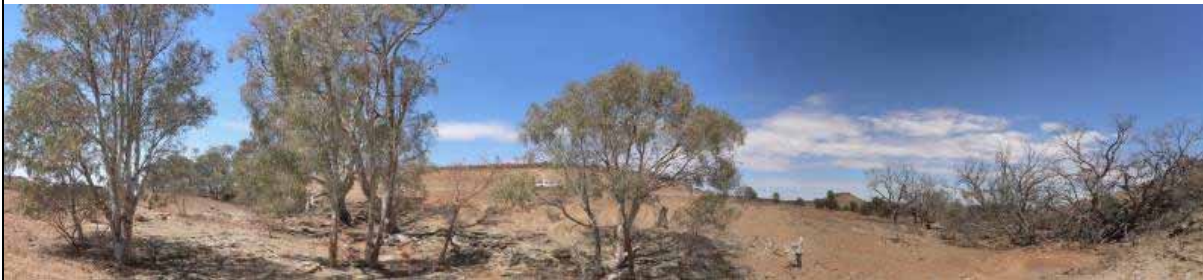
Aldoona Spring, evidence of downstream drying of spring indicated by dead red gums. October 2008 (Mel White).

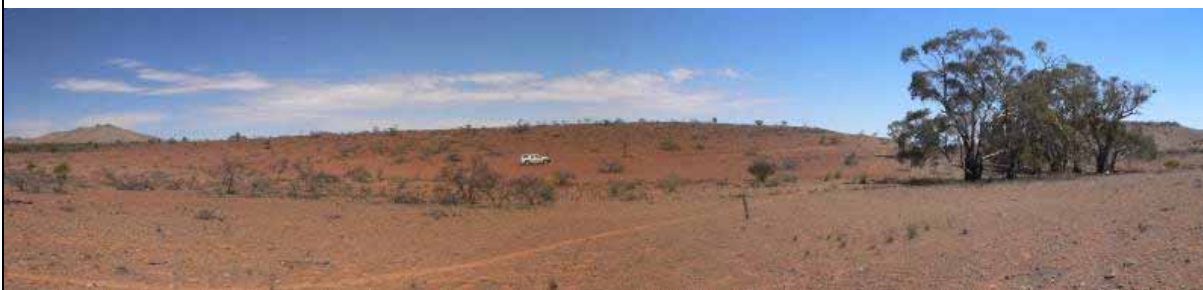
Aldoona Spring (where the red gums are on right). This photo clearly indicates the importance of the groundwater in the Flinders Ranges system, as upstream of the groundwater fed spring there are no water dependant species ie. red gums growing in the creek line. October 2008 (Mel White).

MODERATE - LOW: Based on the low restoration potential and its low value as a key aquatic refuge. It is advised that fenced springs be used as pilot studies for understanding the processes in designing alternative watering points and also for developing and implementing spring management plans.

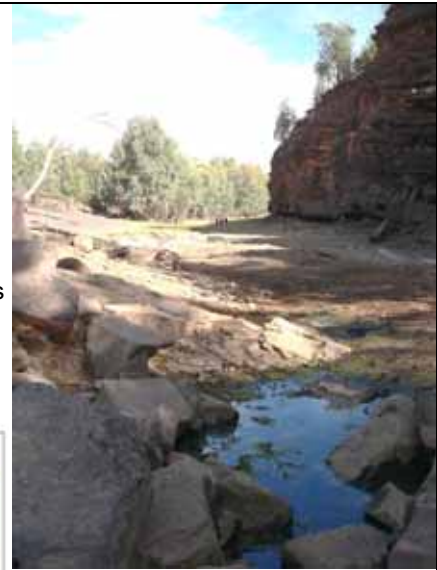
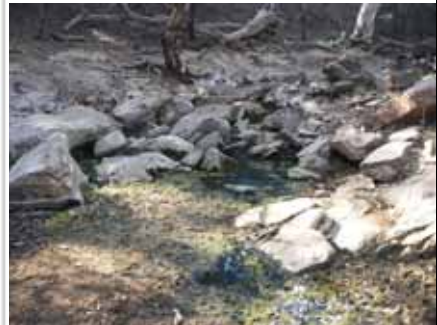
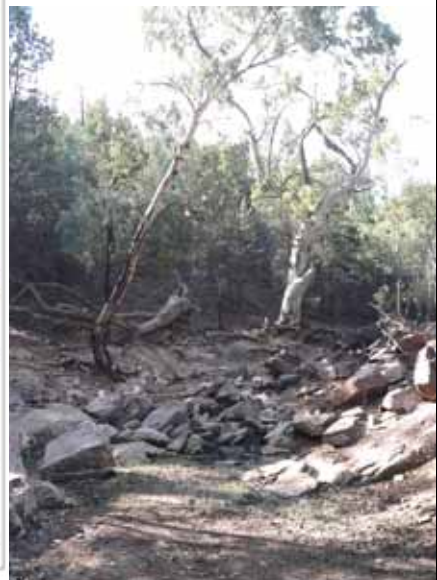
Size: at time of visit, 2 x 2 m. Evidence that pool is ~50 m long.

Depth: at time of visit, ~0.2 m.

Charlies Camp Spring.
Photos taken in October 2008 by
Mel White.

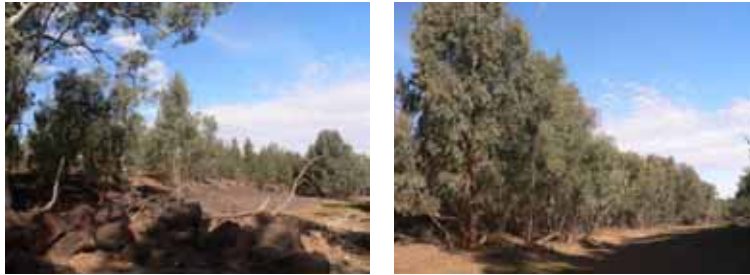
Young mature red gums downstream of Charles Camp Spring.
October 2008 (Mel White).

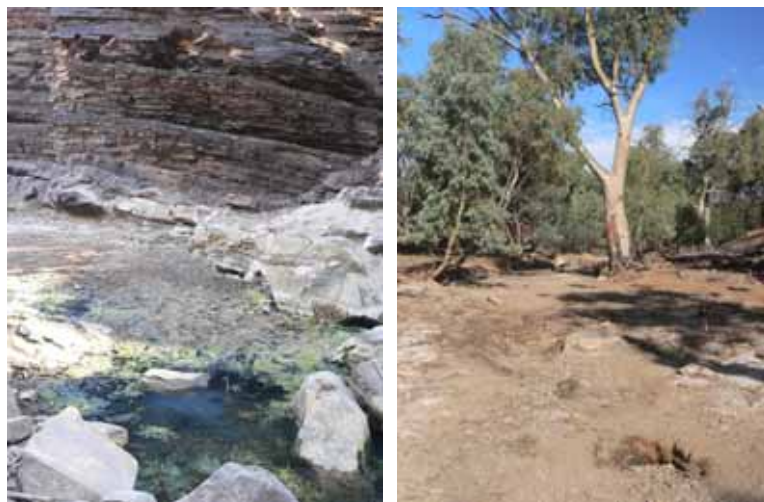
Charles Camp Spring (left) is highly used by goats, which means that the kangaroo's dig for water in the streambed (right), as the goats are territorial and will chase native animals away from water sources. Photo taken in October 2008 (Mel White).

MODERATE: Based on the moderate-low restoration potential. Although goat control is occurring on the property, goat management at this site is difficult due to its inaccessible location. However it should be noted that this site is adjacent to Flinders Ranges National Park and has not run stock for the last 12 years.

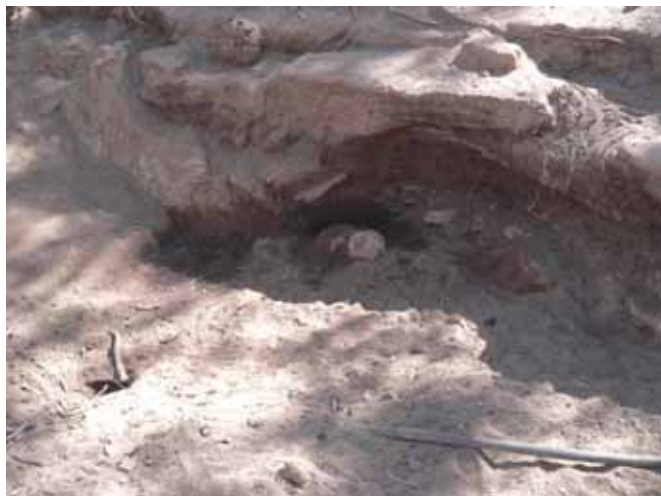
The damp soil of where Doodney's Well Spring exists.
October 2008 (Mel White).

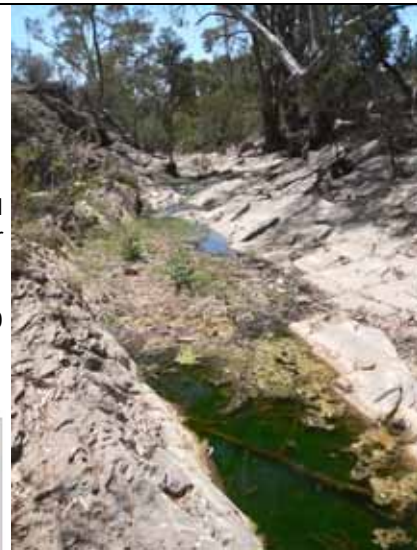
Size: at time of visit, the spring flowed as a series of pools for ~ 130 m with the width of pools being ~ 1m.

Depth: at time of visit, varied depths of 0.2 – 0.8 m.

Werta Spring.
Photos taken in October 2008 by
Mel White.

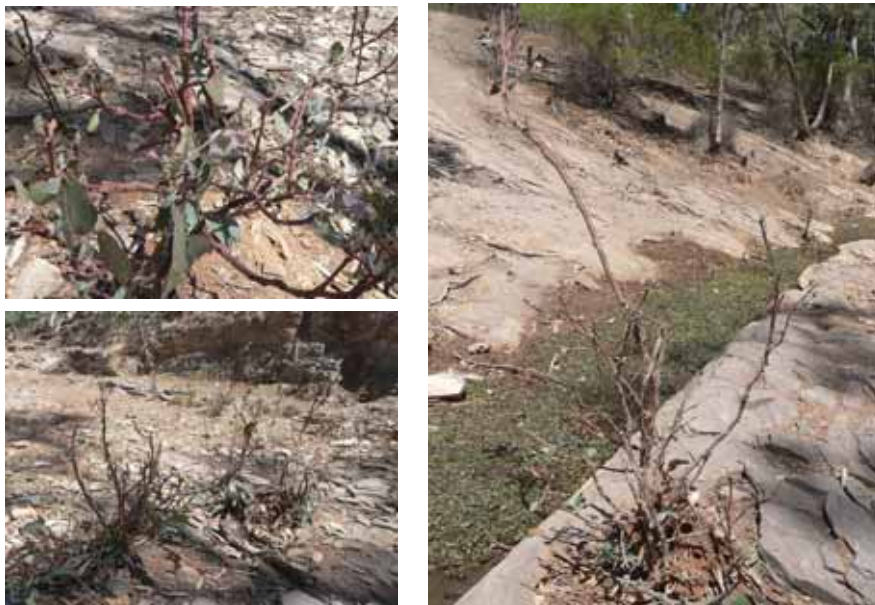
Grazing of red gum saplings at Werta Spring. October 2008 (Mel White).

LOW: This spring is in good condition with minimal threats noted, land management practices should be maintained.

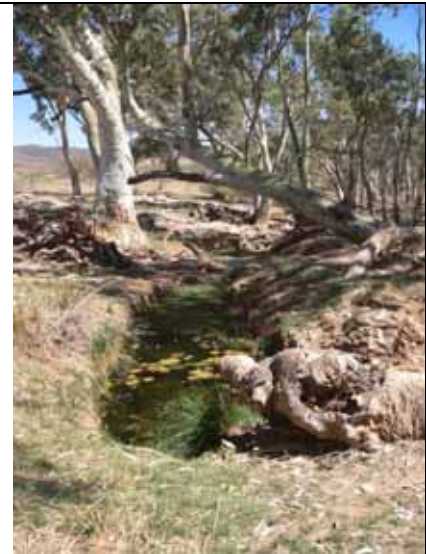
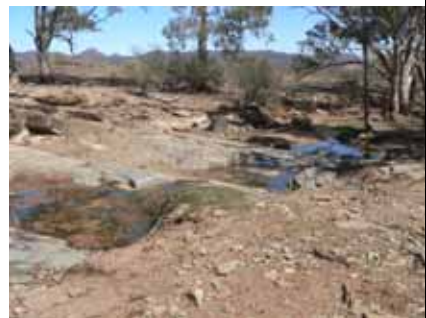
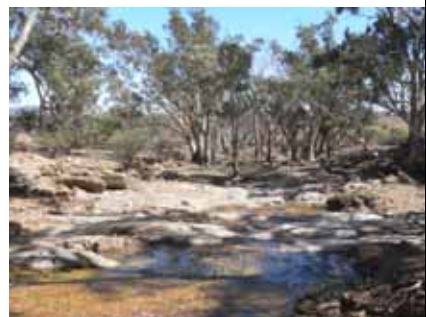
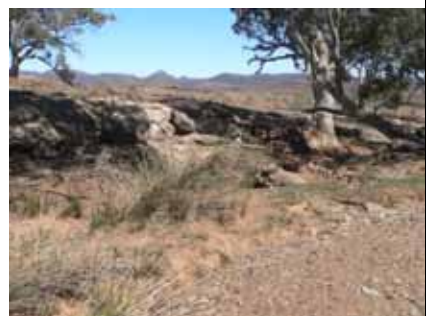
Depth: at time of visit, shallow <50cm depth across all pools.

These pools are part of the 1st Spring system.
Photos taken in October 2008 by Mel White.

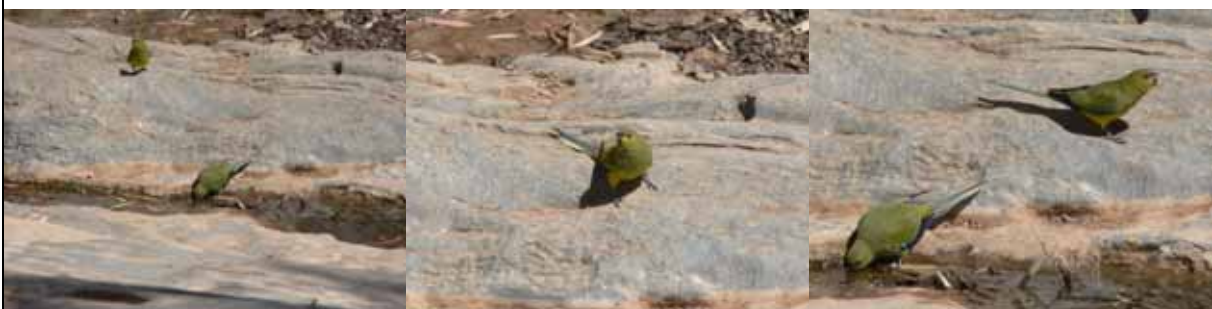
Photographs of the Elegant Parrot drinking from a pool of water at 1st Spring. October 2008 (Mel White).

MODERATE: Based on the site by itself; though as a collective with 2nd and 3^d Oratunga Spring's it would have HIGH priority. This is due to its position in the landscape and its high restoration potential.

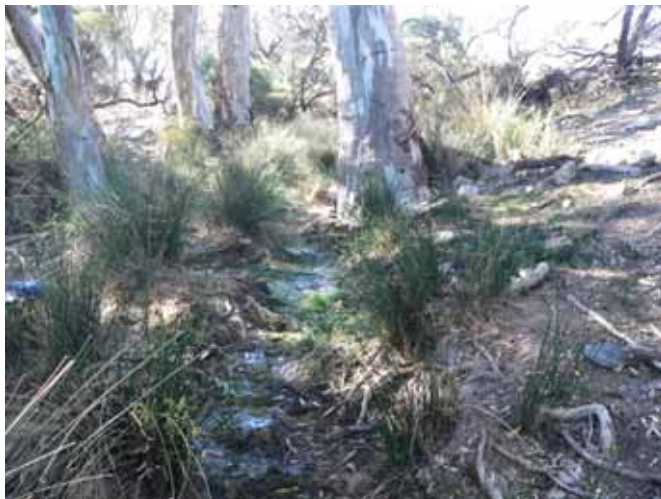
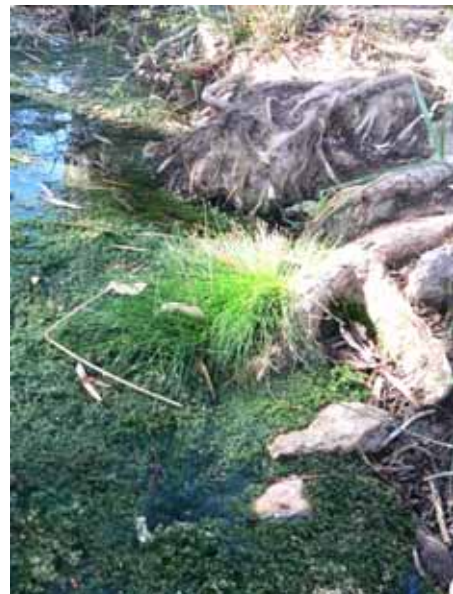
Photographs of 2nd Spring. October 2008 (Mel White).

LOW: Site is in good condition so current land management practices should be maintained. Site should be visited frequently after the fencing of 1st Spring has been completed to ensure that stock don't transfer grazing and drinking preference to 2nd Spring and hence degrade the site.

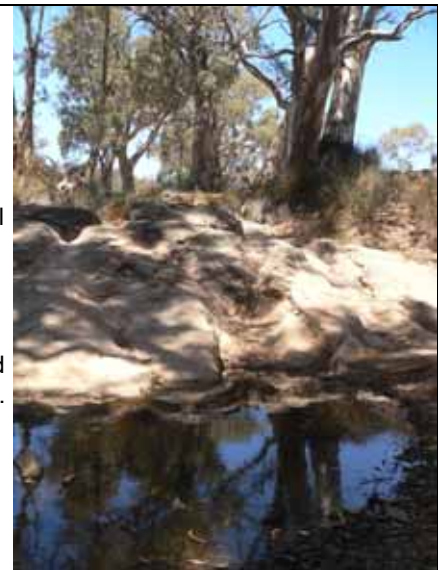
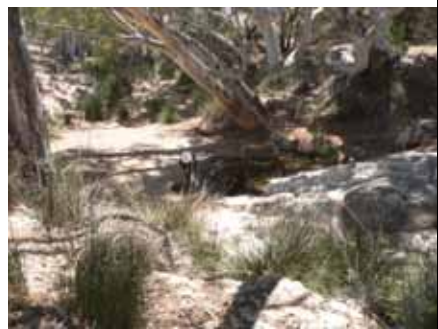
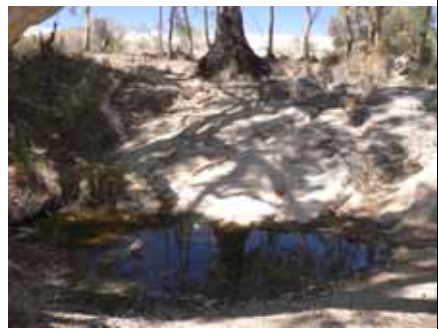
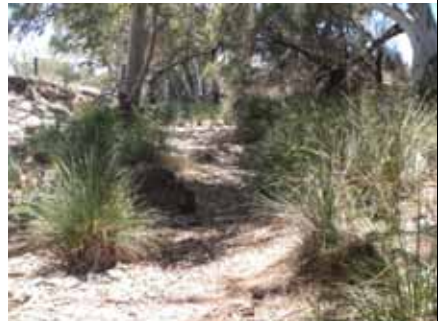
This single pool and dry stream bed are part of the 3rd Spring system. Photos taken in October 2008 by Mel White.

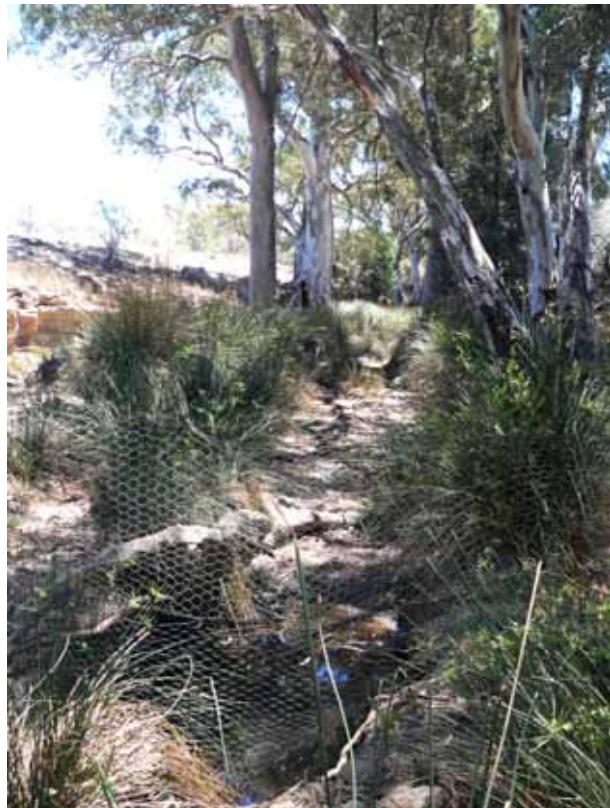
3rd Spring is located on the property boundary, with another permanent pool being seen on the other side of the Oratunga fence line (photo). If an intervention was to be applied at this spring, both properties would need to be onboard to ensure its success. October 2008 (Mel White).

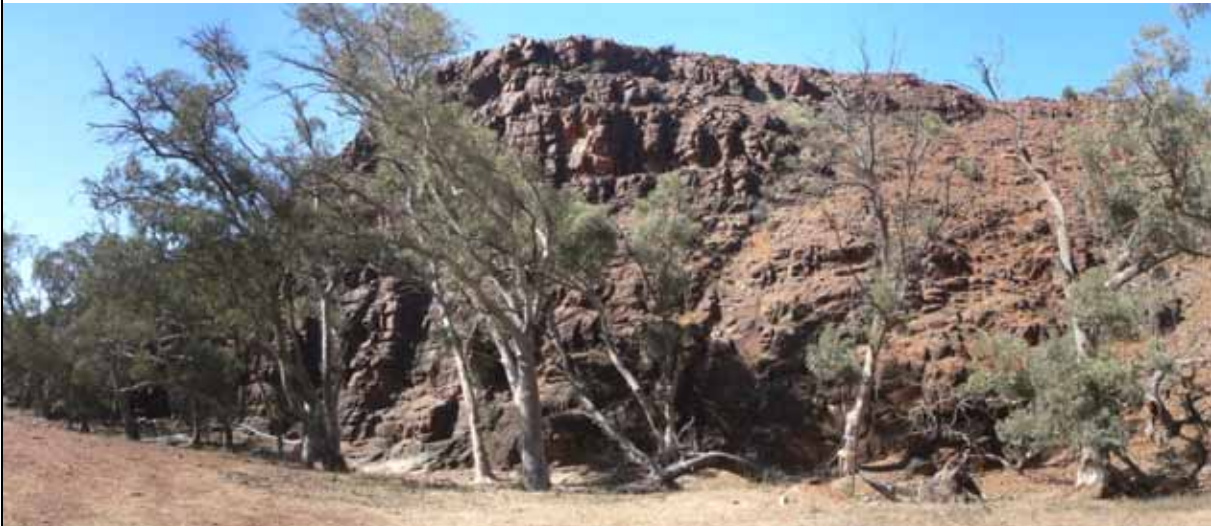
Riparian zone of the creek line where Little Spring is located. October 2008 (Mel White).

LOW: Till an inventory of all springs in the area is completed, it is advised that no intervention is undertaken at this spring as its value in the landscape is very similar to Reedy Creek Spring which is in better condition and is located downstream from this spring.

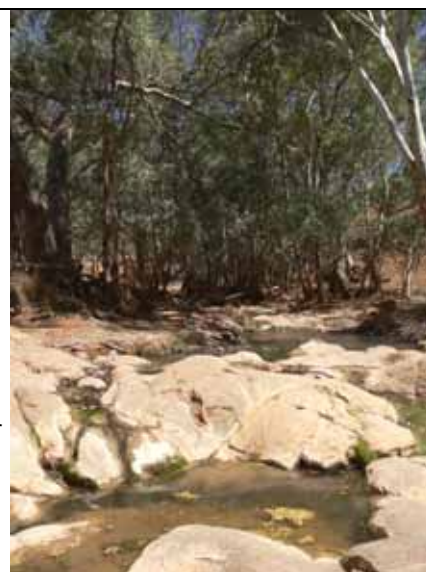
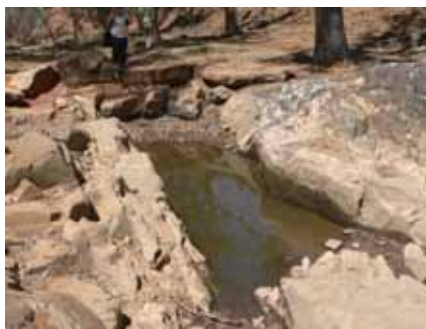
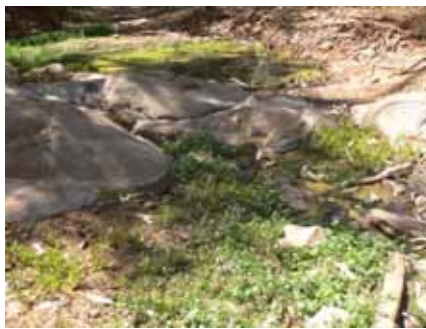
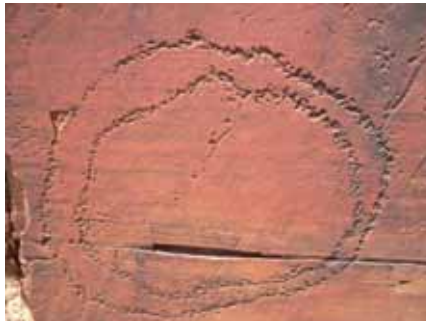
The 3rd photo from the top showing the nutrient loving aquatic plant *Rorippa nasturtium-aquaticum*. The bottom photo is of Aboriginal carvings at the site. Photos taken in October 2008 by Mel White.

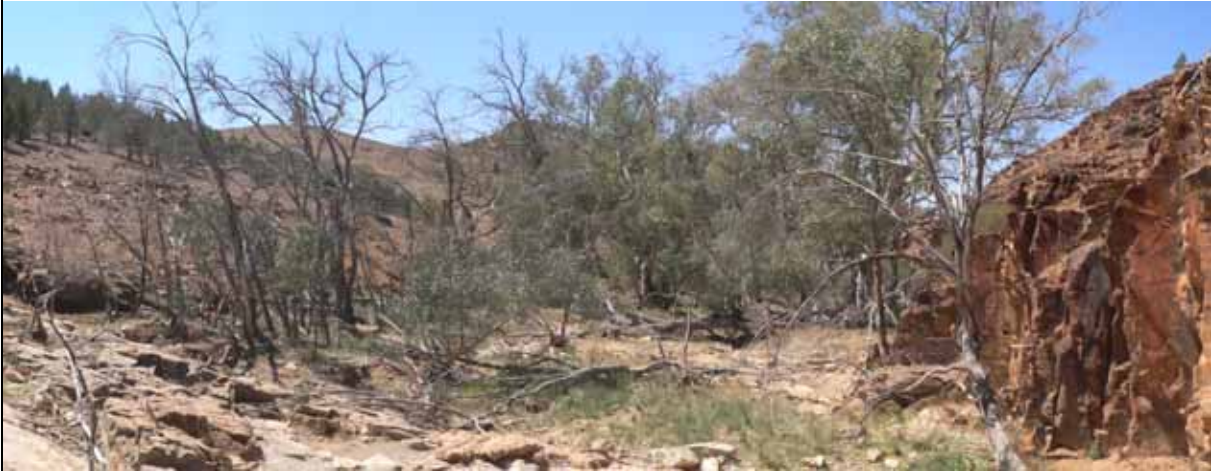
Riparian zone of the creek line downstream of Reedy Creek Spring. October 2008 (Mel White).

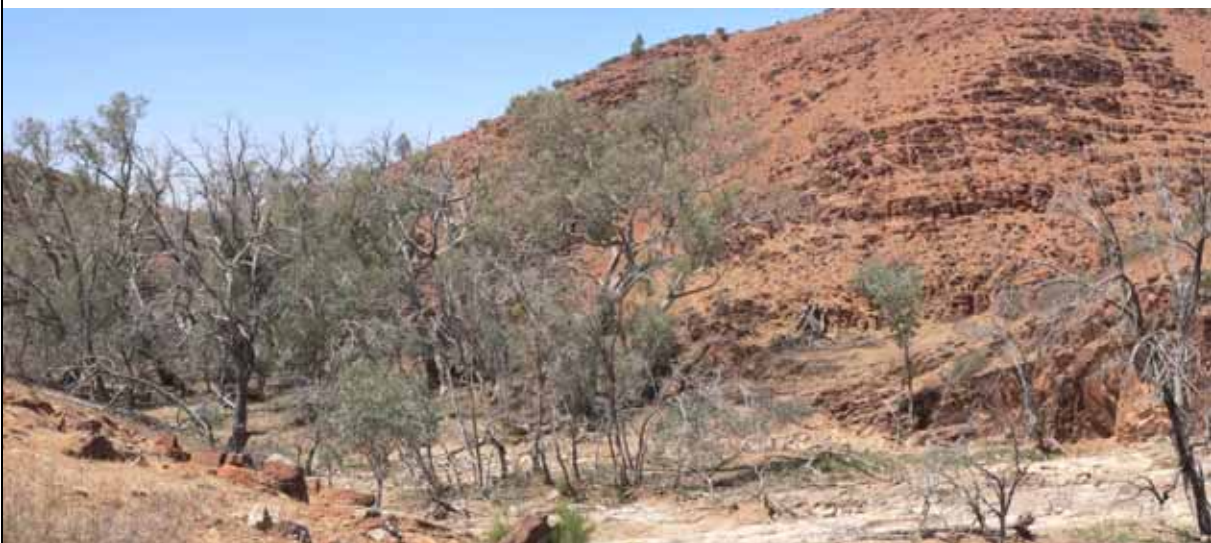
Riparian zone of the creek line downstream of where Reedy Creek Spring is located. October 2008 (Mel White).

MODERATE: Based on the moderate restoration potential and its permanence as a 'key aquatic refuge' located downstream of another spring. Consultation with the Aboriginal People of the area would be advised to determine cultural importance of the site for future investments.

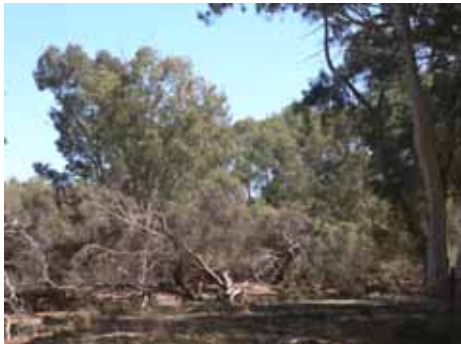
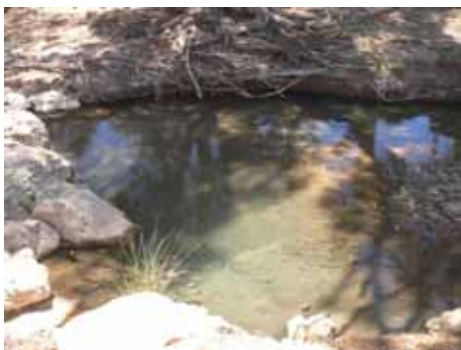
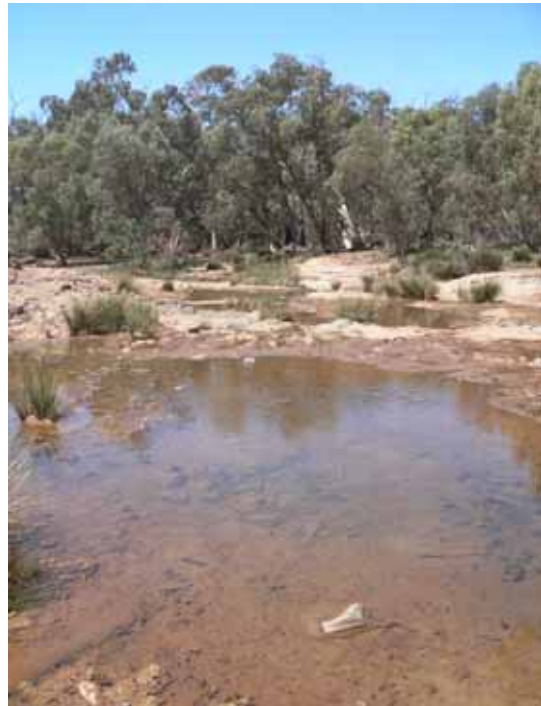
Yadnapunda Spring complex. October 2008 (Mel White).

HIGH: This spring has a high likelihood of being a key aquatic refuge that has a diverse array of spring habitats and riparian vegetation. It is recommended that for future assessments that a fish survey be undertaken at this site.

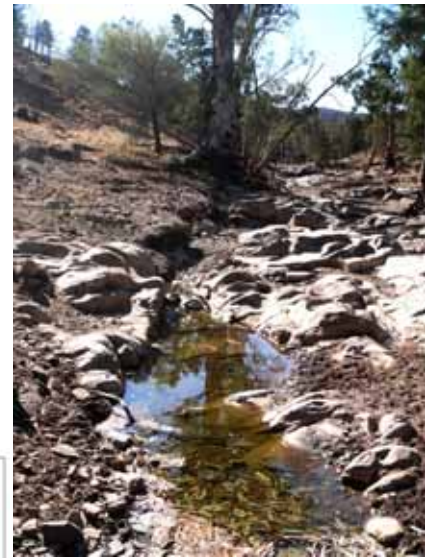
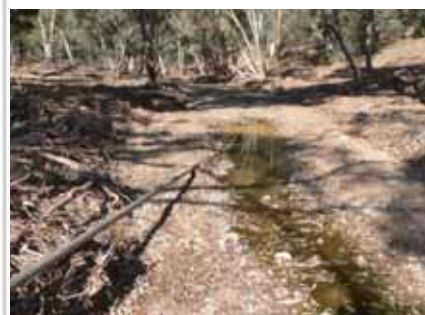
Depth: at time of visit, mostly shallow < 0.5m except for pool where water is piped to property 0.5 – 1.0 m deep.

These pools are part of the Pettana Spring system.
Photos taken in October 2008 by Mel White.

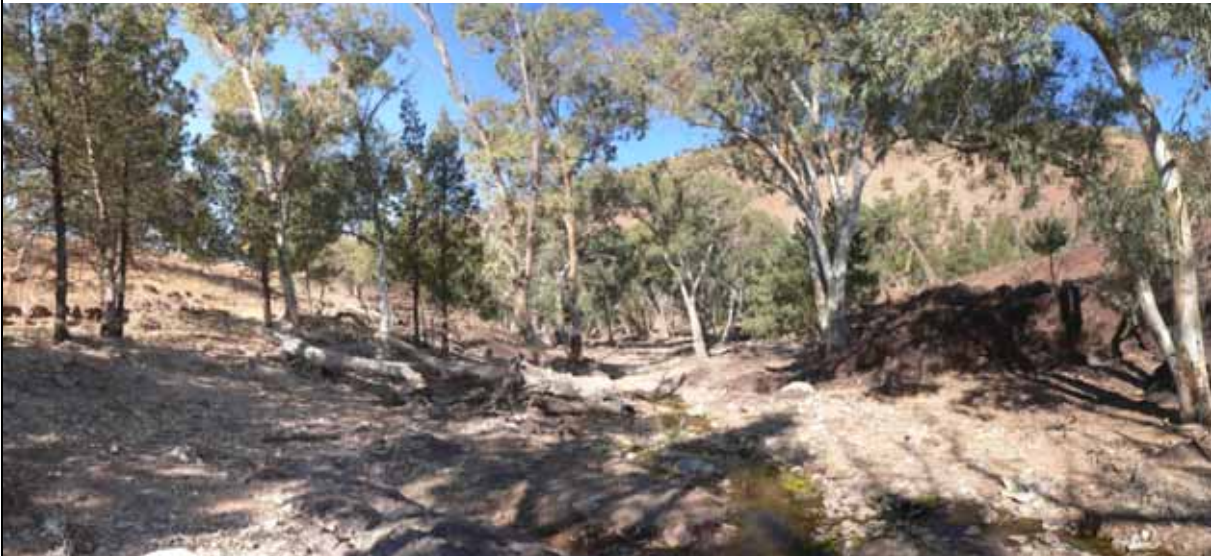
Photograph of riparian zone (red gum and native pine) of Pettana Spring in October 2008 (Mel White).

MODERATE: Based on the springs moderate restoration potential, its hydrological permanence in being a key aquatic refuge for the sub-catchment.
