Bushfire and Salinity

Lower Eyre Peninsula Case Study

Report DWLBC 2010/08

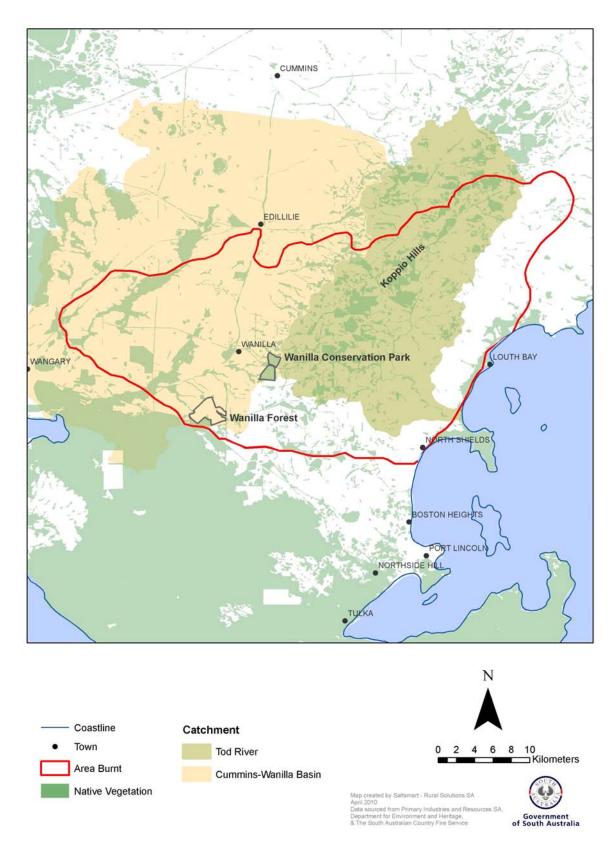
Figure 1. Extent of the 2005 bushfire on lower Eyre Peninsula (outlined in red)

On January 11th 2005, an extreme bushfire event swept across the lower Eyre Peninsula. The fire burnt across 83,000 ha of land, including the southern half of the Cummins-Wanilla Basin and the Koppio Hills (Figure 1). Along with agricultural land, significant areas of native vegetation, forestry and conservation parks were burnt.

The Environment Resources and Development Committee (ERDC) reported that extreme weather conditions on Black Tuesday, consisting of high temperatures, low humidity and very strong winds, combined to exacerbate the fire (ERDC 2005). Strong north to north-westerly winds fanned the fire and drove it from near Wangary to the coast at North Shields in three hours (refer to Figure 1).

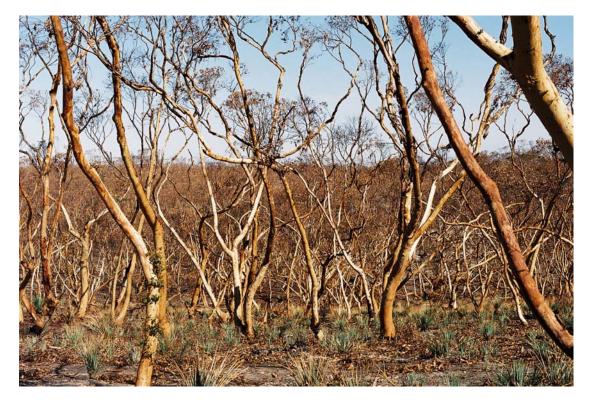
Figure 2. Wanilla Conservation Park (located within the Wanilla focus catchment) following the fire, April 2005

Using monitoring data from bores inside and outside the bushfire zone, groundwater trends were analysed and compared to investigate any impact of the bushfire on depth to groundwater. This was undertaken within the context of knowledge gained from previous salinity studies, combined with more recent inspection of saline sites and vegetation health. As illustrated in Figures 2 and 3, significant regeneration of the vegetation burnt in 2005 had occurred by 2007.

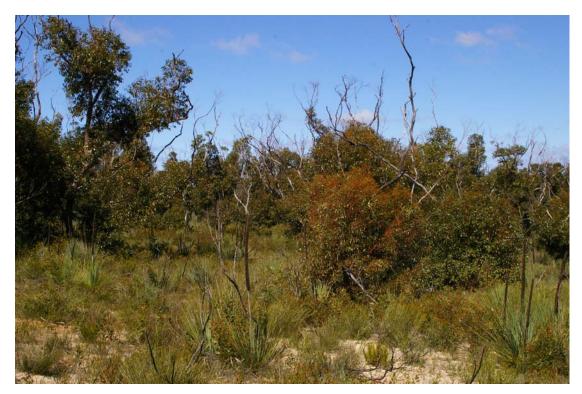
Figure 3. Regeneration of Wanilla Conservation Park, September 2007

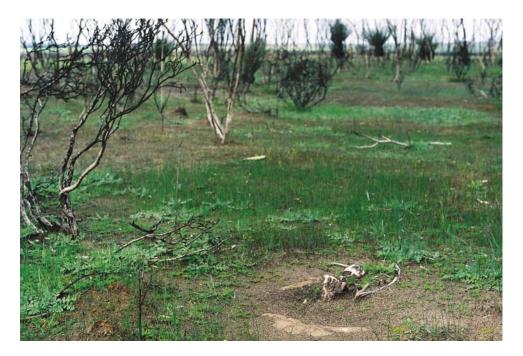
Figure 4. Piezometer tube in the Cummins-Wanilla Basin, melted by the bushfire (bottom of the photograph, taken in August 2005)

Several unprotected bores (PVC risers with no outer standpipe) were damaged in the 2005 bushfire (Figure 4). Melted tubes were repaired in November 2005 (Appendix A). Sites protected by an outer steel casing were not damaged.

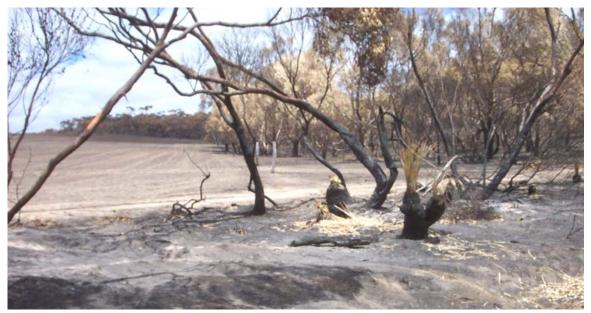
Figure 5. Burnt agricultural land and scrubland (February 2005)

Significant areas of grassland, scrub and stubble paddock were burnt (Figure 5). Flammable fuel loads for agricultural lands, at the time of the fire, were estimated at between 0.5 to 3.0 t/ha, while that of roadside vegetation was estimated at 5.0 to 7.0 t/ha (ERDC, 2005). This high intensity summer fire resulted in 14,000 ha of remnant woodland vegetation being burnt (DEH, 2007), along with smaller areas of planted vegetation.

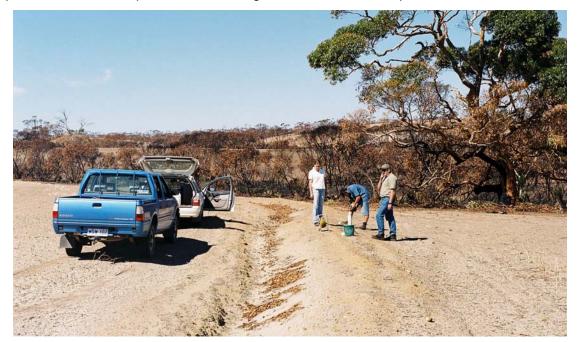
Figure 6. Monitoring bores located in the WANILLA network, April 2005

The three main Obswell networks in the area affected by bushfire are CUMMINS (bores labelled CUM and MKT), WANILLA (bores labelled WNL) and TODRIVER (bores labelled KPP). A field audit of these networks identified suitable sites for more intensive groundwater monitoring following the bushfire (Figure 6). A subset of 52 bores were selected (Figure 7). Appendix A lists their specifications, along with a list of bores repaired after the fire.

The nearest groundwater monitoring bores to the Myers and Chesher properties (WNL050 and WNL051) are 2 to 3 km away (refer to Figure 7). The long-term groundwater trend at both sites is classified as seasonal (Appendix C), being -0.02 and +0.02 m/yr respectively. Groundwater level in both bores is shallow (0-2 m), with WNL051 recording its highest level on record in November 2005 (0.31 m above the ground surface). In the 2005 to 2007 period, groundwater levels in WNL050 was at its highest level since 1992.

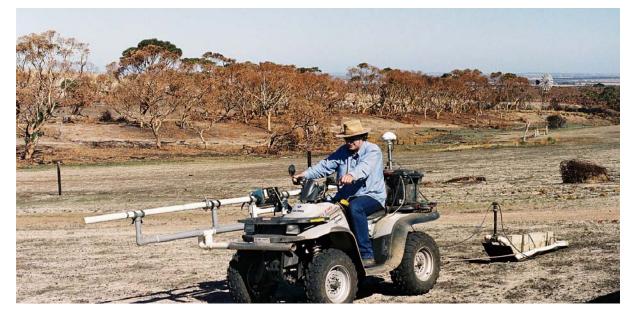
Figure 9. EM quad-bike survey in the Wanilla focus catchment, April 2005

An EM meter measures the bulk apparent electrical conductivity (ECa) of the soil profile to a depth determined by the type of instrument (EM31 or EM38) and the orientation of the instrument coils. The EM meter is responsive to variations in soil moisture, soil salinity and clay content of the soil and regolith. Following calibration with soil samples, the intensity of salt affected land may be assessed using the criteria shown in Table 1.

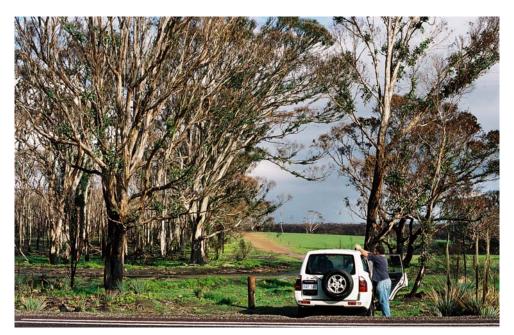
Figure 10. Regeneration of eucalypts on the north-eastern edge of the Wanilla Forest

Following reports of new salinity outbreaks on burnt land east of the Wanilla Forest, a field inspection of two properties (landholders Greg Myers and John Chesher) was undertaken. Located on the leeward side of the Wanilla Forest (Figure 11), the vegetation on these properties were all but destroyed in the bushfire, the intensity of which was likely exacerbated by a firestorm generated within the forest. The Wanilla Forest (Figure 1) comprised tall eucalypts in the northern half, with pines in the southern half. While the eucalypts in the forest have since regenerated (Figure 10), the pines were destroyed in the fire.

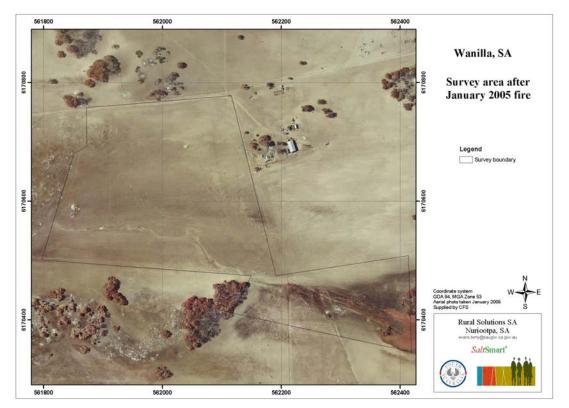
Figure 12. Post fire aerial photograph (infrared image where green vegetation is seen as red shades) showing the "cooked vegetation" and salinity outbreak on the Chesher property (patchy areas in bottom of photo)

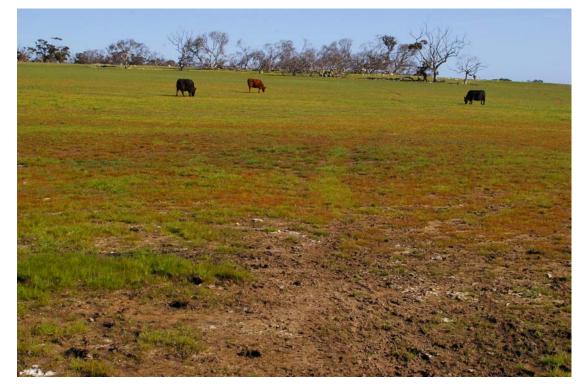
Figure 14. Salinity (patchy bare ground) encroaching up a drainage line on the Chesher property, September 2007

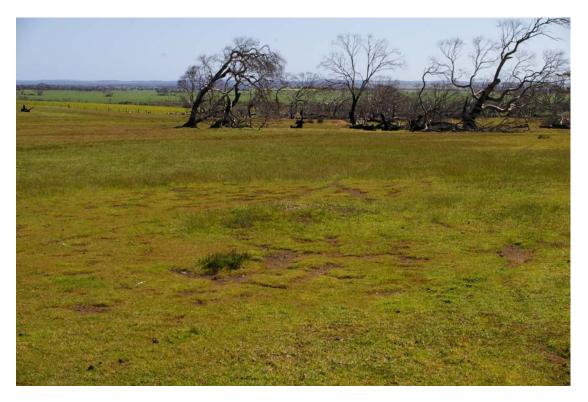
Figure 15. Salinity spreading on the Myers property, September 2007
