HYDROGEOLOGICAL
REPORT ON WATER
WELL MONITORING IN
ABORIGINAL LANDS
TO MAY 2002

DWLBC
Report
2002/26

Hydrogeological report on water well monitoring in Aboriginal lands to May 2002

August 2002

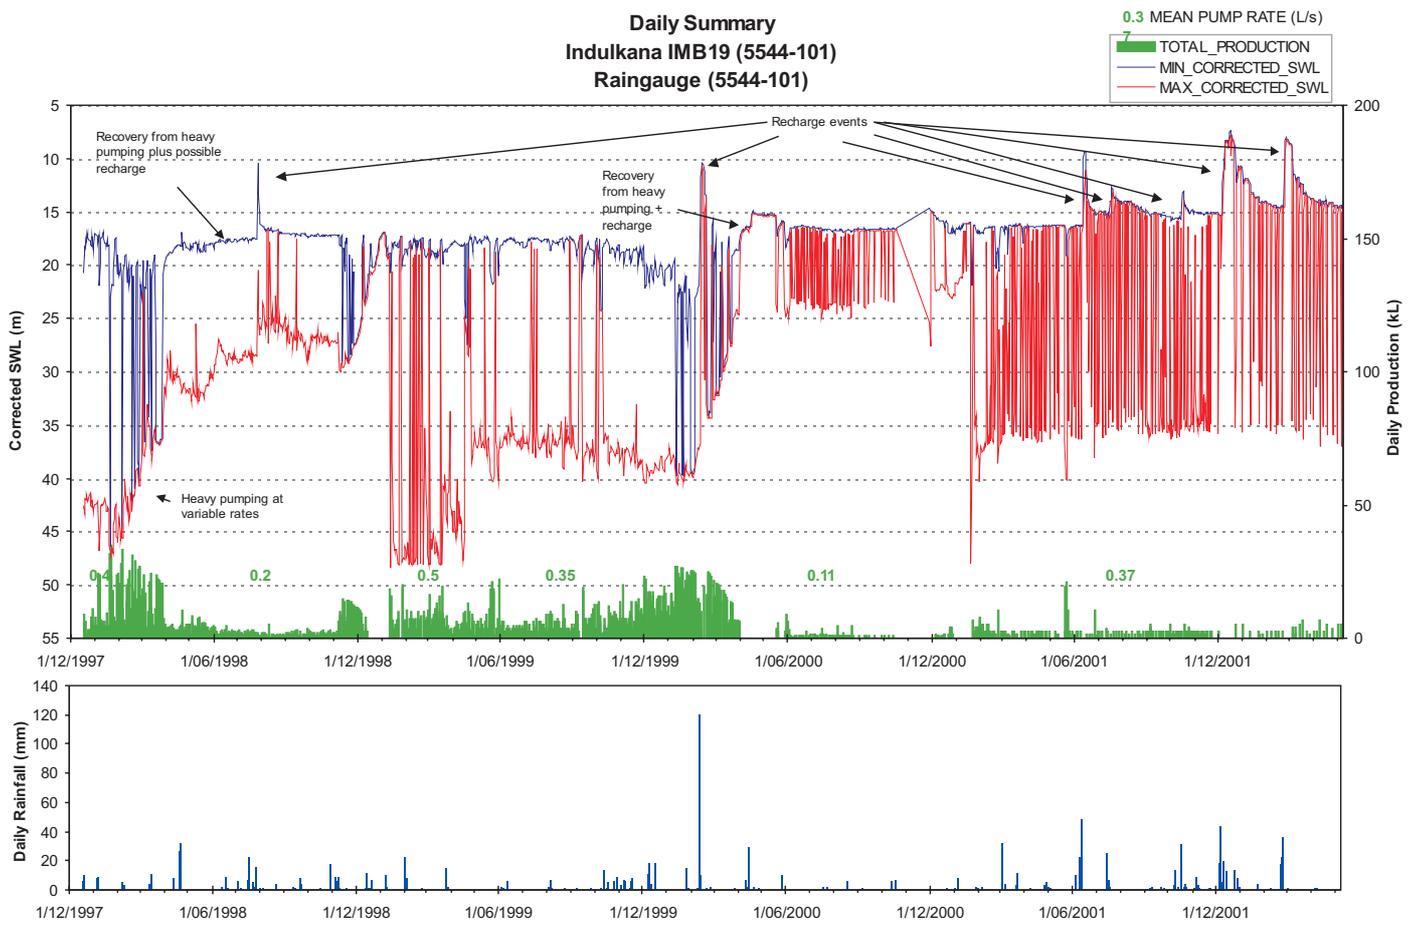
Figure 1.3 Daily Summary, Indulkana IMB 19

The pump rate for this well has ranged from 0.1 L/s to 0.5 L/s, with proportional drawdowns of 6 m to 30 m. The latter drawdown dropped the pumping SWL to nearly 50 m, which is getting close to the water cut at 55 m and could cause problems if sustained for extended periods. The current pumping rate of 0.37 L/s results in an acceptable pumping SWL of about 35 m.

This well should yield at least 5 kL/day indefinitely, barring extended droughts of over 10 years. Higher daily pumping rates should be restricted to a day or two duration. The water quality, which deteriorated to 1110 mg/L TDS by 1997, was quite variable over the 1977-97 period (see RB 2000/27). It is probable that this variation correlates with recharge, and that the water extracted now is of much lower salinity than in 1997. This would be worth checking.

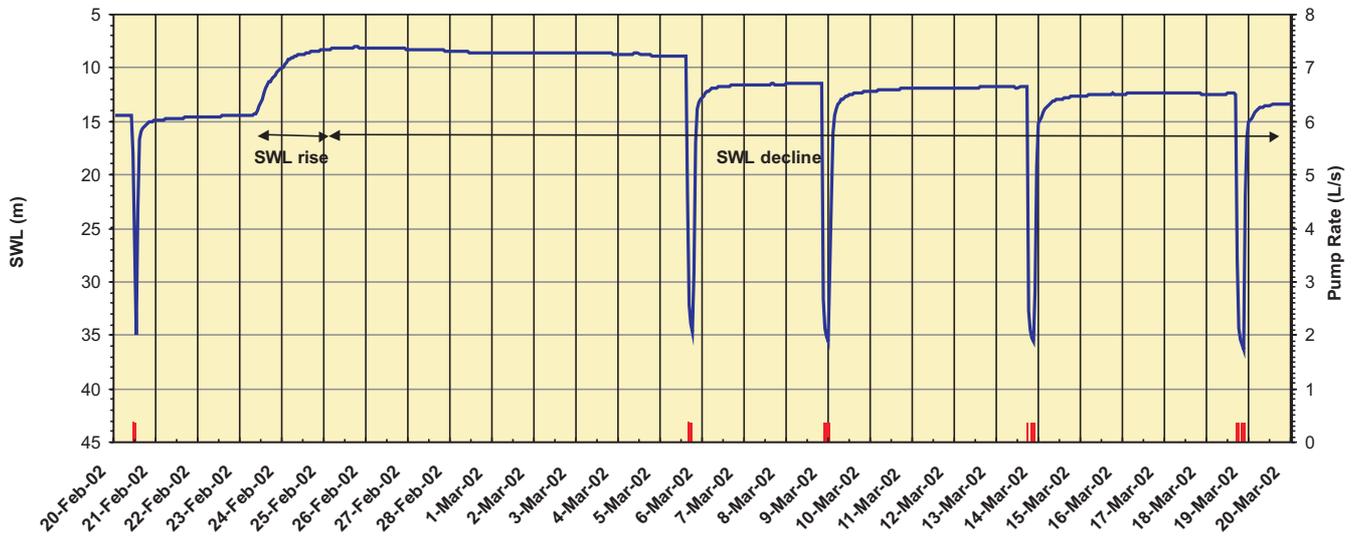
Figure 1.4 Recharge Event, Indulkana IMB 19

Indulkana IMB 19
Recharge event on 23 February 2002

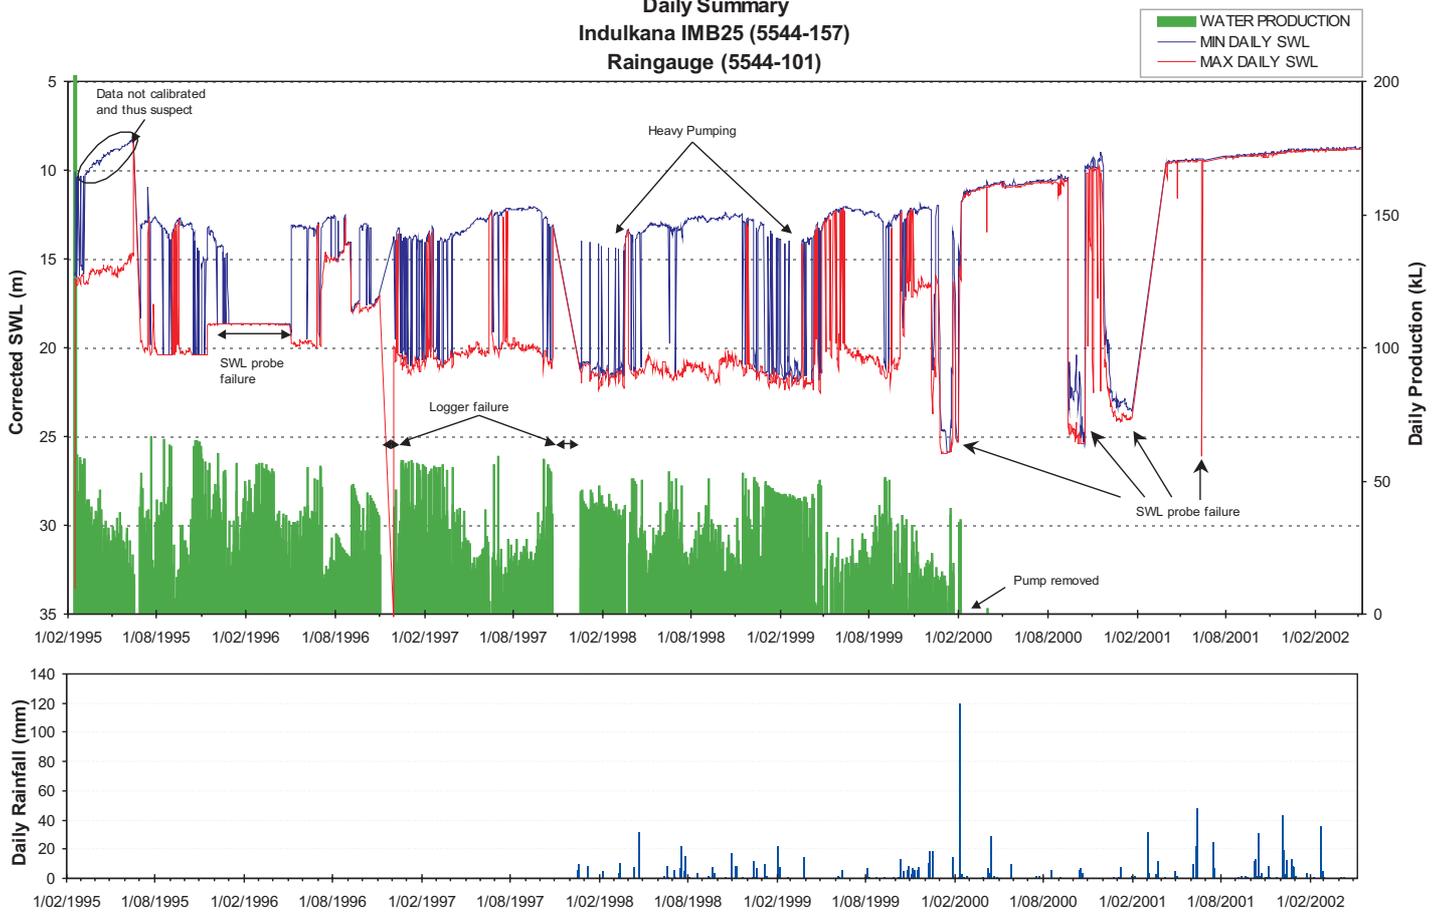
Figure 1.7 Daily Summary, Indulkana IMB 25

While there is some unreliable SWL data, as indicated in Figure 1.7, most of the data is good. It shows the depressing effect of heavy pumping in February 1998 and 1999, and the subsequent recovery in the following winters, especially July 1999, when the demand on the well eased. Superimposed on these effects is the gradual rise in SWL from 1997 to

the present. It seems likely that the rainfall events do not have any immediate or dramatic effect on water levels in the aquifer and that the evidence points to a gradual recharge of the aquifer over months and years.

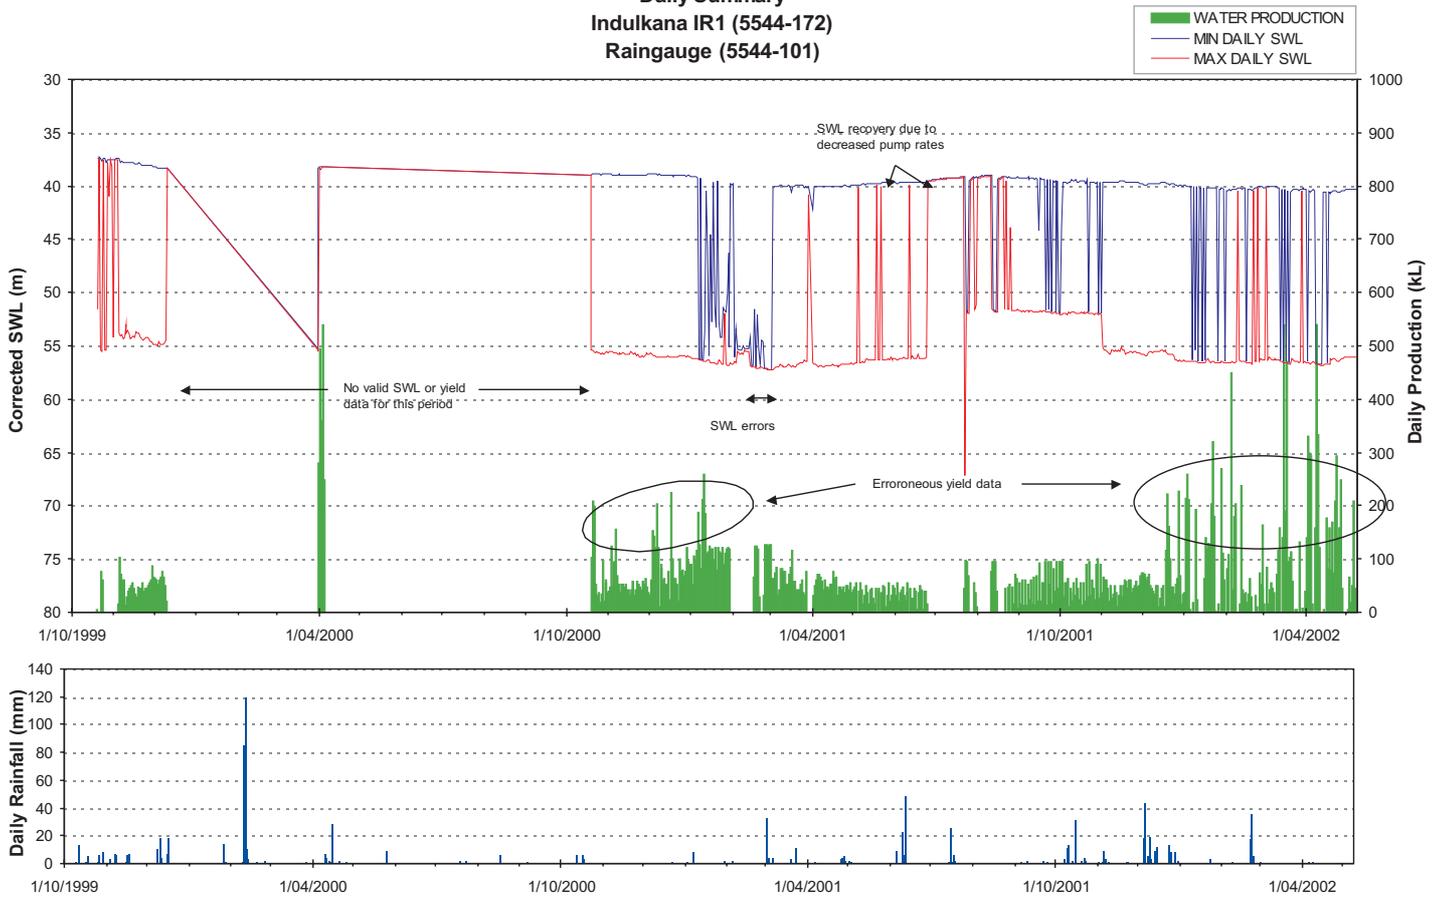
Figure 1.9 Daily Summary, Indulkana IR 1

The water levels in both wells IR-1 and IR-2 have declined as a result of water extraction (Figs 1.9 and 1.10). Moreover, there is no indication of recharge in either well, in spite of substantial rains and strong recharge indications in most of the other wells in this area. It is therefore possible that the water in these aquifers is not of recent origin and may not be replaced. In that case the wells have a life of about 6-15 years, assuming no change in the pump rates or in the rate of SWL decline for other reasons. Continued monitoring should clarify this situation.

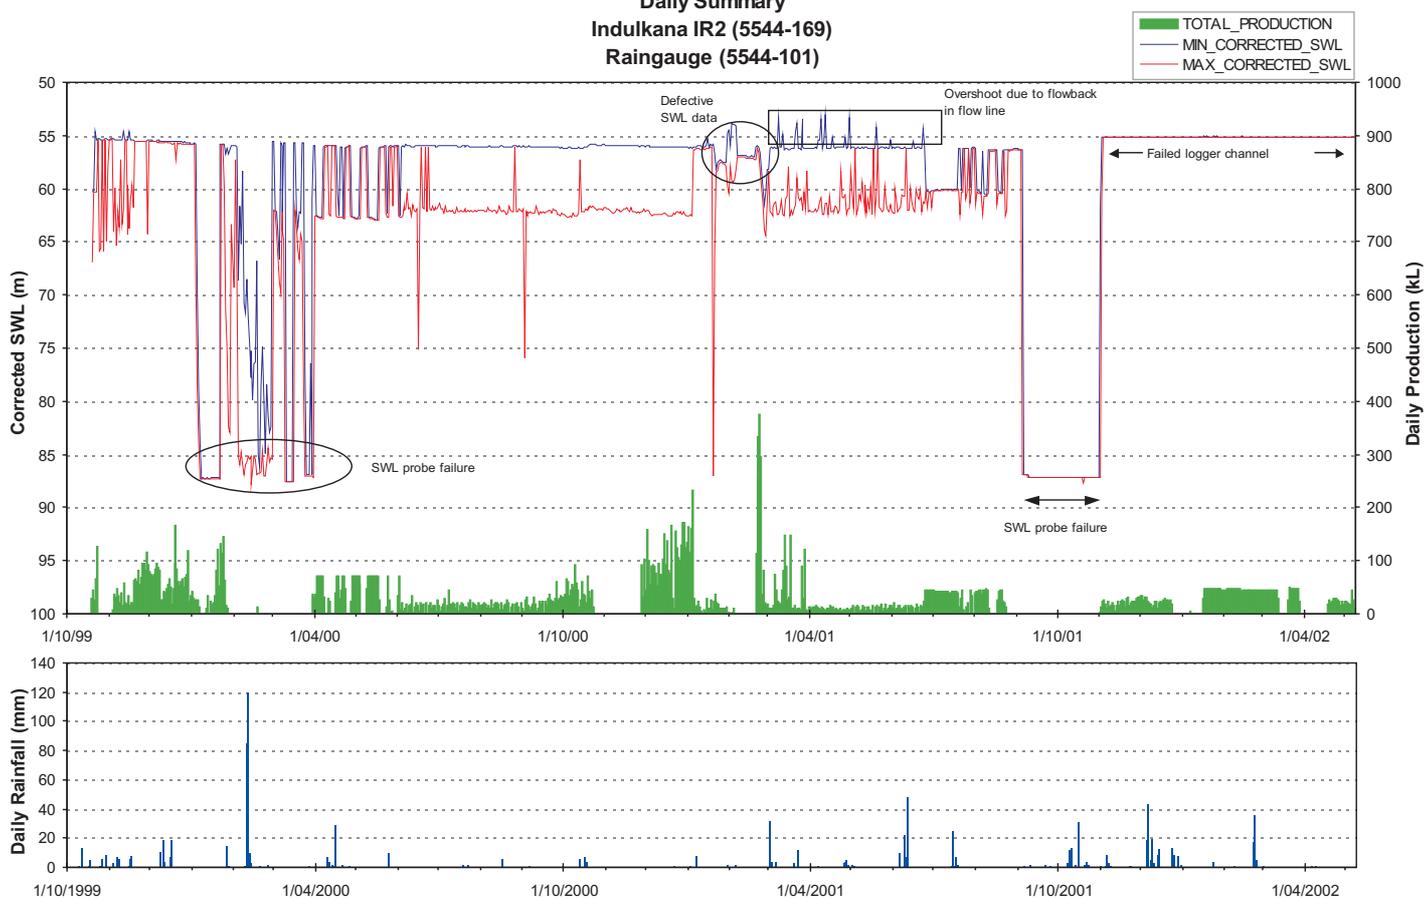
Figure 1.10 Daily Summary, Indulkana IR 2

Much of the data is again defective, particularly since early September 2001 (Fig. 1.10). The upward spikes in the non-pumping SWL between March and June 2001 result from a malfunctioning non-return valve which allows water from the pipeline to flow back into the well on cessation of pumping (flowback). The general response of the well to pumping can still be observed, however.

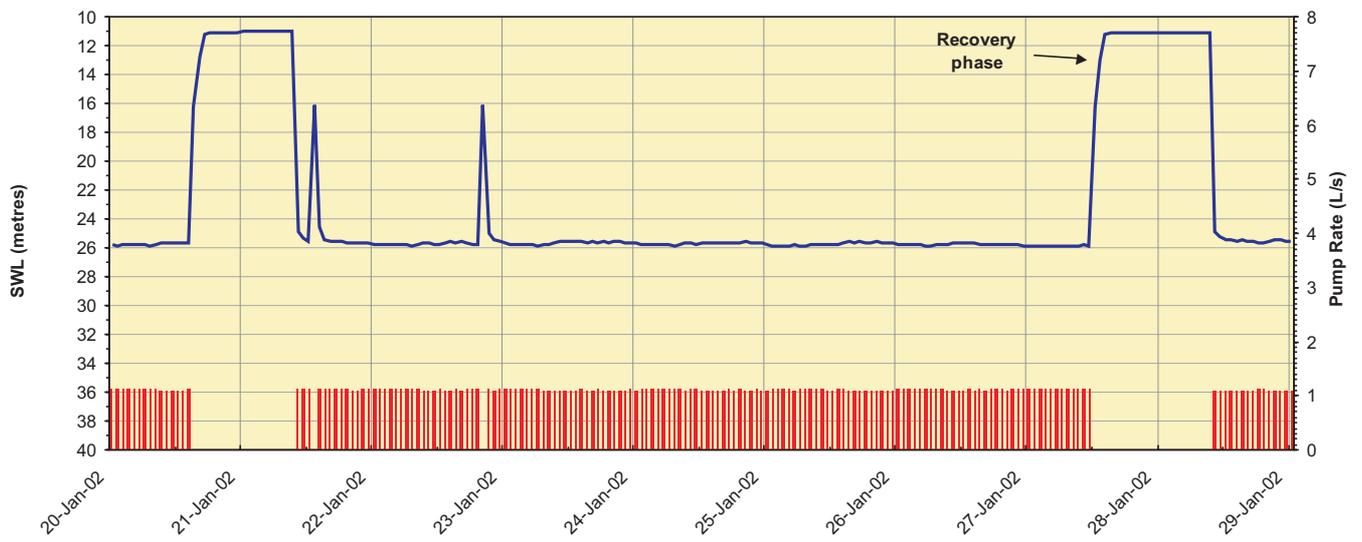
Figure 2.5 Effect of continuous pumping, Mimili M3

Mimili M3 Effect of continuous pumping

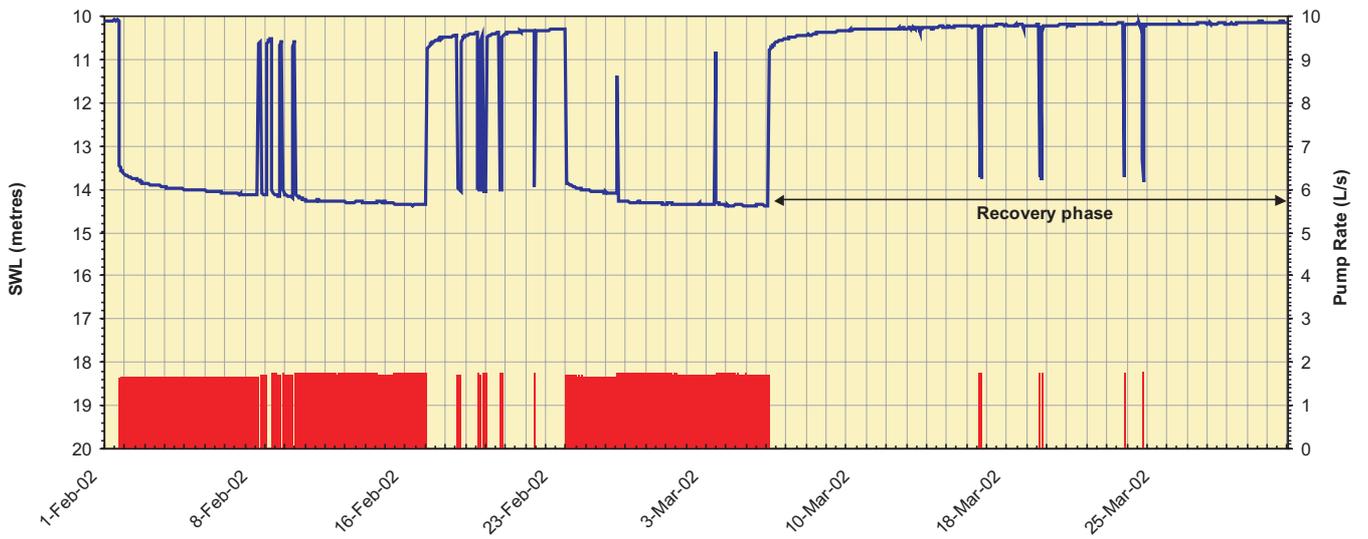
Figure 3.4 Effect of continuous pumping and slow recovery, Fregon FRG 1

Fregon FRG 1
Effect of continuous pumping and slow recovery

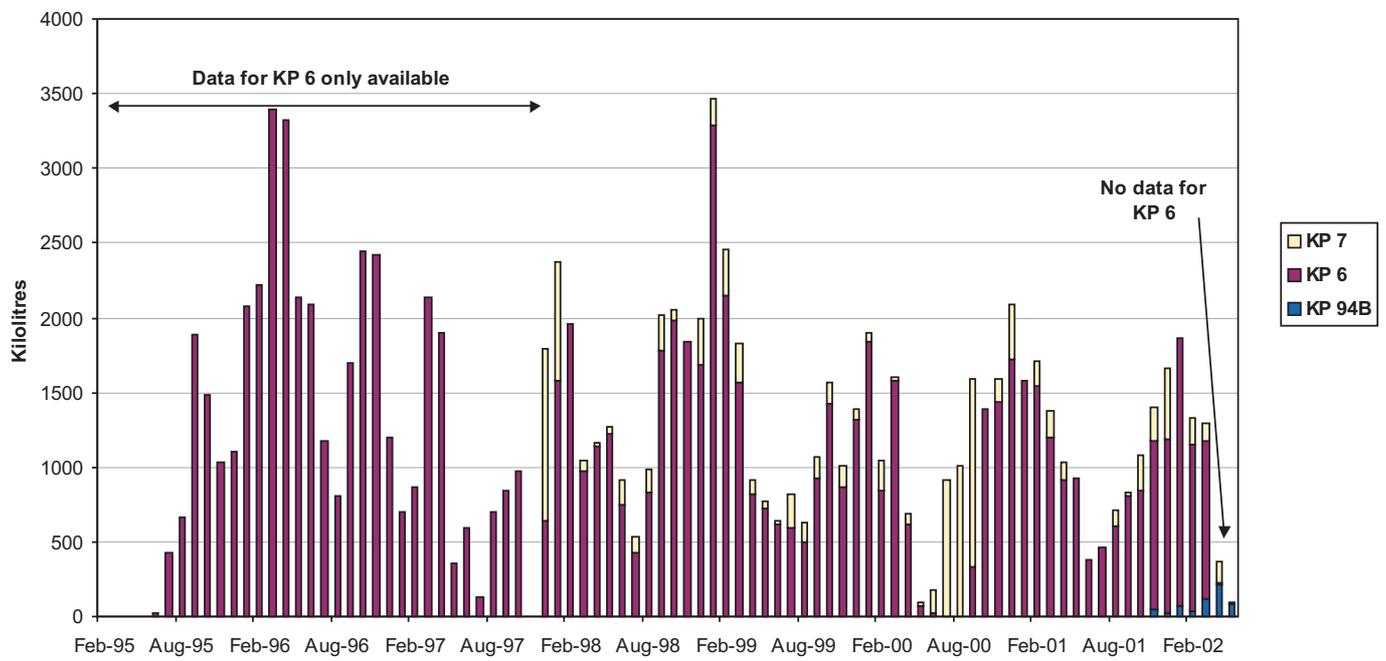
Figure 4.2 Community water production at Kenmore Park

Much the same as in previous years. Monitoring of well KP-6 failed early in April, so consumption figures for April and May are incomplete (Fig. 4.2). Again the bulk of supply came from KP-6, with a minor, but increasing, contribution from KP-98 (this well was called KP-94B).

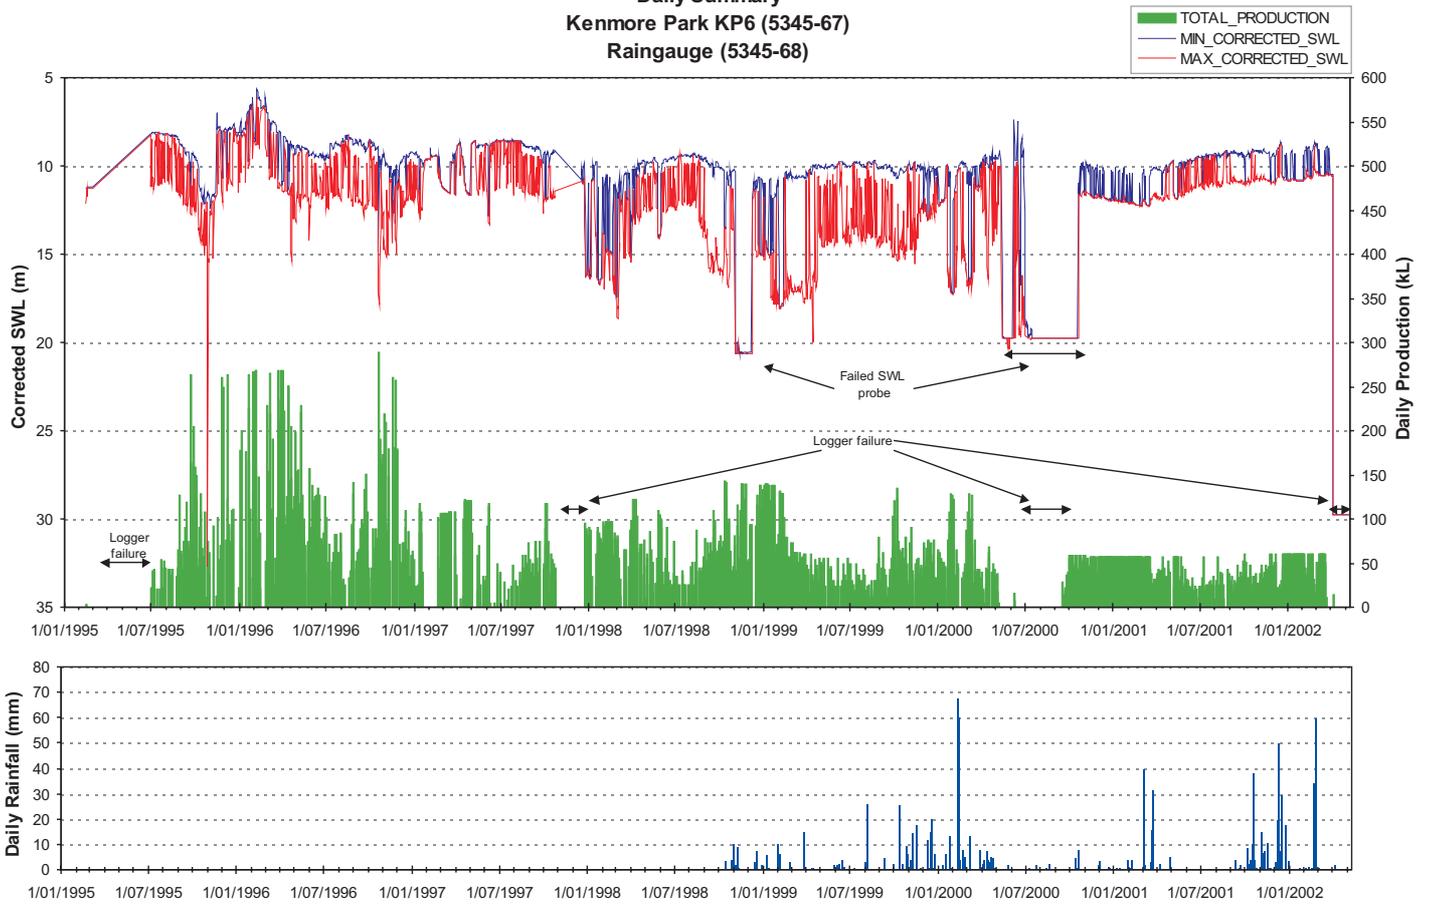
Figure 4.3 Daily Summary, Kenmore Park KP 6

Data gathered since April 1998, when the submersible transducer was replaced by a surface unit, is more reliable than earlier data (Fig. 4.3). The latter contained numerous shifts that have been corrected as far as possible, but variations in SWL during 1997 and earlier are less reliable than those from 1998 onwards.

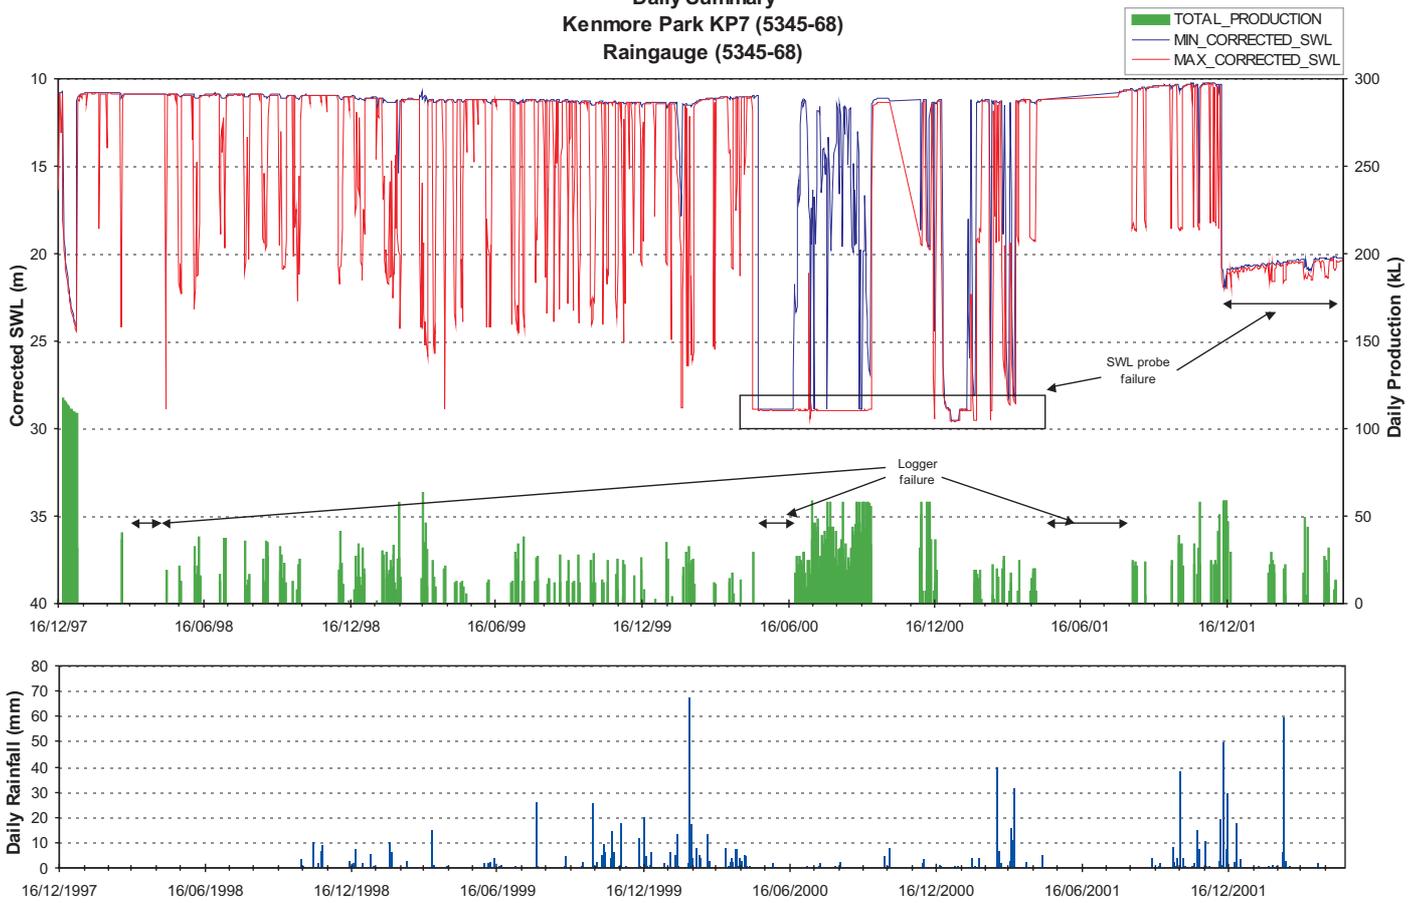
Figure 4.5 Daily Summary, Kenmore Park KP 7

The SWL monitor failed in late December, so that hourly levels are not available. Otherwise, apart from a period in late 2000 and early 2001, the SWL data for this well is very good (Fig. 4.5).

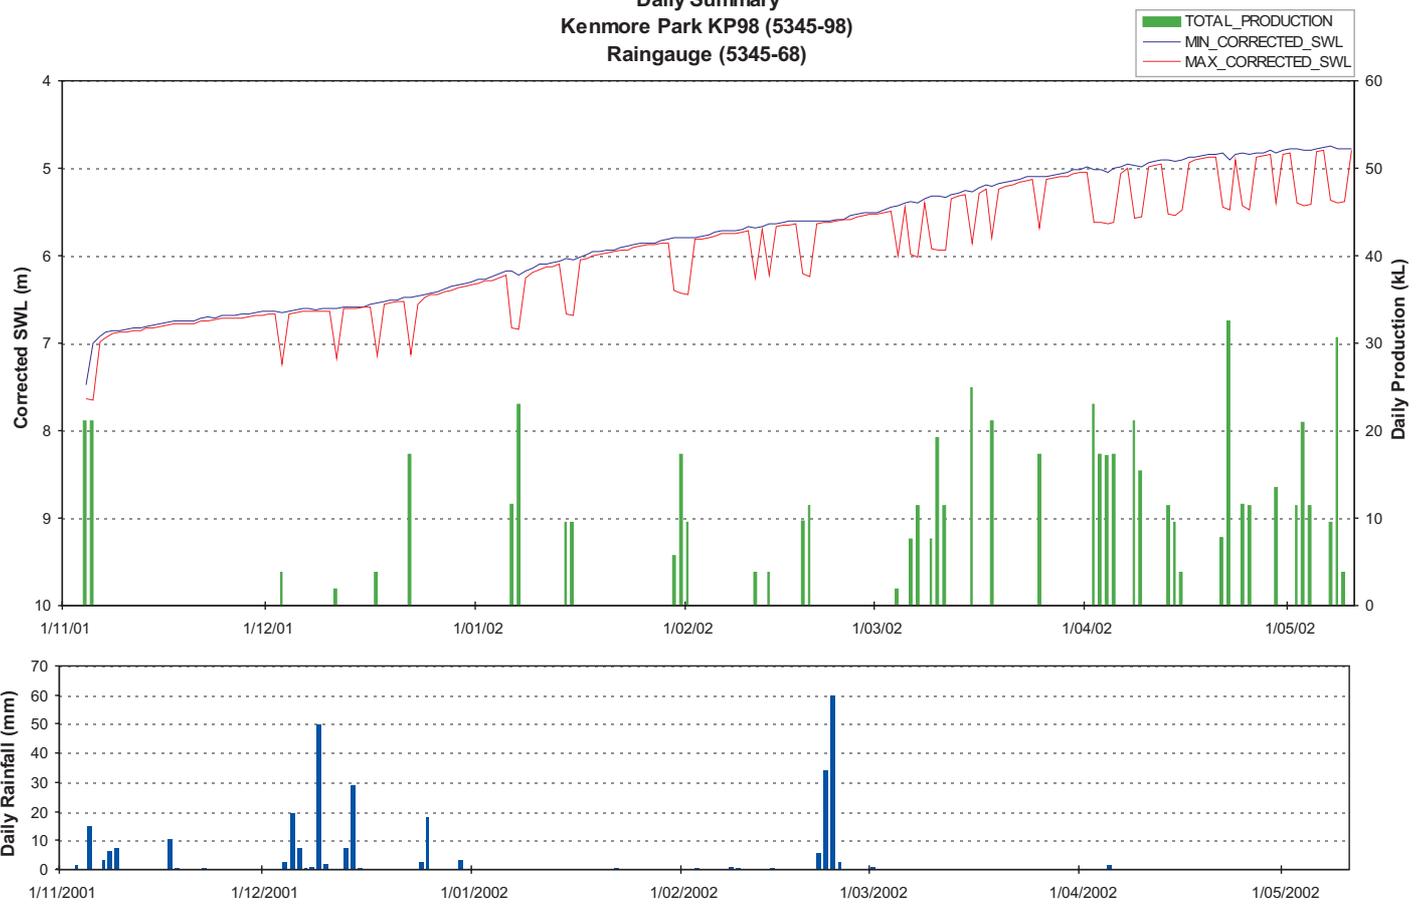
Figure 4.8 Daily Summary, Kenmore Park KP 98

This well has only been monitored since November 2001 and has not been pumped heavily (Fig. 4.8). The most extended pumping was on April 21-22, when the well was pumped for 12 hours at 0.5 L/s (Fig. 4.9). This caused a drop in SWL of 0.7 m at start of pumping, but minimal further decline over the 12 hours, indicating that the rate could be continued for much longer times. More extensive use of this well would allow KP-6 to be rested and to recover.

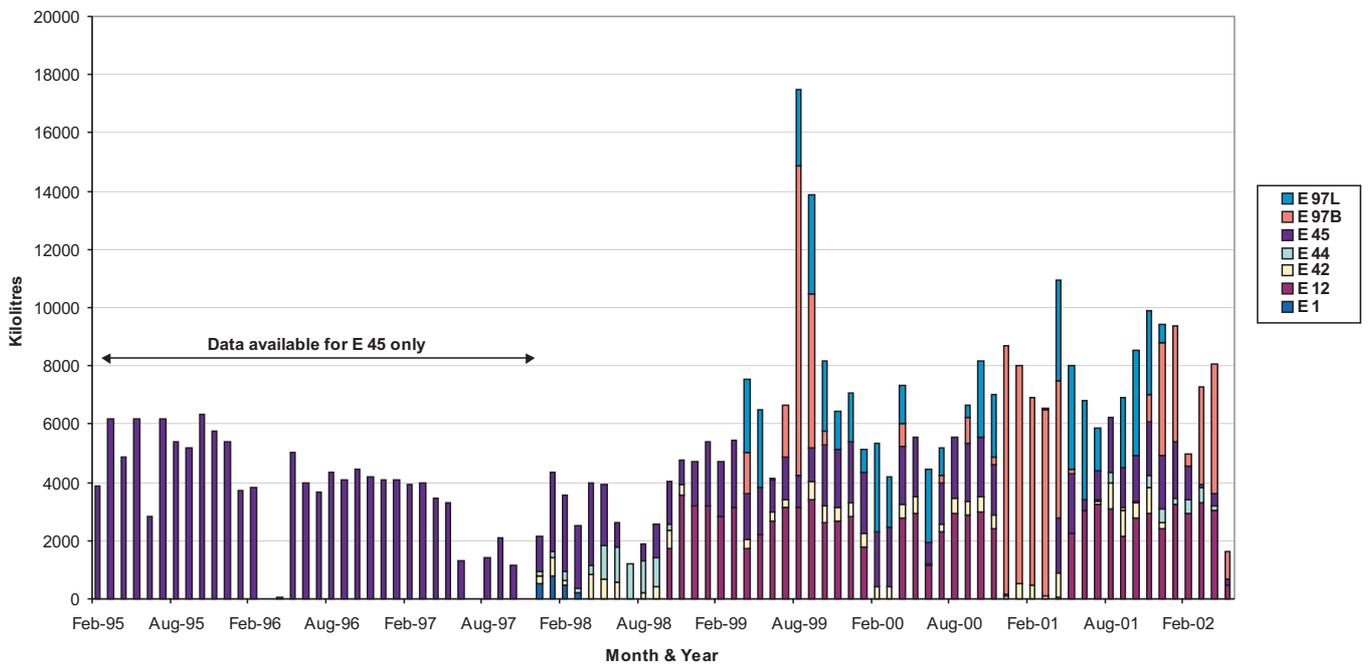
Figure 5.2 Community water production at Pukatja

Water came mainly from four wells, E-12, E-45, E97B and E-97L (Fig. 5.2). The monthly water production plot omits E-97L for the last 6 months as the logger had failed, but the accumulated flow figure in the table below is correct. Overall the water consumption is marginally higher than earlier years.

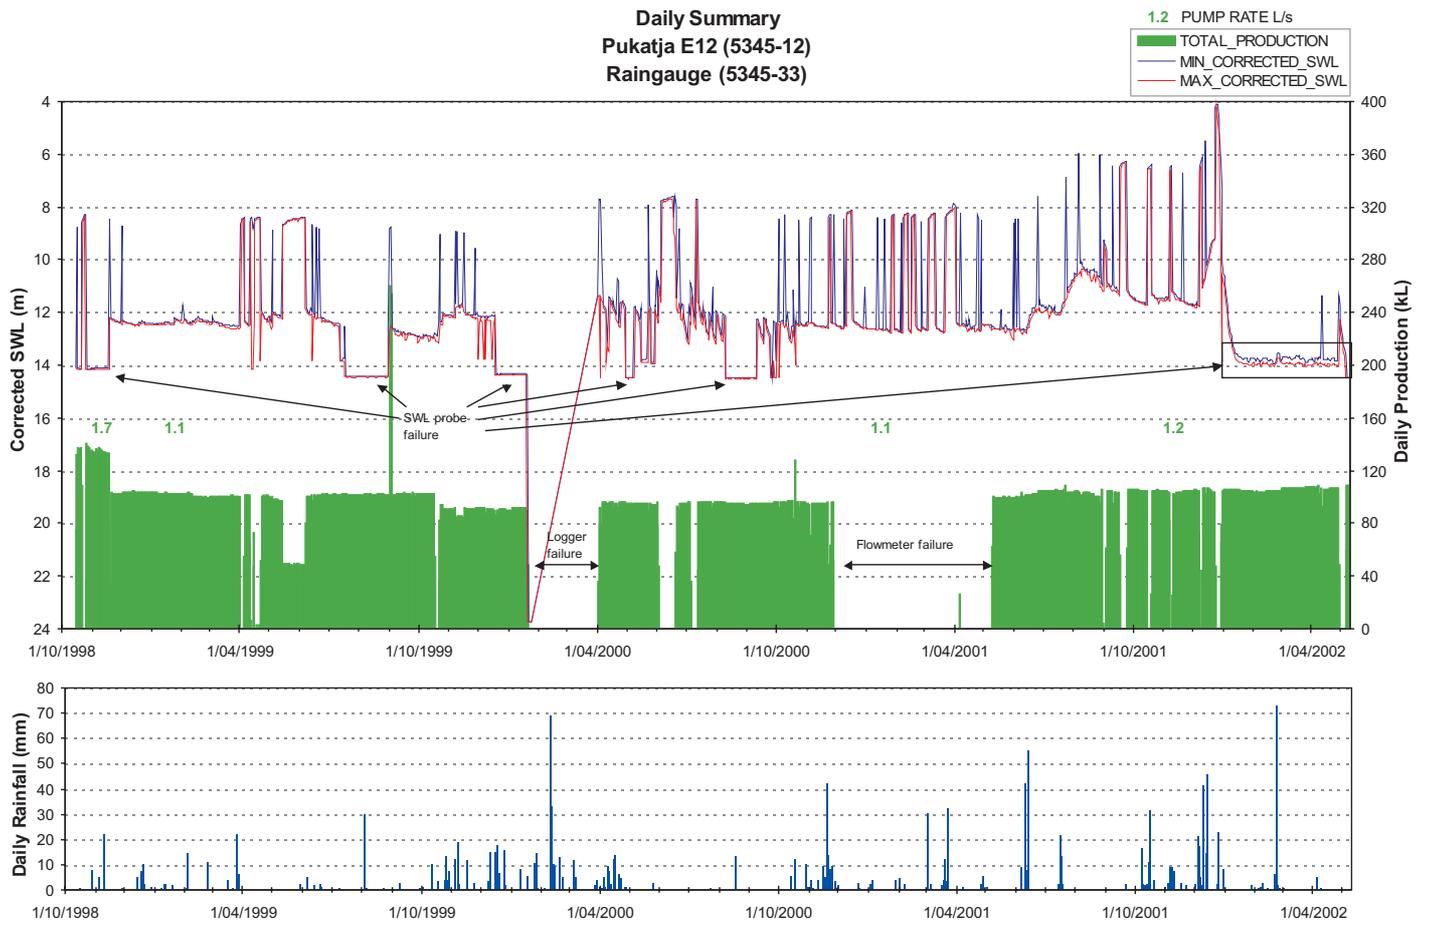
Figure 5.3 Daily Summary, Pukatja E 12

From 1971 to March 2000 the non-pumping SWL was consistently between 8.1 m and 8.4 m (Fig. 5.3). Neither continuous pumping (100 kL/day) nor natural drainage caused any decline in this level. It seems probable that recharge started with the rains of February 2000, with a clear rise in SWL to above 8 m when the well was rested in June 2000. While it will be interesting to see what happens to the SWL once recharge has ceased, past history indicates that the base level of about 8 m is unlikely to be affected other than by an extended period of drought.

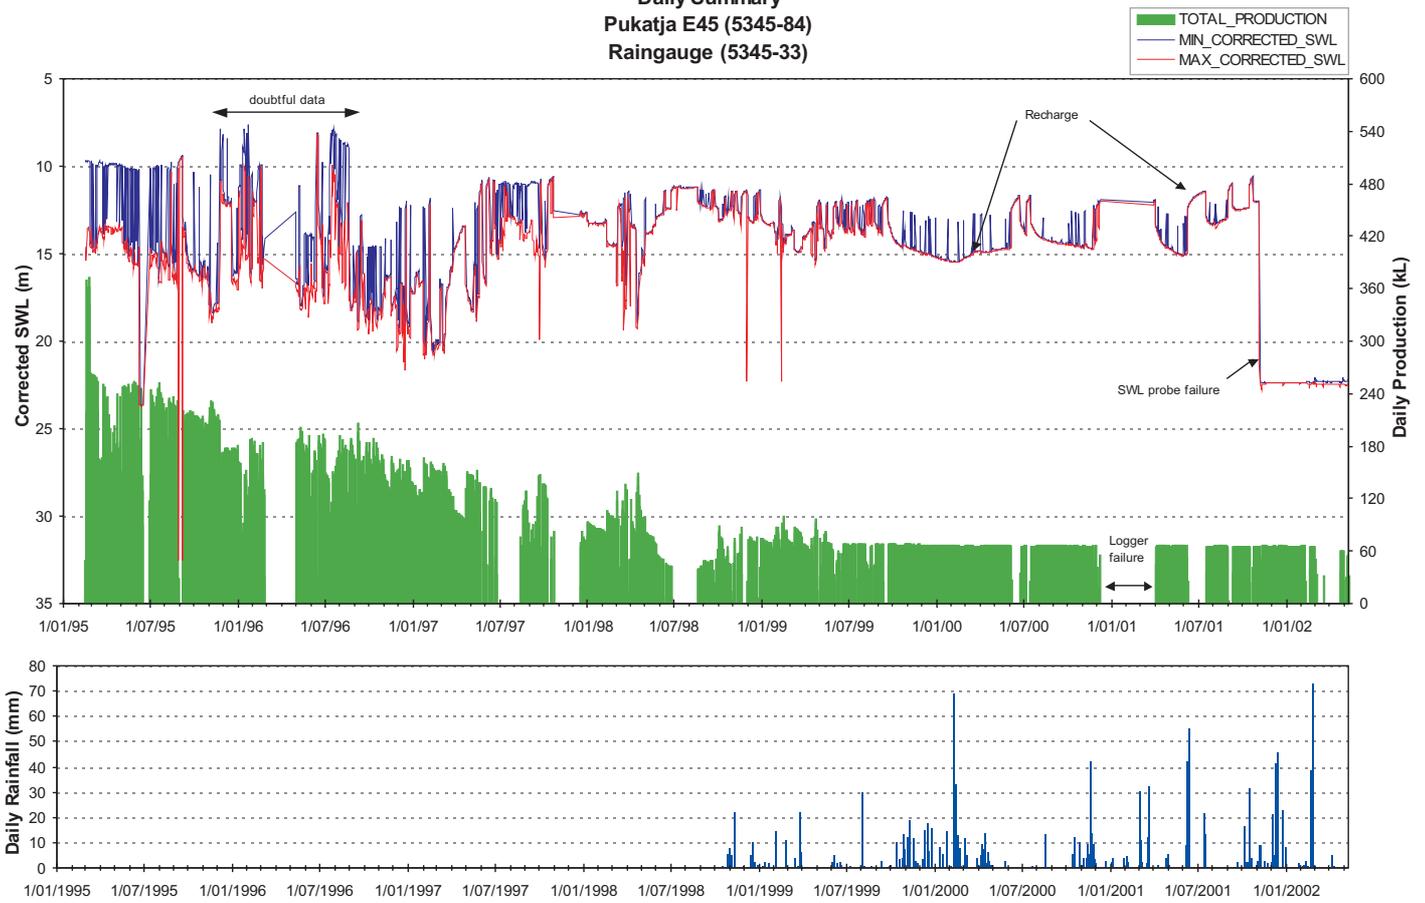
Figure 5.6 Daily Summary, Pukatja E 45

The SWL monitor failed on 5 November 2001, only a few days after the download, so only pump rates are available for the rest of the period (Fig. 5.6). This is unfortunate because the SWL rose by 6 m in this interval to 5.9 m (from manual measurement in May 2002) and it would have been instructive to see the graph of this rise. The aquifer has benefited from five recharge events over the past two and a half years, but this was by far the biggest rise. The water level is now above the stabilized level at the time the well was drilled in 1989 (9.2 m).

E-45 has contributed a steady 65 kL/day to Pukatja's water supply for the last 3 years without any sign of stress, although the SWL was declining gradually before the recent recharge events. Before 1998 pumping at higher levels caused considerable stress to this well, but it appears that the recent regime of pumping 0.75 L/s continuously is sustainable. Higher pumping rates should be avoided other than possibly for short periods.

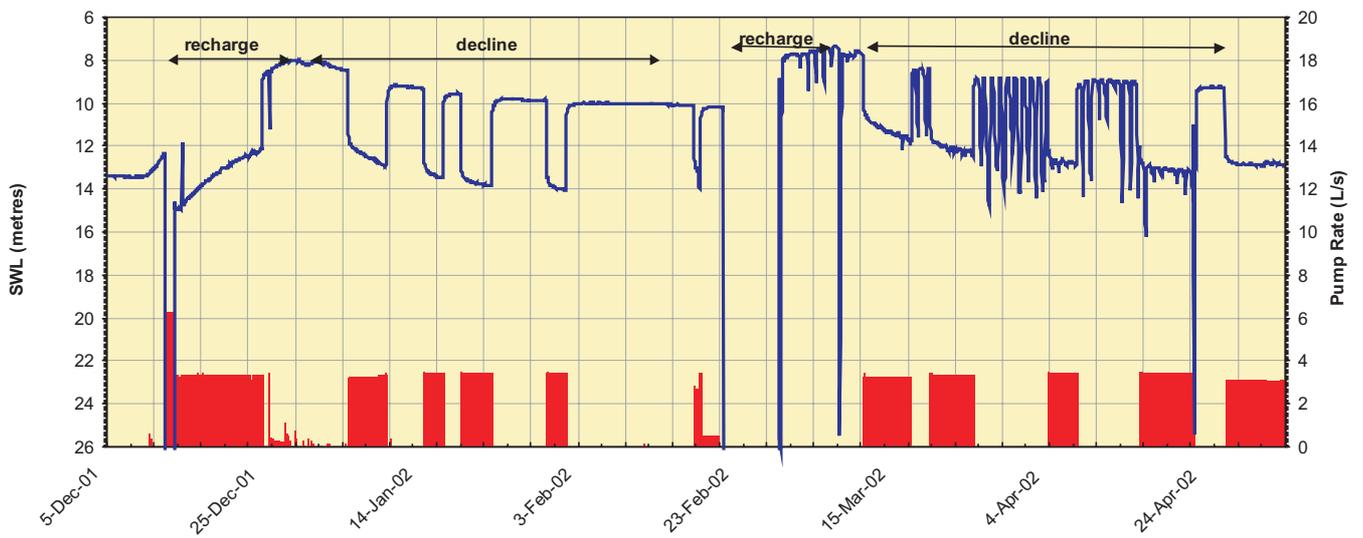
Figure 5.8 Effect of recharge Dec. 2001 and Feb. 2002, Pukatja E 97B

The rainfall events of December 2001 and February 2002 had a much more dramatic effect on the water levels in the aquifers than earlier events (e.g. February 2000) of equal magnitude. It is uncertain whether this is caused by earlier rains having saturated the subsurface, by the precise area in which the rain fell, or some other cause. Whatever the mechanism, all wells benefited substantially from these recharge events. It appears that all wells, including those north of the community which were getting fragile, are now restored to their productivity at the time of drilling.

Pukatja E 97B
Effect of recharge events in December 2001 and February 2002

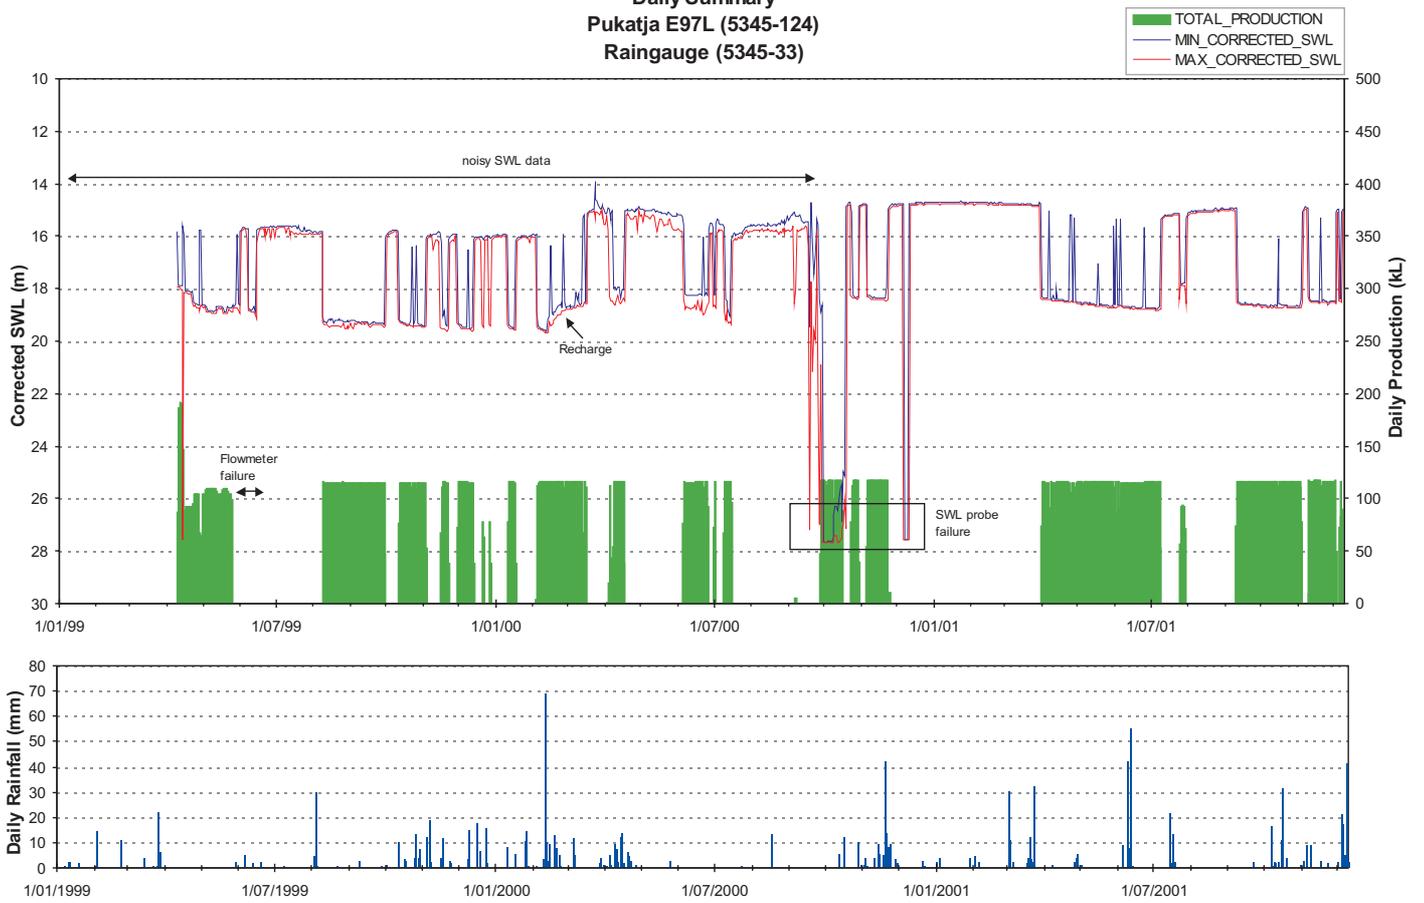
Figure 5.9 Daily Summary, Pukatja E 97L

The logging unit failed in early December 2001, so there is no record of the well's response to the subsequent recharge events. However, it is clear that there was recharge as the water level in May 2002 was 11.6 m, 3.4 m higher than in December and 2.7 m higher than in 1997. Like E-97B, this well sustains long term pumping at the current rate of 1.4 L/s, but this rate should not be increased (Fig. 5.9).

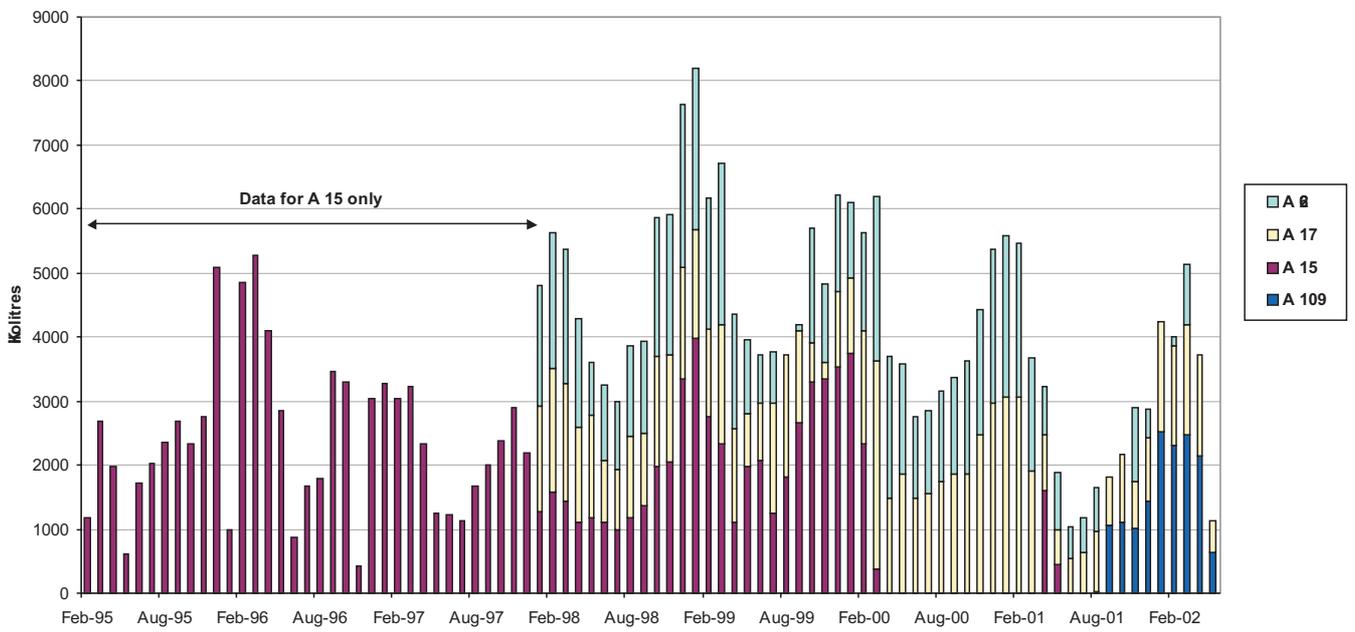
Figure 6.2 Community water production at Amata

All four wells have contributed significantly at various times (Fig. 6.2). However, well A-15 was decommissioned after a failed attempt to clean it out, and was replaced by A-109 drilled a few metres away. The latter well appears as good a supplier as, if not better than, its predecessor.

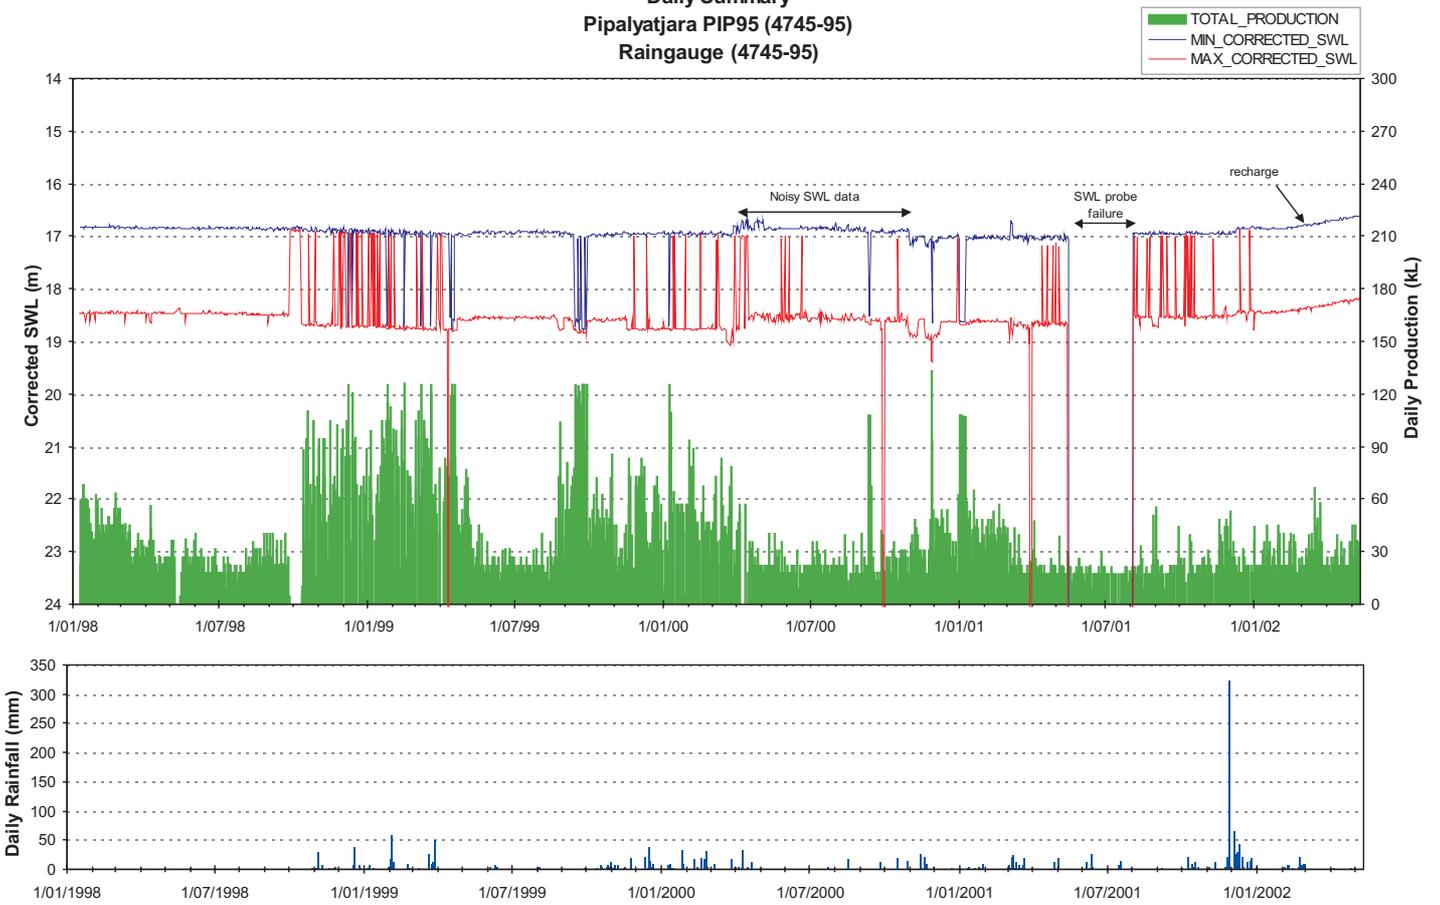
Figure 8.2 Daily Summary, Pipalyatjara PIP 95

The non-pumping SWL remained at about 17 m until the recharge from the summer rains, which caused an immediate but gradual rise (Fig. 8.2). In May the SWL had risen to 16.6 m and appears to be still rising. Pumping causes a drawdown in SWL to about 18.5 m, still well above the water cuts at 22–30 m.

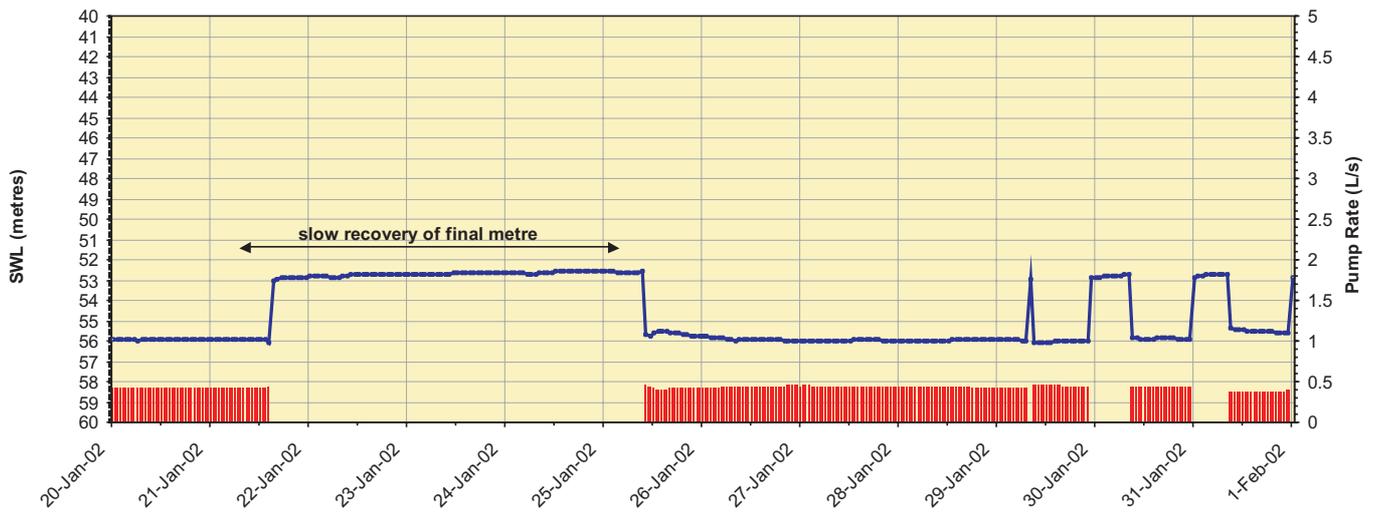
Figure 9.8 Effect of slow recovery, Nepabunna N 2

Between August 2000 and November 2001 there was a lot of equipment failure, so informative data is rather sparse. However, overall the earlier data indicates a similar picture, with a pump rate varying from 0.9 to 0.2 L/s and the non-pumping SWL remaining between 52 and 53 metres. There is some uncertainty about the non-pumping SWL because this well is slow to recover the final metre or so (a week or more) and the well is never rested this long (Fig. 9.8).

Nepabunna N 2
Example of slow SWL recovery from pumping
