HYDROGEOLOGICAL
REPORT ON WATER
WELL MONITORING IN
ABORIGINAL LANDS
TO MAY 2002

DWLBC
Report
2002/26

Hydrogeological report on water well monitoring in Aboriginal lands to May 2002

August 2002

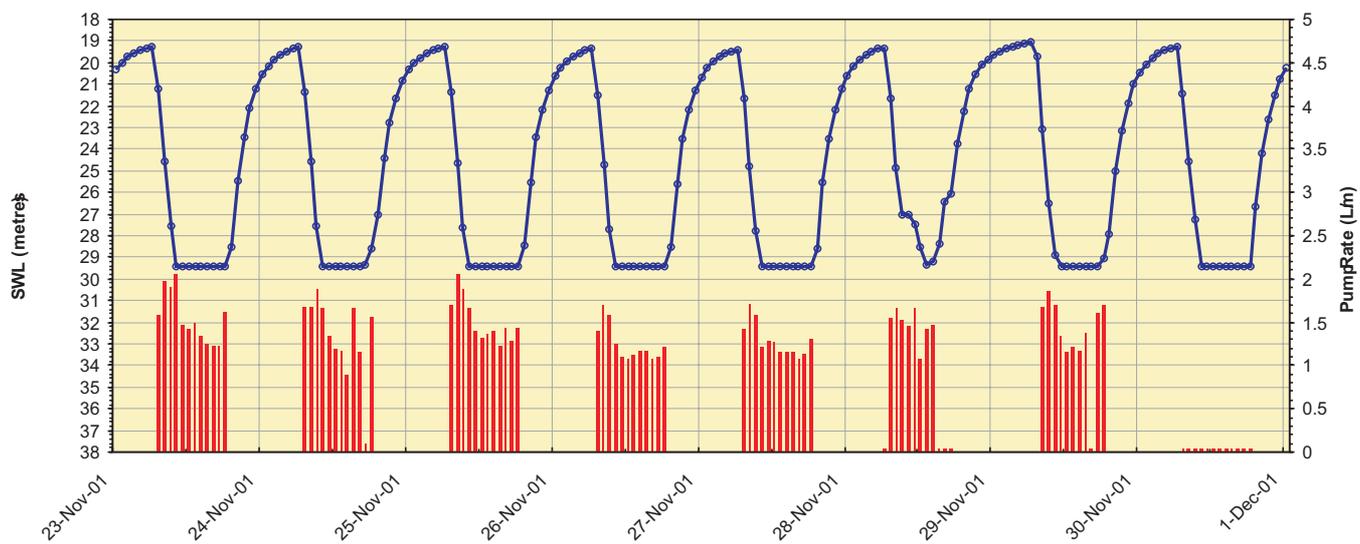
Figure 11.4 Detailed daily SWL variation, Oak Valley OV 7

A detailed study of the SWL variations during pumping (Fig. 11.4) shows that the measured SWL drops steadily for 4 hours after pumping commences, but is then constant at 29.4 m for 8-10 hours while pumping continues. This seems unlikely, and it is more

Oak Valley OV 7
 Drawdown effects of pumping
