**Assessment of Soil
Cracking & River Bank
Slumping in the Lower
Murray**

Part 1 Report

REV C

November 2008

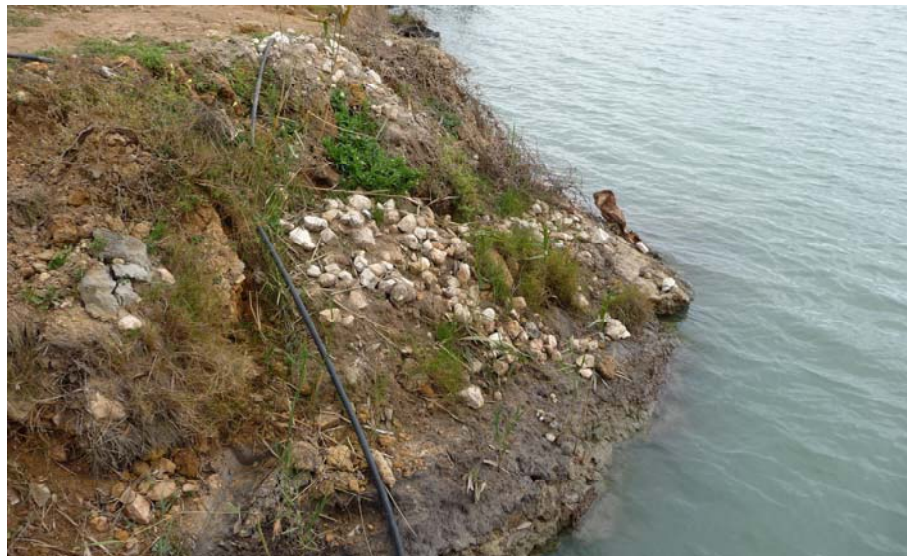
Houseboat Concepts has remedial action planned.

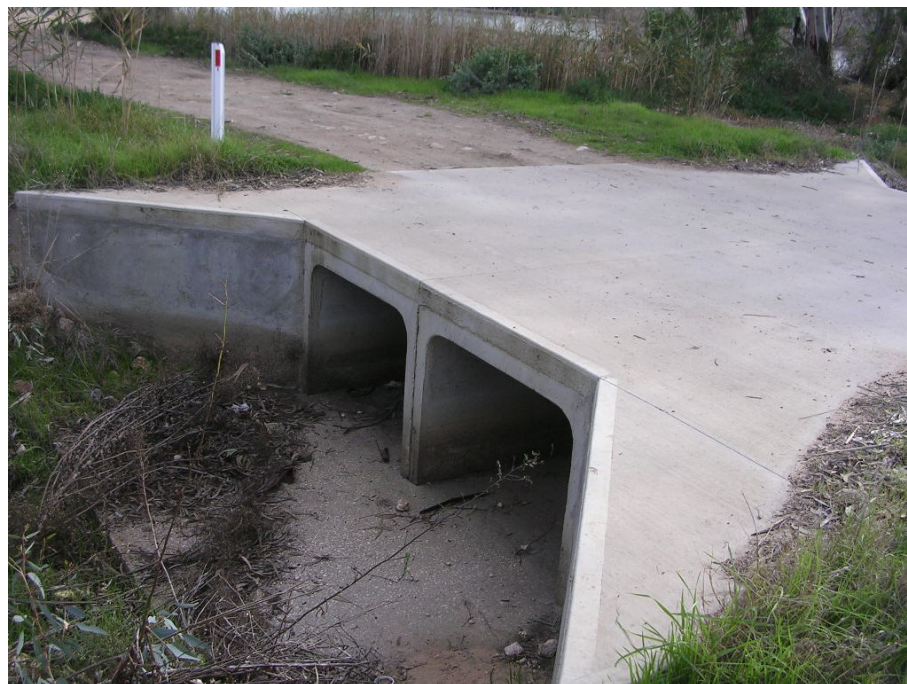
9.4 Kroehns Landing

This structure comprises 2 concrete culvert bays forming a bridge for a minor track extending from the rear of the shacks. The track is over the inlet to the wetland and provides access to farmland between the river and the wetland currently sown to what appears to be a cereal crop.

The structure appears to have limited usefulness as a regulating device for water flow into the wetland.

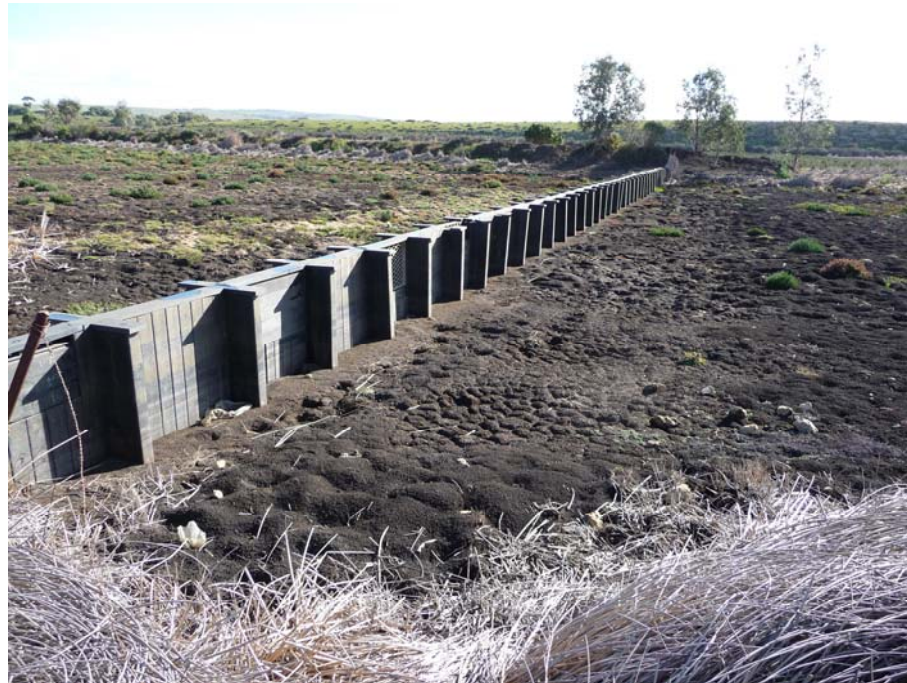
9.5 Reedy Creek

The Reedy Creek Regulator consists of a series of connected bays with a mix of half height trash racks above stoplogs and full height stoplog bays. The structure is approximately 900mm high and is constructed from piles supporting the bays and their stoplog channels. The stoplogs are held captive by caps between the piles and screwed down using coach bolts. There is no skirt on either side of the structure.

The structure is built into clay material which is expected to have acceptable properties for water retaining structures. It could be expected that high flow from Reedy Creek ("flash flooding") could cause some wash and erosion initially but that water entering from the river would be at low velocity. Because of the low height of the structure, it will overtop and bypass spill will occur due to the flatness of the surround terrain.

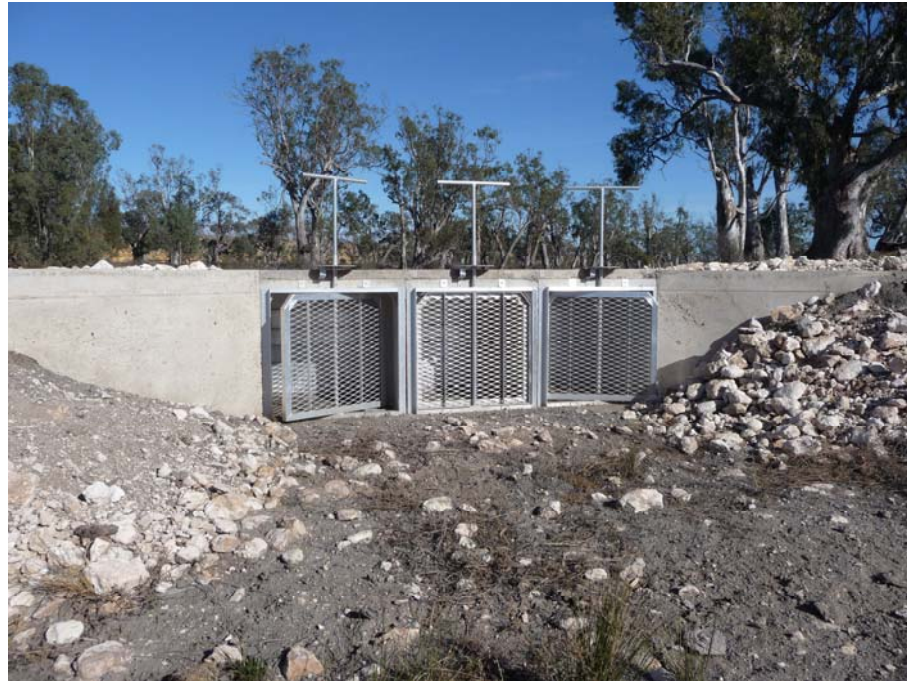
9.6 Sugar Shack

The structure comprises 3 bays of culverts placed over a concrete floor slab and topped with a concrete slab. There are wing walls on all sides projecting at approximately 45°. The spaces behind the wing walls have been backfilled with what appears to be granular material including paddock rocks – these do not appear to have been crushed – up to small boulder size (around 200 mm nominal dimension). There is no evidence that this backfilling has been compacted.

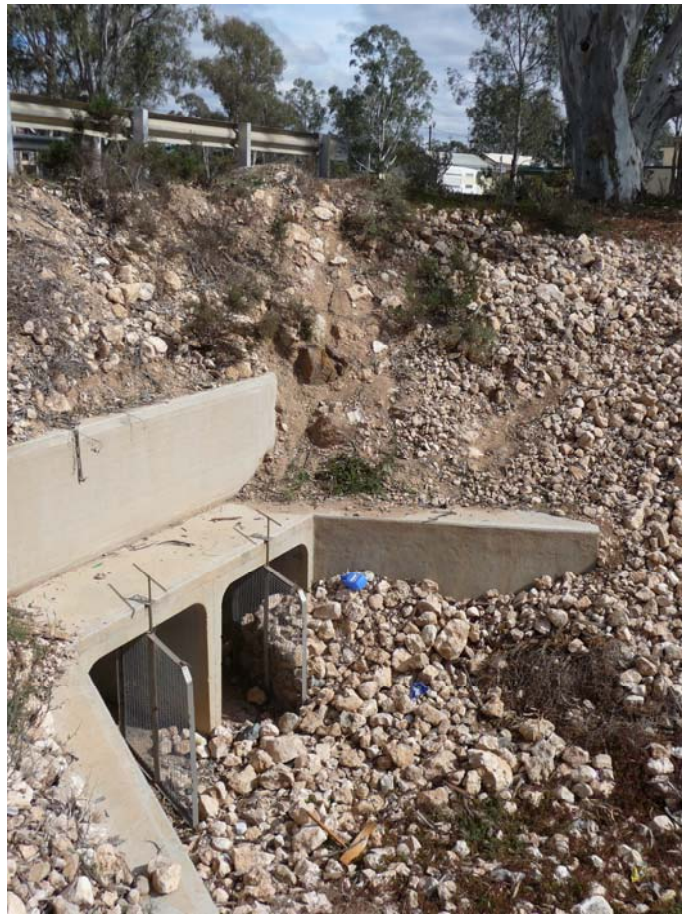
9.9 Blanchetown Inlet No. 4

The structure is part of a crossing of an inlet creek to the wetland which is a narrow causeway with Armco railings.

We could not rule out rectification costs involving six figures.

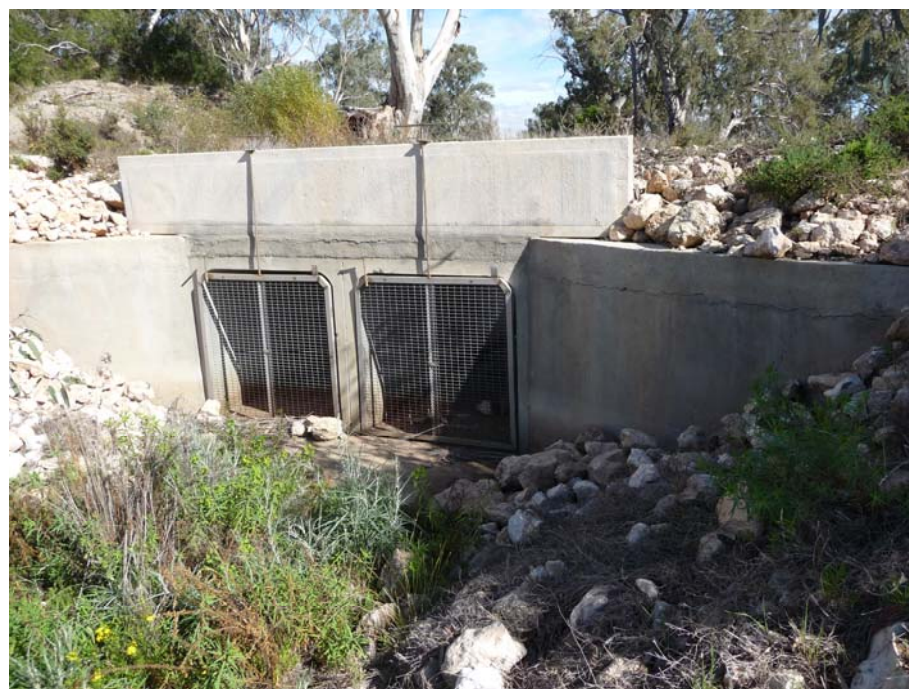
9.10 Portee Creek Inlet

The structure comprises 2 bays of culverts set into a concrete base and capped by a concrete slab. There are wing walls both sides projecting at approximately 60° to the axis of the culverts. There are headwalls above the extremities of the culverts and these are approximately 0.5m high and 4m long retaining around 0.3 m depth of unsealed pavement.

We could not rule out rectification costs involving several tens of thousands of dollars.

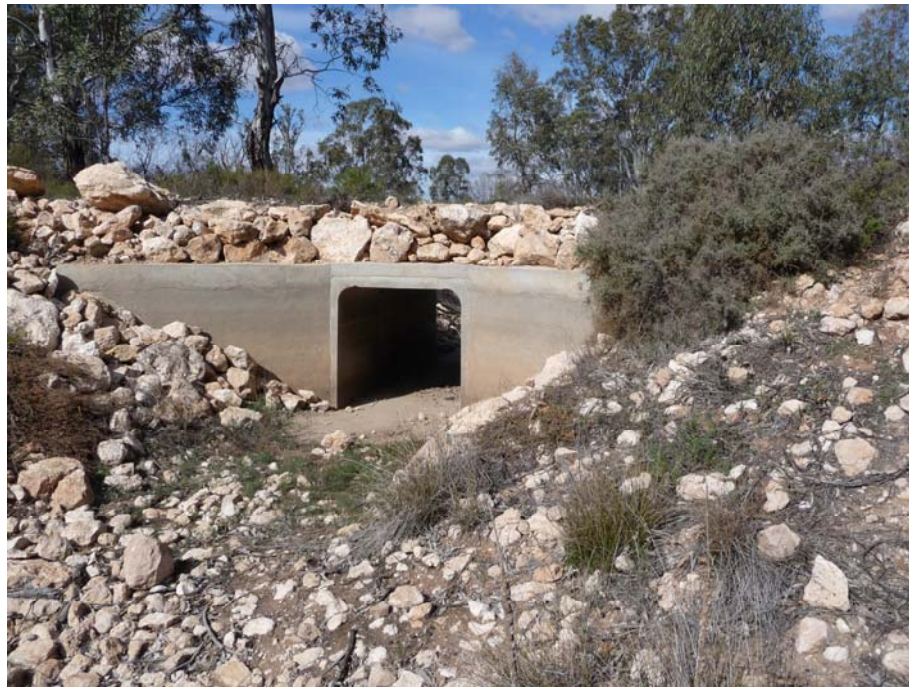
9.11 Sweeney Lagoon Inlet

This structure comprises one culvert placed on a concrete floor slab with wingwalls both sides.
