Study into River Bank Collapsing - Lower River Murray

INSPECTION REPORT

- Final
- 17 February 2010

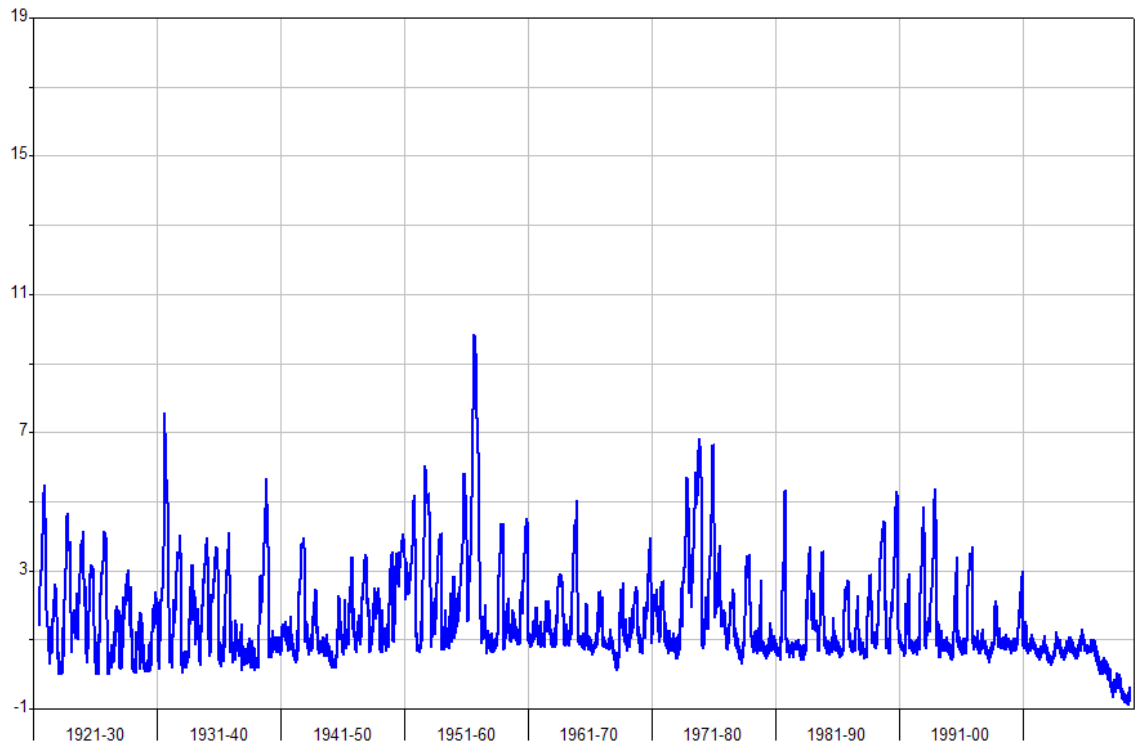
This level is lower than has ever been experienced previously in the pool, prior to and since barrage construction in the 1930s. Figure 2-1 shows historical water levels immediately downstream of Lock 1 from 1921 to present and Figure 2-2 from 2005 to present, showing the marked lowering in water level that has taken place since 2005. There has been a progressive step-wise decrease in water levels in the years 2006, 2007, 2008 and 2009, with water levels falling rapidly at ≈ 0.2 m/month through summer. Figure 2-3 shows water level history at Murray Bridge (Long Island), where water levels dropped to ≈ 1.05 m over late summer 2008-2009.

■ **Figure 2-1 River Murray at Lock 1 Downstream (A4260903) - Historical record of daily water levels (m AHD) from 1921 to present.**

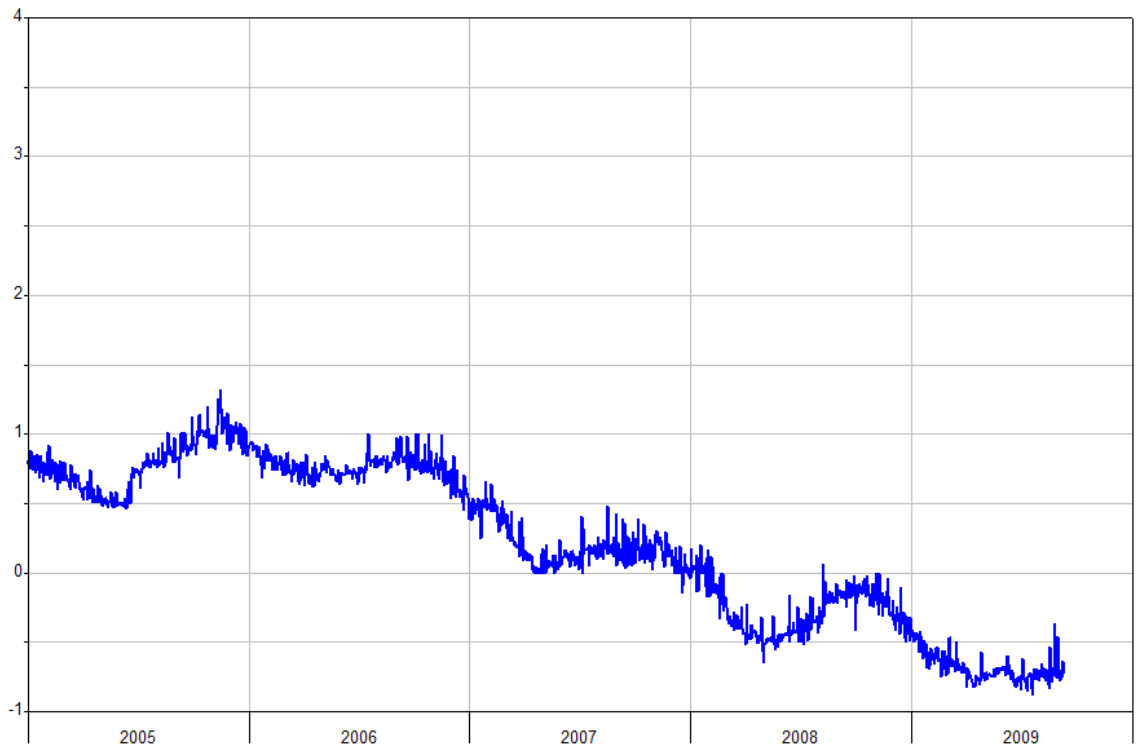
■ **Figure 2-2 River Murray at Lock 1 Downstream (A4260903) - Daily water levels (m AHD) for past 5 years from 2005 to present.**

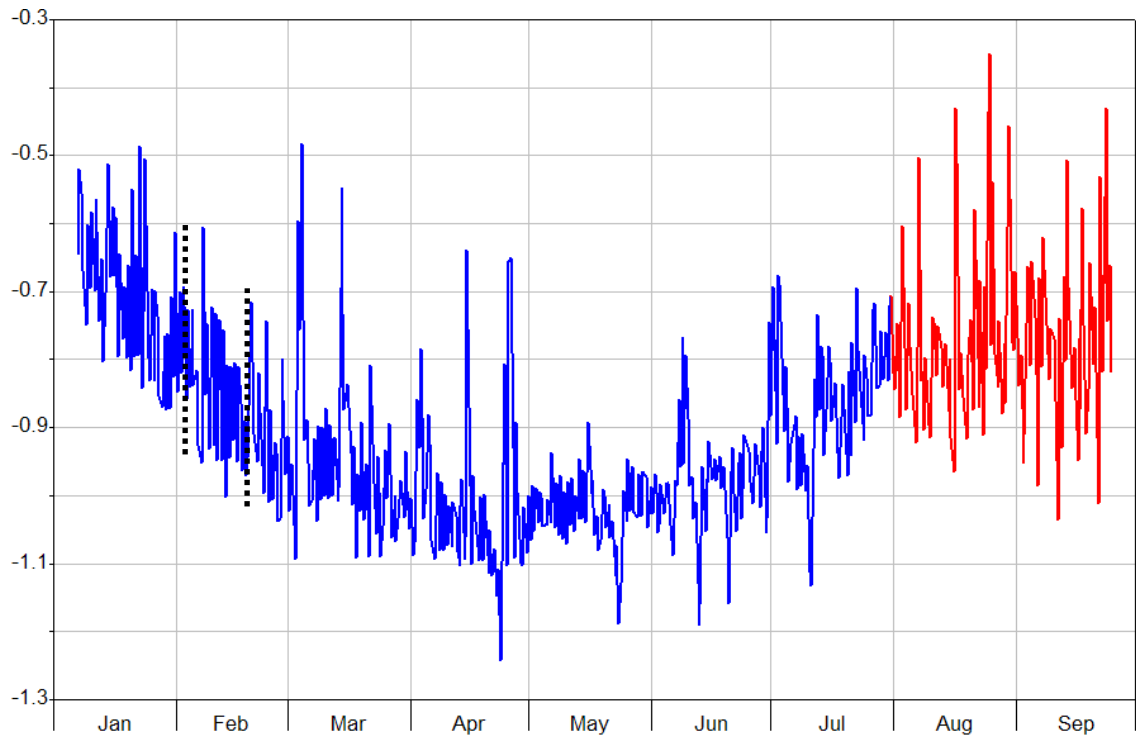
The timing of collapses alongside lowering of water level supports the theory that water level lowering is triggering bank failure. As pool levels lowered, collapses began to occur in succession from about 4 February 2009. Major slips were documented at Long Island Marina, Riverglenn, Woodlane and Bells Reserve (Table 2-1).

- **Figure 2-3 River Murray at Murray Bridge (Long Island) - Daily water levels (m AHD) from January 2009 to present. Dashed lines indicate timing of major failures at Long Island Marina (4 and 20 February 2009).**
- **Table 2-1 Major incidents recorded in incident register.**

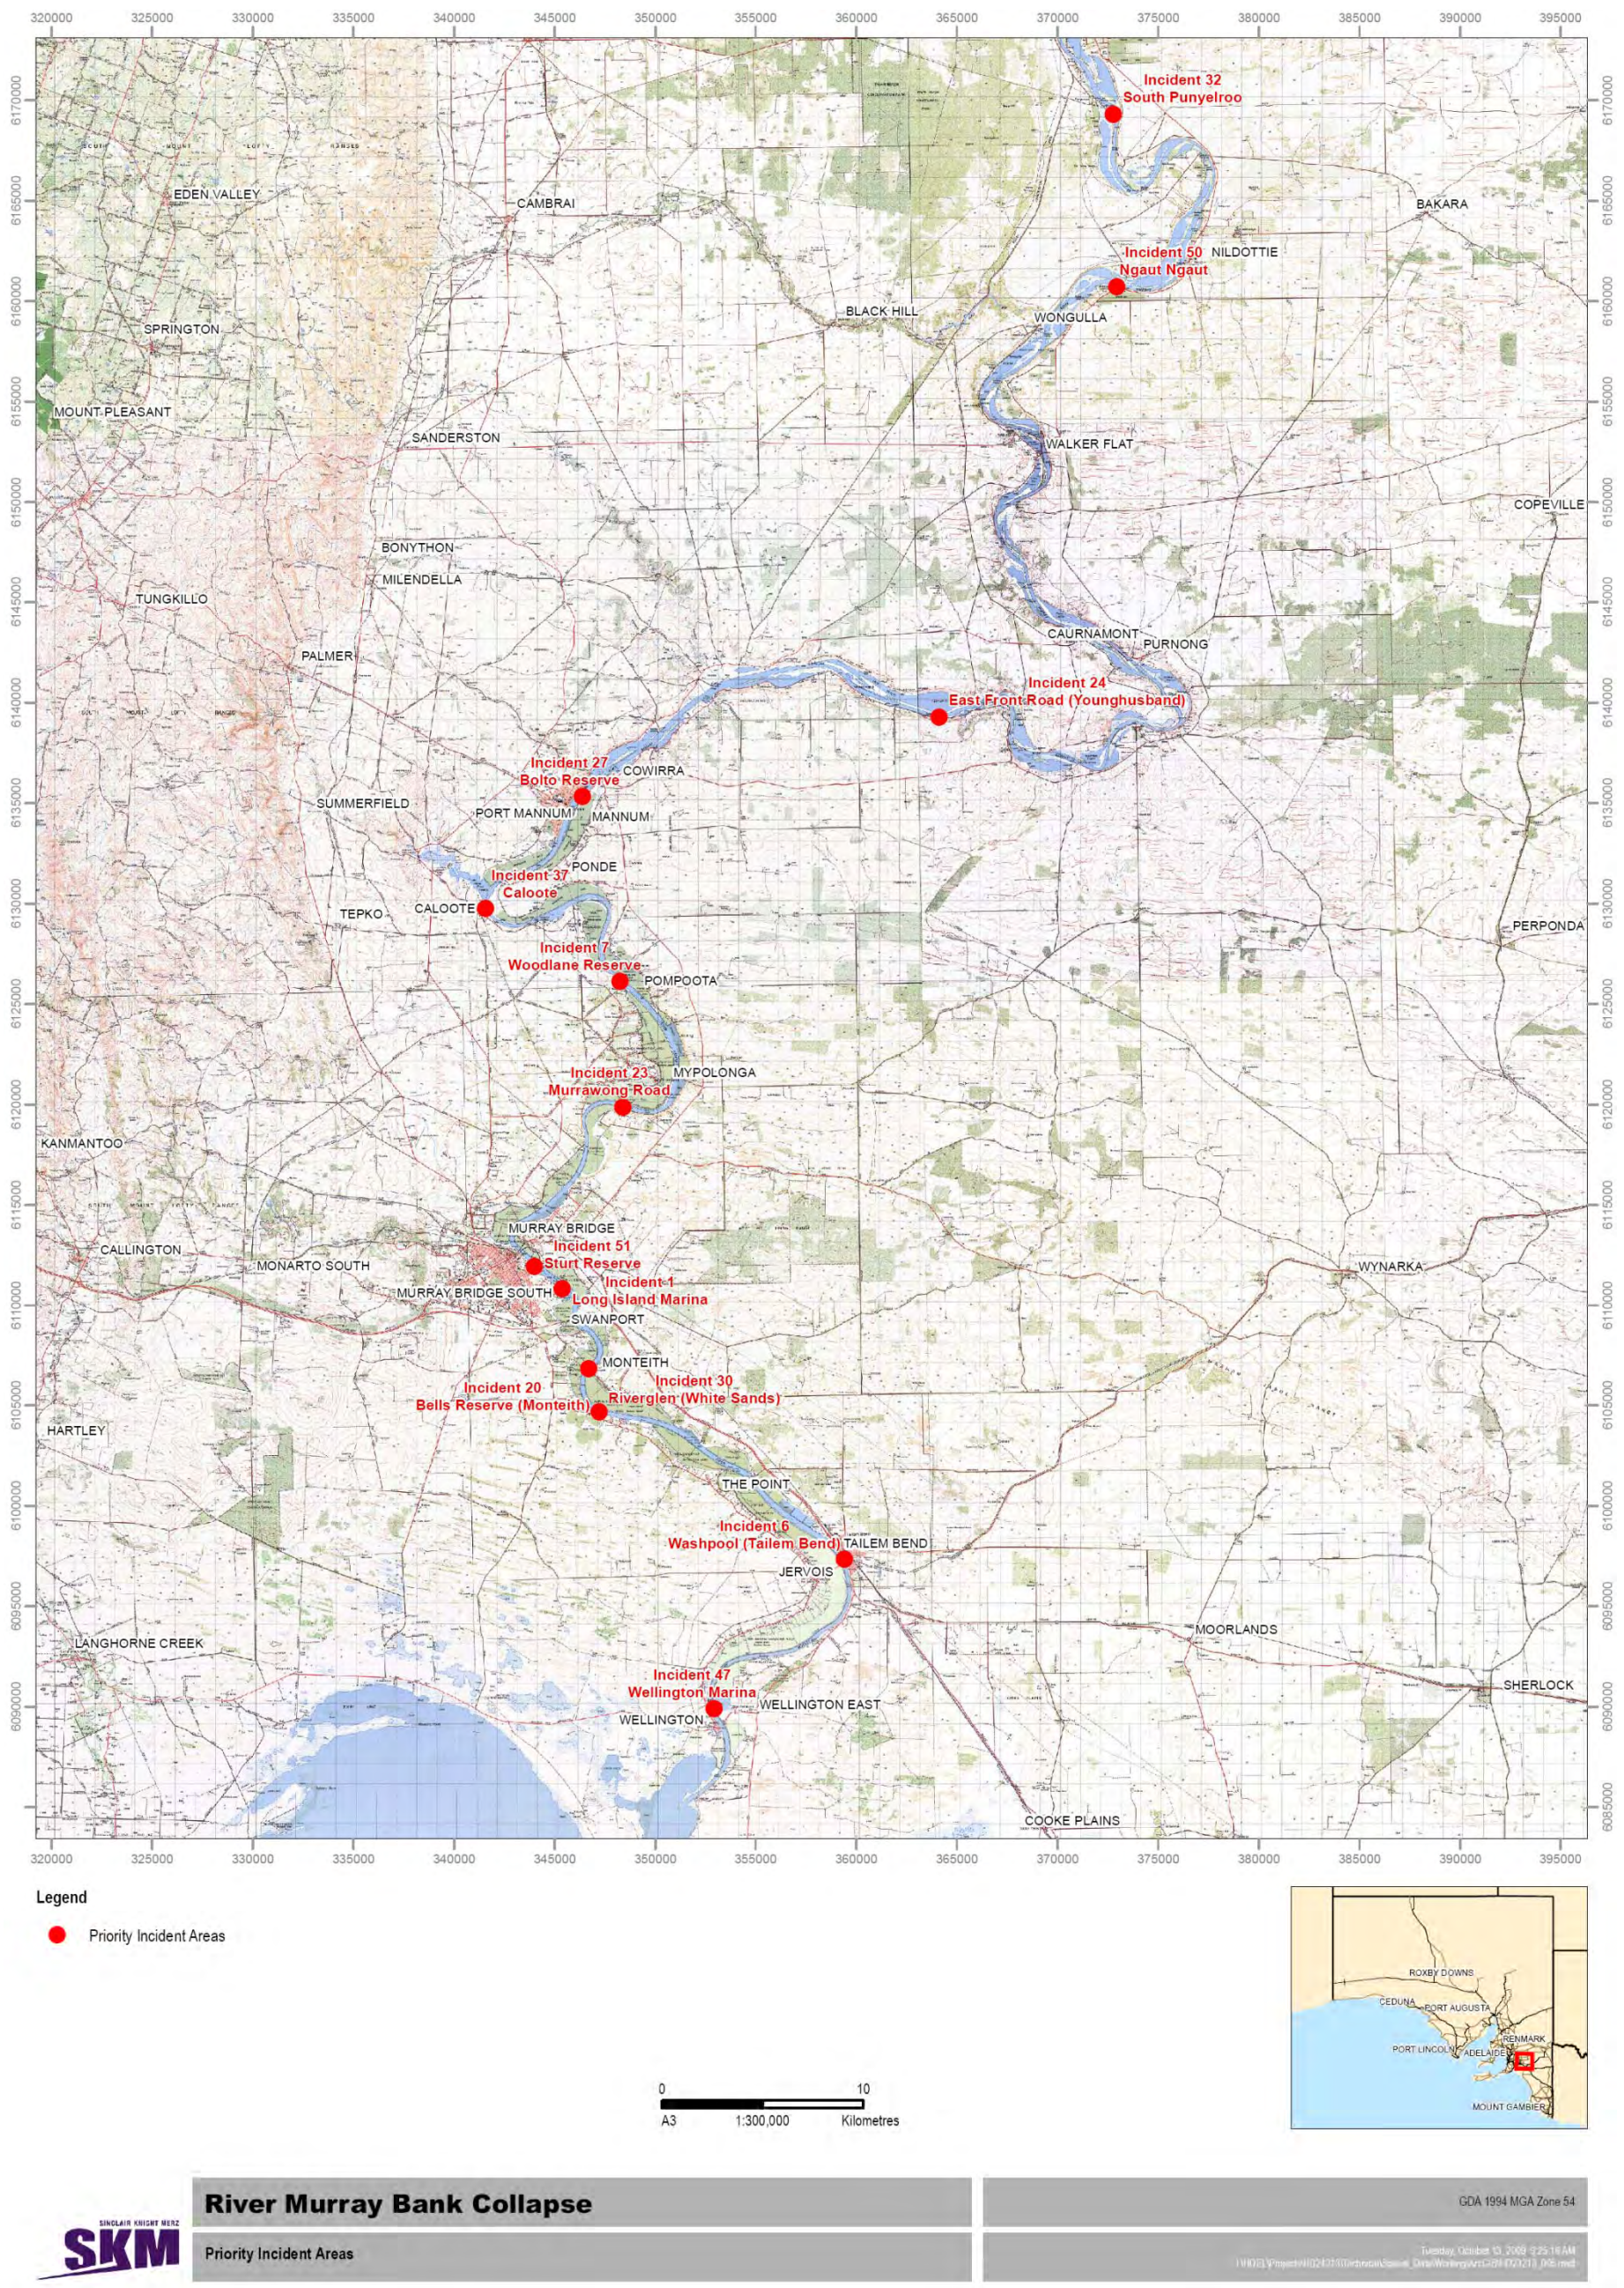
37	Caloote	Tension cracks and slumping	Almost certain	Catastrophic	Catastrophic	Boreholes and survey	Vacate houses downstream of boat ramp, no mooring of boats	Measure tension cracks, repeat survey	Critical
7	Woodlane Reserve	Rotational slip, toppling and tension cracks	Almost certain	Catastrophic	Moderate	Boreholes and survey	No mooring at the site, fence off failure area	Measure tension cracks	Critical
23	Murrawong Road	Rotational slip/slab failure and tension cracks	Almost certain	Catastrophic	Moderate	No further investigations advised at this time	Advise people road is no longer safe, no mooring of boats	Measure tension cracks, repeat survey	Critical
51	Sturt Reserve	Tension cracks and shallow slide	Almost certain	Catastrophic	Catastrophic	Boreholes and survey	Fence of Sturt Reserve, advise residents to vacate premises	Measure tension cracks, repeat survey	Critical
1	Long Island Marina	Rotational slip, tension cracks and toppling	Almost certain	Catastrophic	Moderate	Borehole and survey	Prevent pedestrian access	Measure tension cracks in areas surrounding past failures	Critical

20	Bells Reserve (Monteith)	Tension cracks and slumping	Almost certain	Catastrophic	Minor	Borehole and survey	Prevent pedestrian and vehicle access to areas where slipping and cracking has occurred	Measure tension cracks	Critical
30 & 4	Riverglen (White Sands)	Tension cracks and toppling	Almost certain	Catastrophic	Minor	No further investigations advised at this time	No immediate management actions	Landowners to measure tension cracks	Critical
6	Washpool (Tailern Bend)	Tension cracks and subsidence	Almost certain	Catastrophic	Major	No further investigations advised at this time	Prevent pedestrian access to picnic area and concrete walkway, rebuild platform adjacent to rowing club	Measure tension cracks	Critical
47	Wellington Marina	Tension cracks	Almost certain	Catastrophic	Major	No further investigations advised at this time	Prevent pedestrian and vehicle access, no mooring of boats	Measure tension cracks in surrounding area	Critical

■ Figure 4-1 Sites inspected where a detailed site assessment was completed.

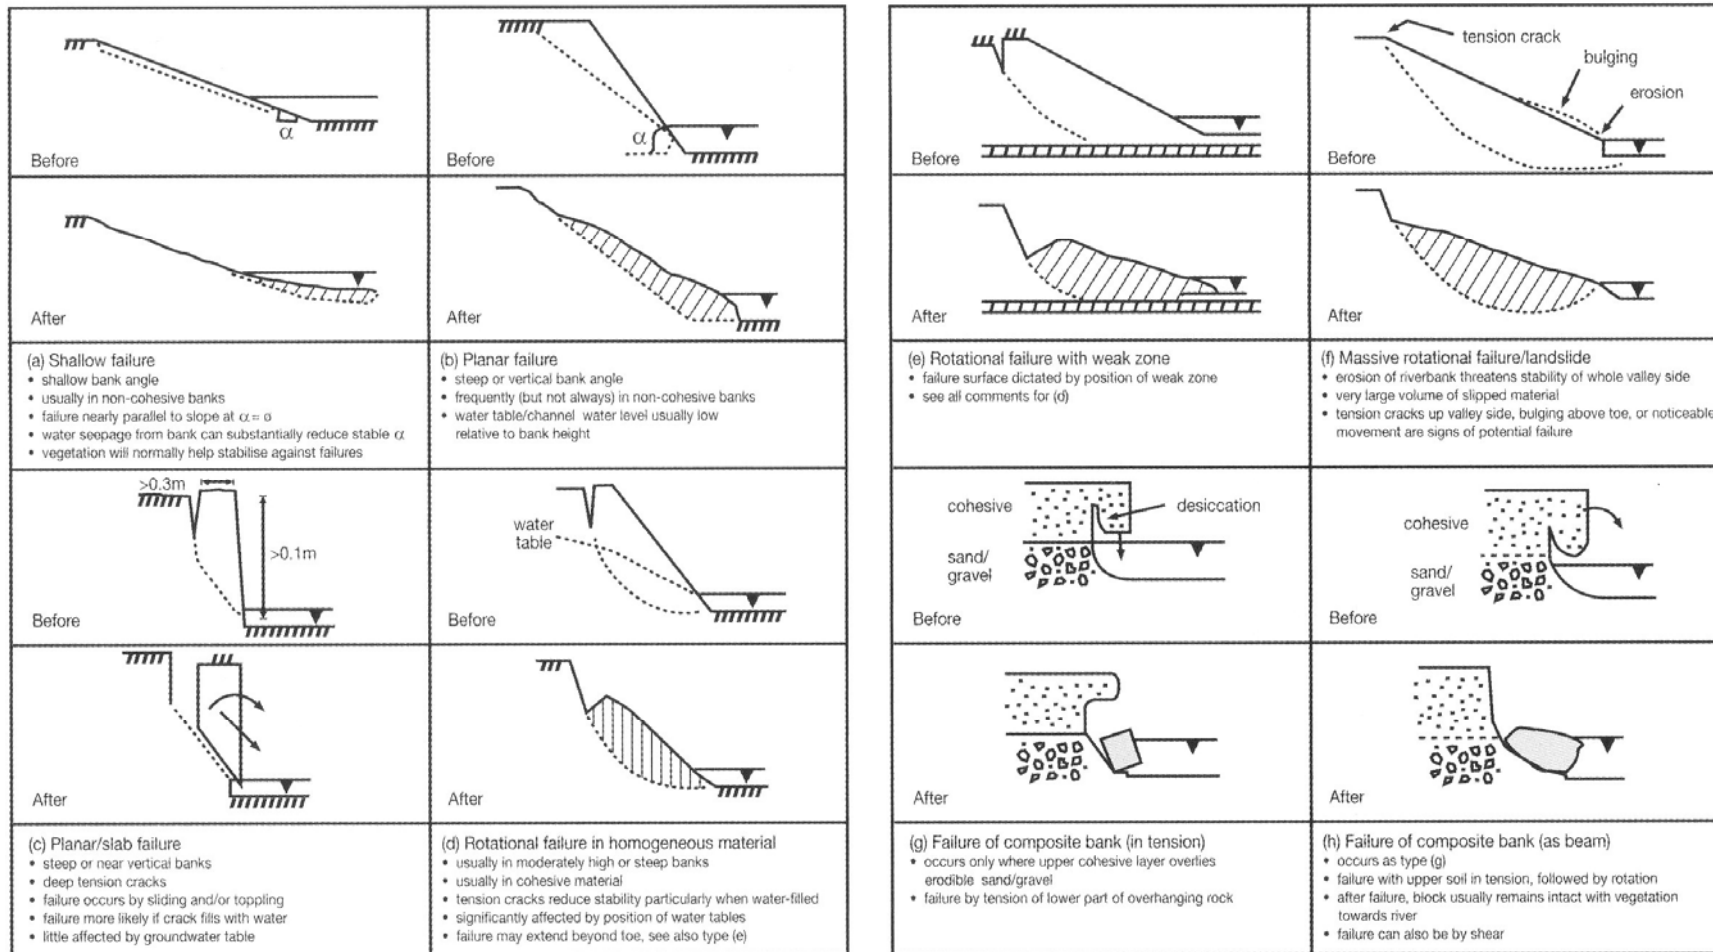
- **Shallow slide** – Shallow seated failure along a shear plane parallel to and just below the bank surface, typically occurs in weakly cohesive soils. See also Figure 4-2 (a) shallow failure and (b) planar failure;

- **Rotational slip** – This is a deep seated movement of all or part of the bank profile in which a block of soil slips along a curved surface. This is a severe type of failure that involves the movement of a large volume of material and generates serious bankline retreat. See also Figure 4-2 (e) rotational failure with weak zone, (f) massive rotational failure/landslide, (d) rotational failure in homogenous material and Figure 4-3;

- **Slab failure** – Blocks or columns of soil topple forward into the channel, often with deep tension cracks separating the failure blocks from the intact bank. Similarly to rotational slips, this represents a severe type of failure involving the movement of large volumes of material and serious bankline retreat. See also Figure 4-2 (c) planar/slab failure and Figure 4-3;

- **Cantilever failure** – Overhanging blocks of soil collapse into the channel by shear, beam or tensile failure. Overhangs are found in layered banks where a resistant, cohesive or root-bound layer overlies an erodible, non-cohesive layer. See also Figure 4-2 (g) failure of composite bank (in tension) and (h) failure of composite bank (as beam);

Of these bank failure modes outlined, deep rotational slips and slab failures would appear to be the main mechanisms causing the large failures and retreat of banklines at sites inspected along the Lower Murray. These two modes of failure can also occur together sequentially, with a large rotational slip forming a steep face that then continues to retreat through slab failures. This would appear to be the case for Long Island Marina (IC 1) and Woodlane Reserve (IC 7). These represent the most severe form of bank failure modes. They are a sign of serious instability, deep below the rooting zone for riparian vegetation. Heavy engineering intervention through re-profiling and improved drainage to increase bank stability will be necessary if the bankline can not be allowed to retreat.

■ **Figure 4-2 Bank failure modes (from Hey et al., 1991).**

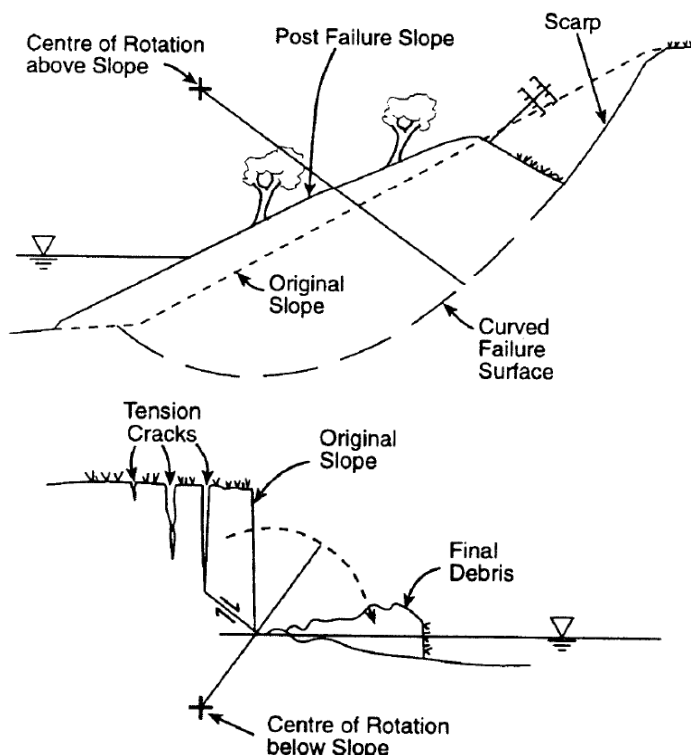
■ **Figure 4-3 Failure mechanisms typical of over-steepened and over-heightened banks: rotational slip (above) and slab failure (below) (from Thorne, 1999).**

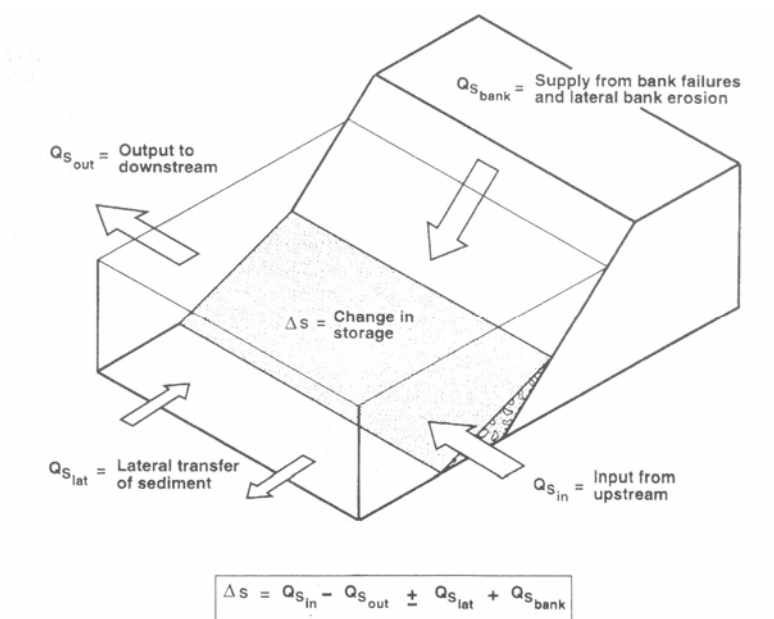
The concept of basal endpoint control is used to demonstrate the linkages between different bank processes with reference to Figure 5-1. Bank failure involves the movement of material directly from the intact bank to the basal area. The removal of material from the basal area depends on its entrainment by flow as shown in Figure 5-1. However, dredging activities may also result in removal of material from the basal area directly or indirectly as a result of removal from mid-channel areas, which in turn impact on lateral transfer of sediments.

The amount and duration of basal sediment storage depends on the balance between the rates of supply from bank processes and removal (entrainment and dredging). The accumulation and or erosion of material from this basal zone exerts an important influence on bank stability. The accumulation of material at the base of bank, has the effect of decreasing bank angle and height, increasing bank stability.

■ **Figure 5-1 Basal endpoint control showing role of sediment fluxes to and from river bank basal zone (from Thorne and Osman, 1988).**

Pressure to dredge areas of channel, particularly around marinas is likely to increase in future. Further geotechnical studies are recommended in the planning stage of any proposed dredging project to demonstrate that removal of material and debris will not impact on bank stability and cause an increase in rates of bank erosion.
