# Study into River Bank Collapsing for Lower River Murray

### GEOTECHNICAL INVESTIGATION REPORT

- Rev E FINAL
- February 2010

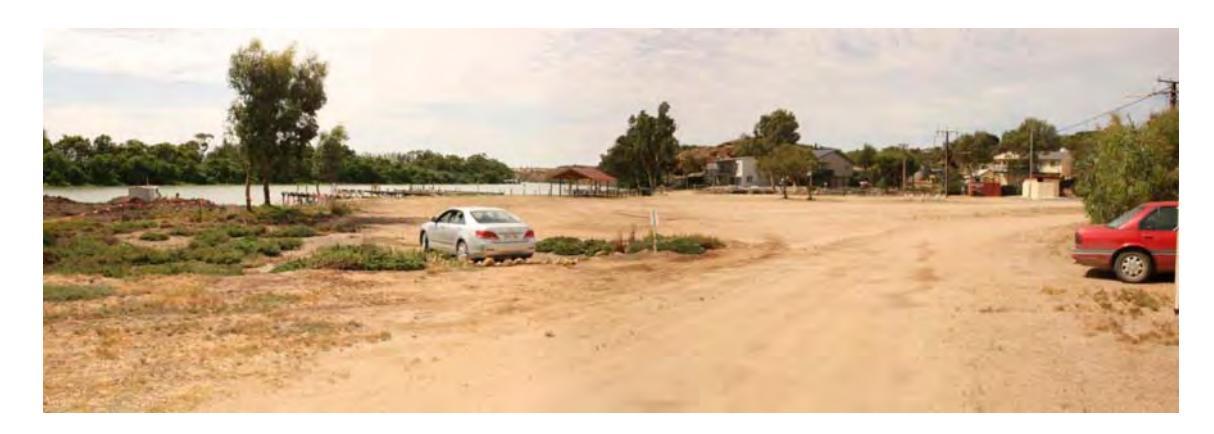
Photo 3 Caloote Landing

Caloote is located on the southern bank of a tight meander bend of the River Murray. A boat ramp and car parking area is located at this site, known as Caloote Landing (**Photo 3**). Similar to Riverfront Road-Murray Bridge, the area around Caloote Landing was formerly a swamp, which was then reclaimed in the 1930's/1940's. Rock for the surrounding cliffs may have been used to provide fill and reclaim the swampy area.

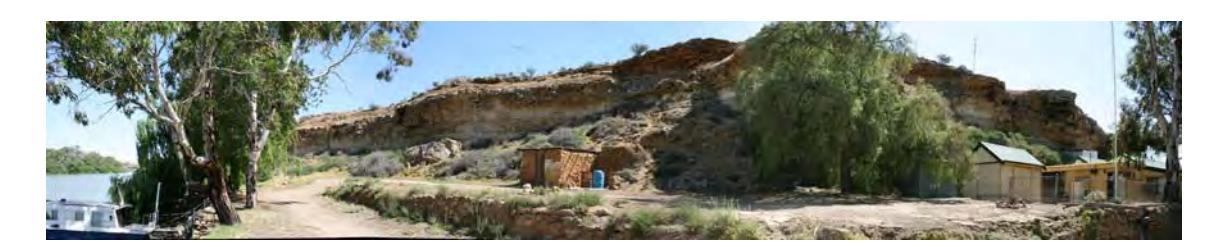
Photo 13 Caloote Cliffs

The existing condition of the rock over hang in the south eastern area indicates that cracks have been progressed in the section (**Photo 11** and **Photo 12**). Furthermore, from the general condition of the cliffs in the area (**Photo 13**) it is evident that there is a high risk of rock fall in southern site which could be catastrophic for the coastal home. A recent rock fall has been reported in November 2009 which is presented in **Photo 14**.

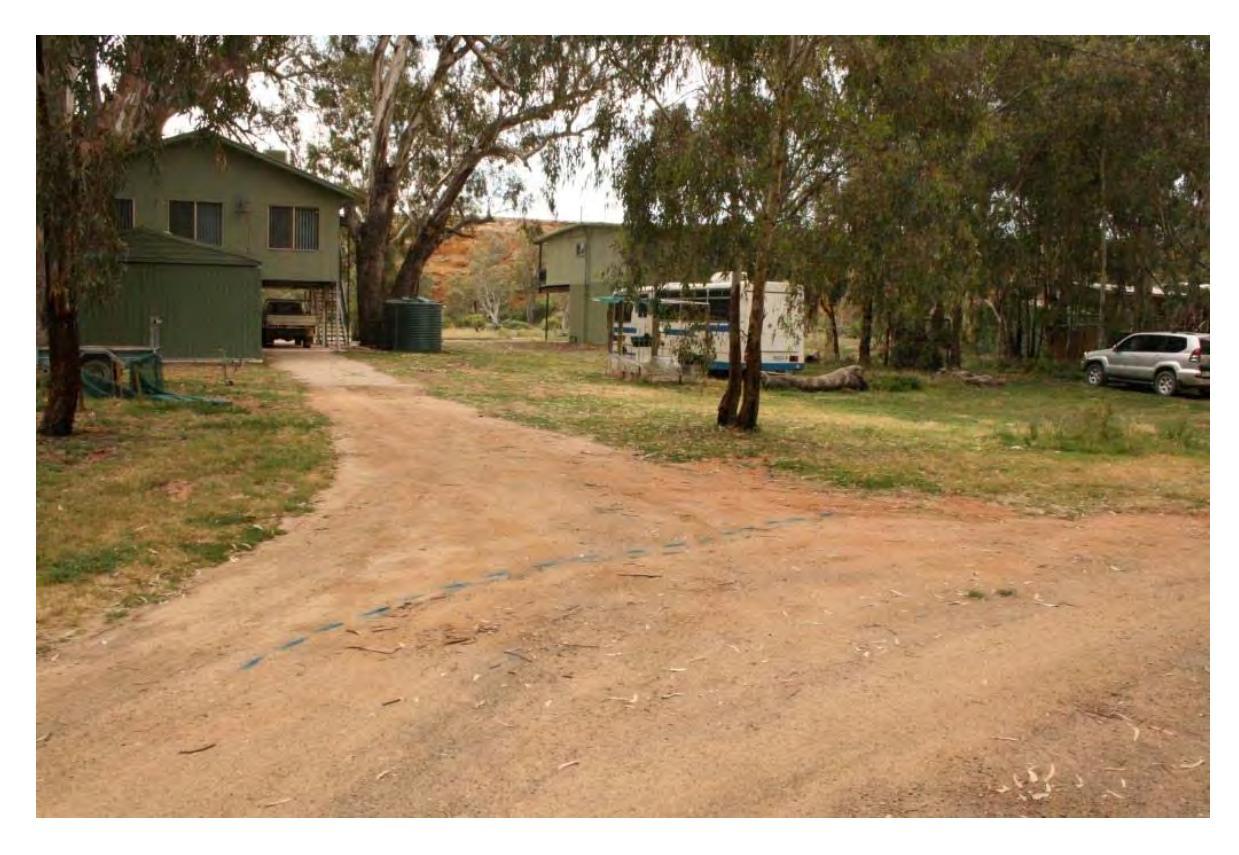
Photo 16 South Punyelroo

Furthermore, the shape and distribution of the cracks (**Photo 16**) indicates that the cracks are likely to be as a result of shrinkage of the top layers due to the reduction in the moisture content.

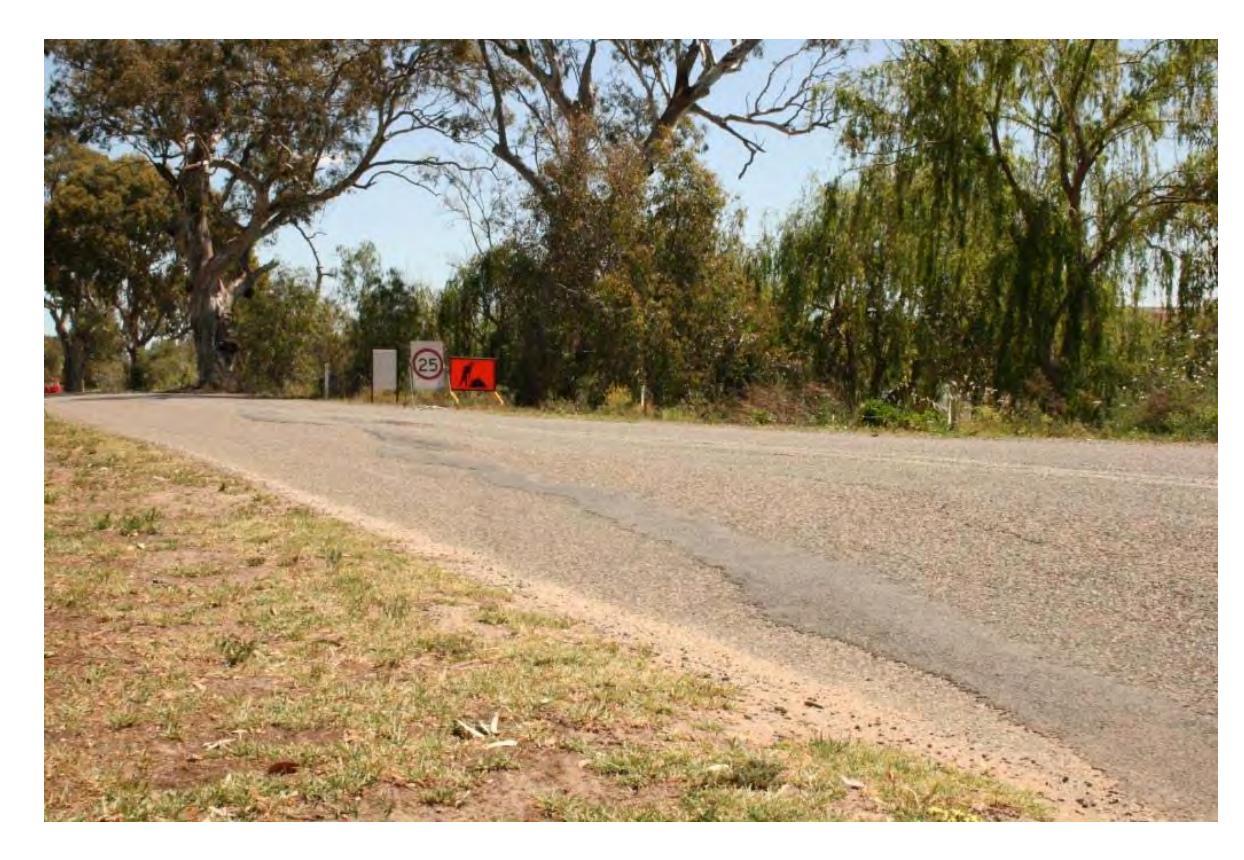
Photo 17 East Front Road

Furthermore, the shape and distribution of the cracks (**Photo 17** and **Photo 18**) indicate that possible failure zones already developed and the remedial works undertaken on the asphalt wearing cannot solve the problem or reduce the probability of the failure.

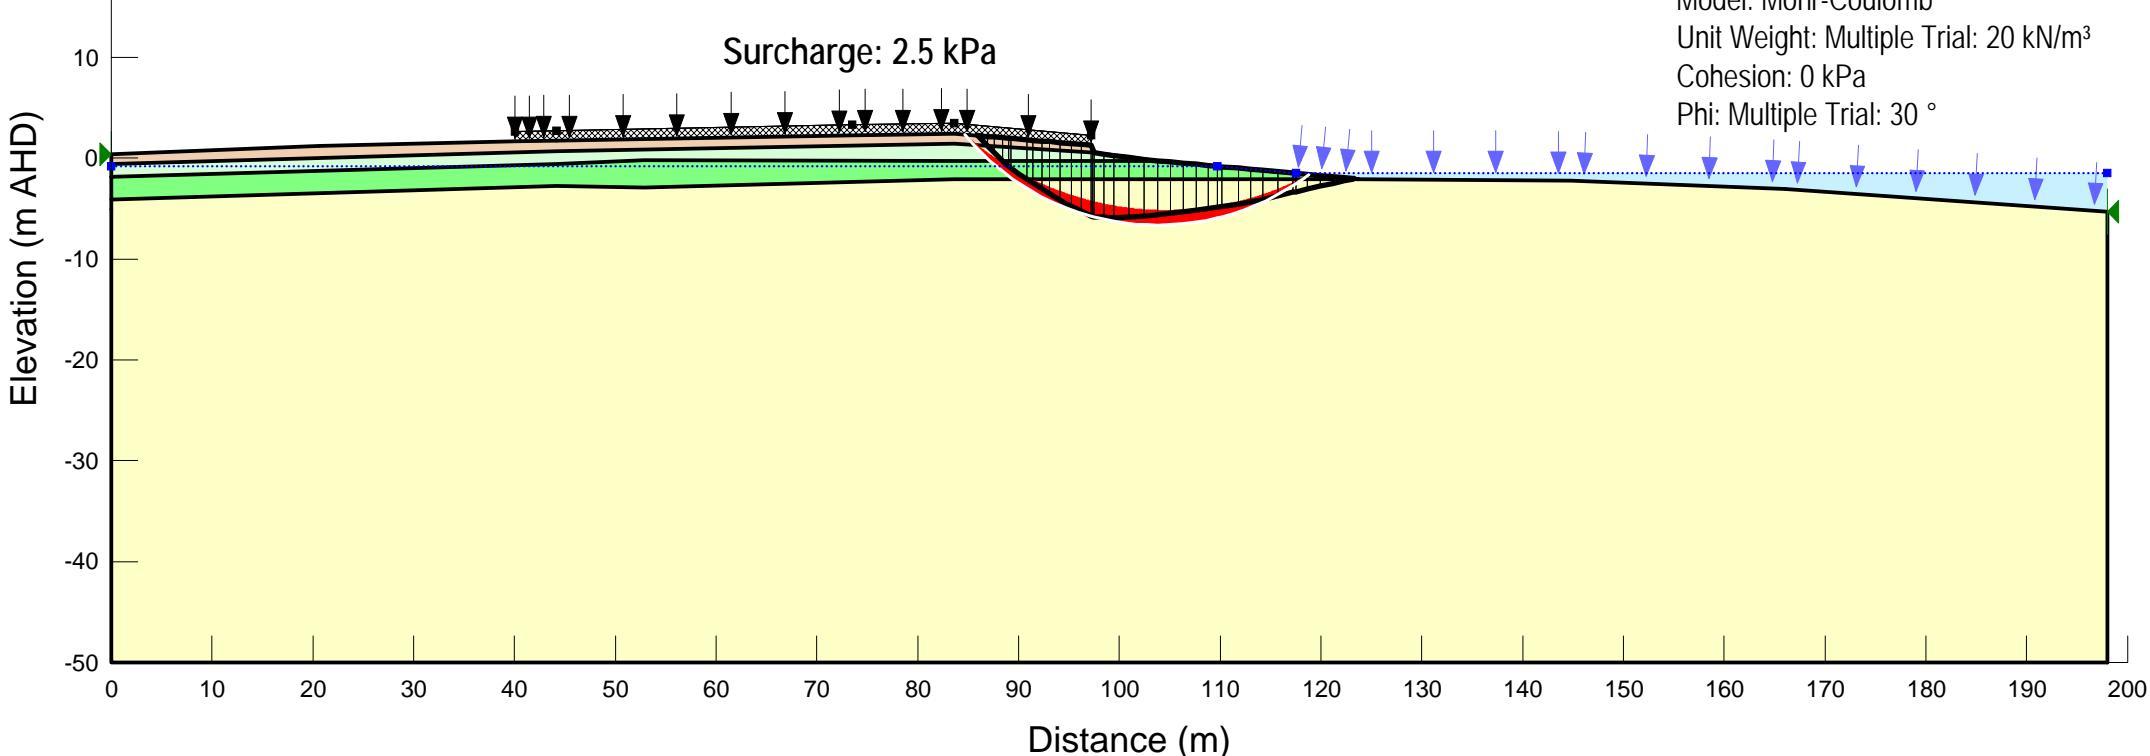
Assessment of the Existing Conditions River Water Level at -0.80m AHD Surcharge of the Properties and Cars Worst Case Sub-surface Profile

Factor of Safety = 1.67

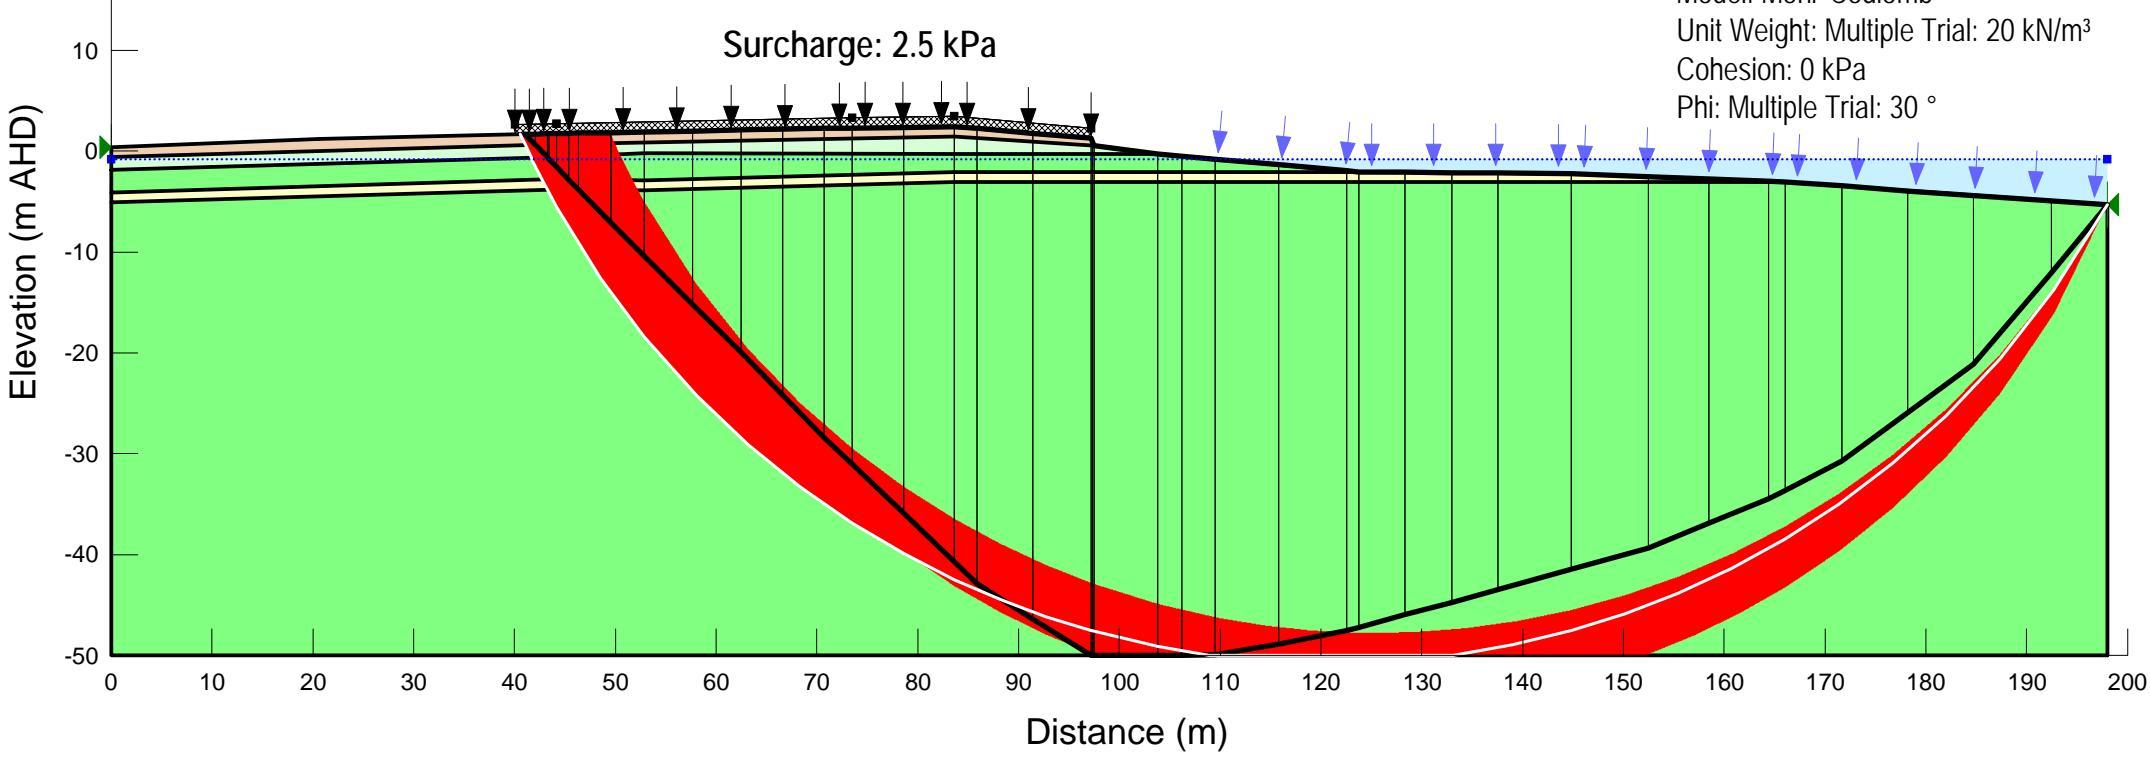
Assessment of the Existing Conditions River Water Level at -1.50m AHD Surcharge of the Properties and Cars Worst Case Sub-surface Profile

Factor of Safety = 1.54

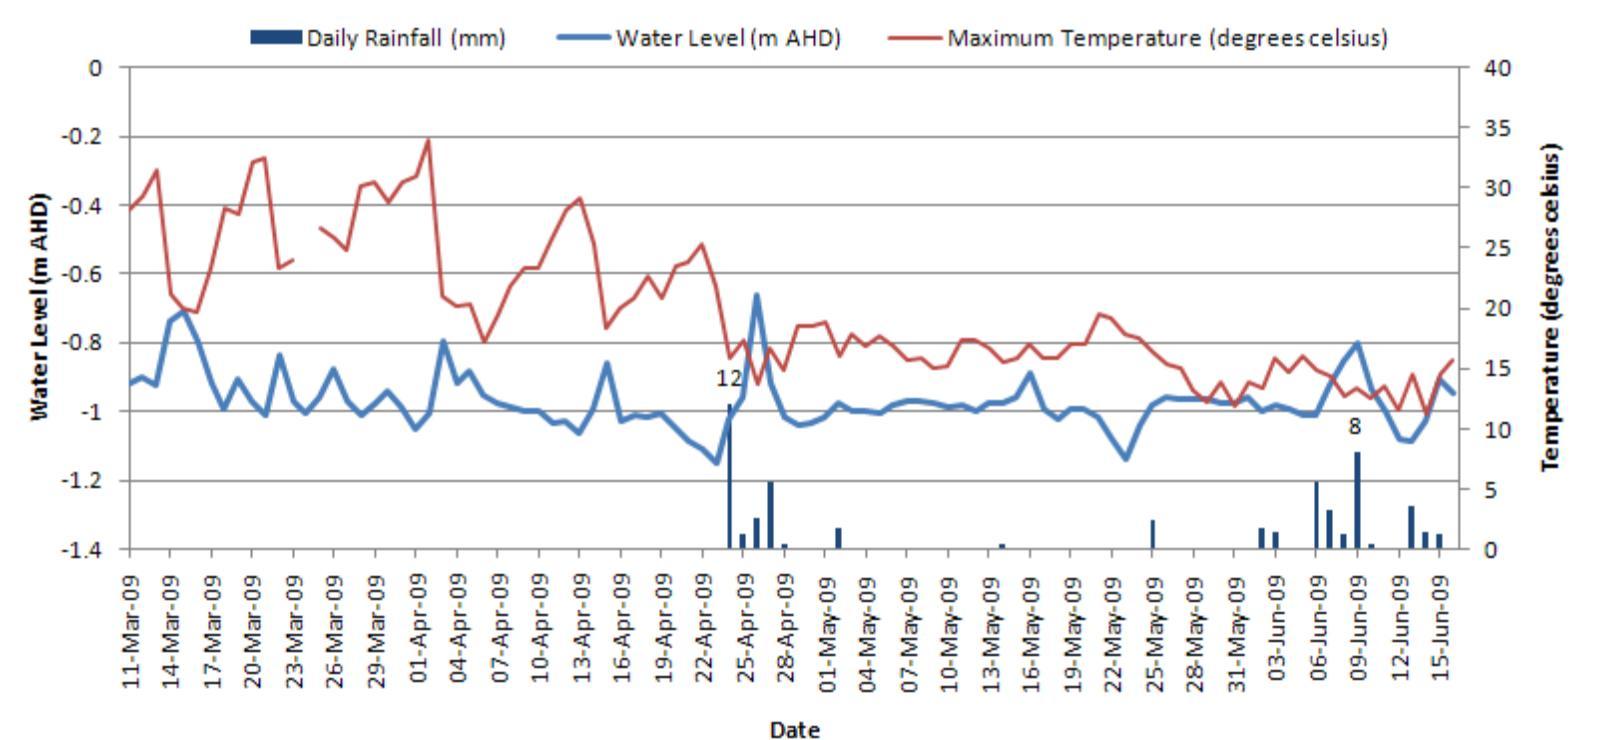
River Murray at Swan Reach (A4261164) – Daily water levels (m AHD) from 11 March to 16 June 2009. Maximum air temperature for region and daily rainfall recorded at Swan Reach are also shown.

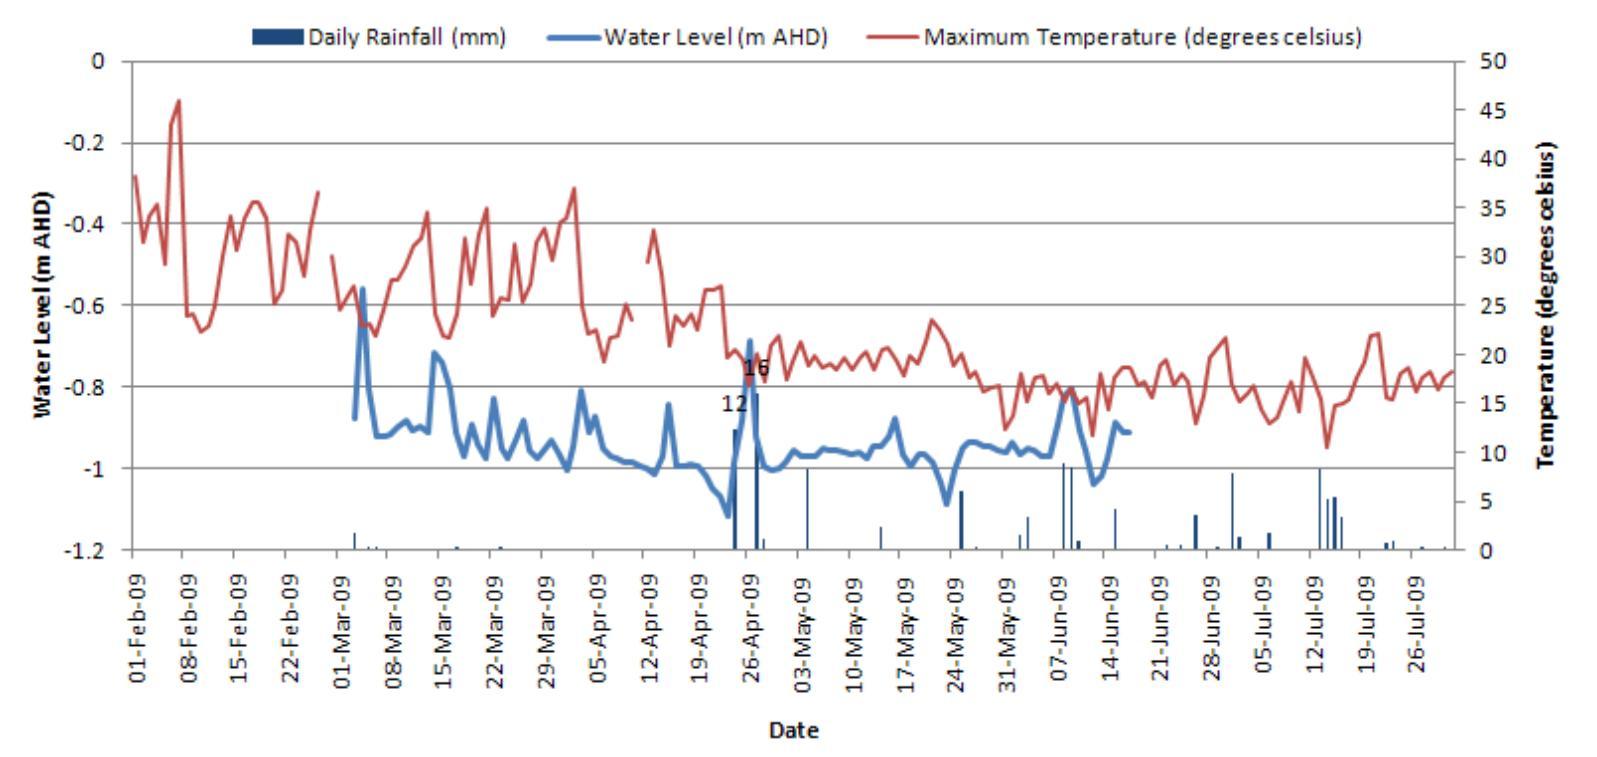
River Murray at Mannum (A4261161) – Daily water levels (m AHD) from 1 March to 28 April 2009. Maximum air temperature for region and daily rainfall recorded at Mannum are also shown.

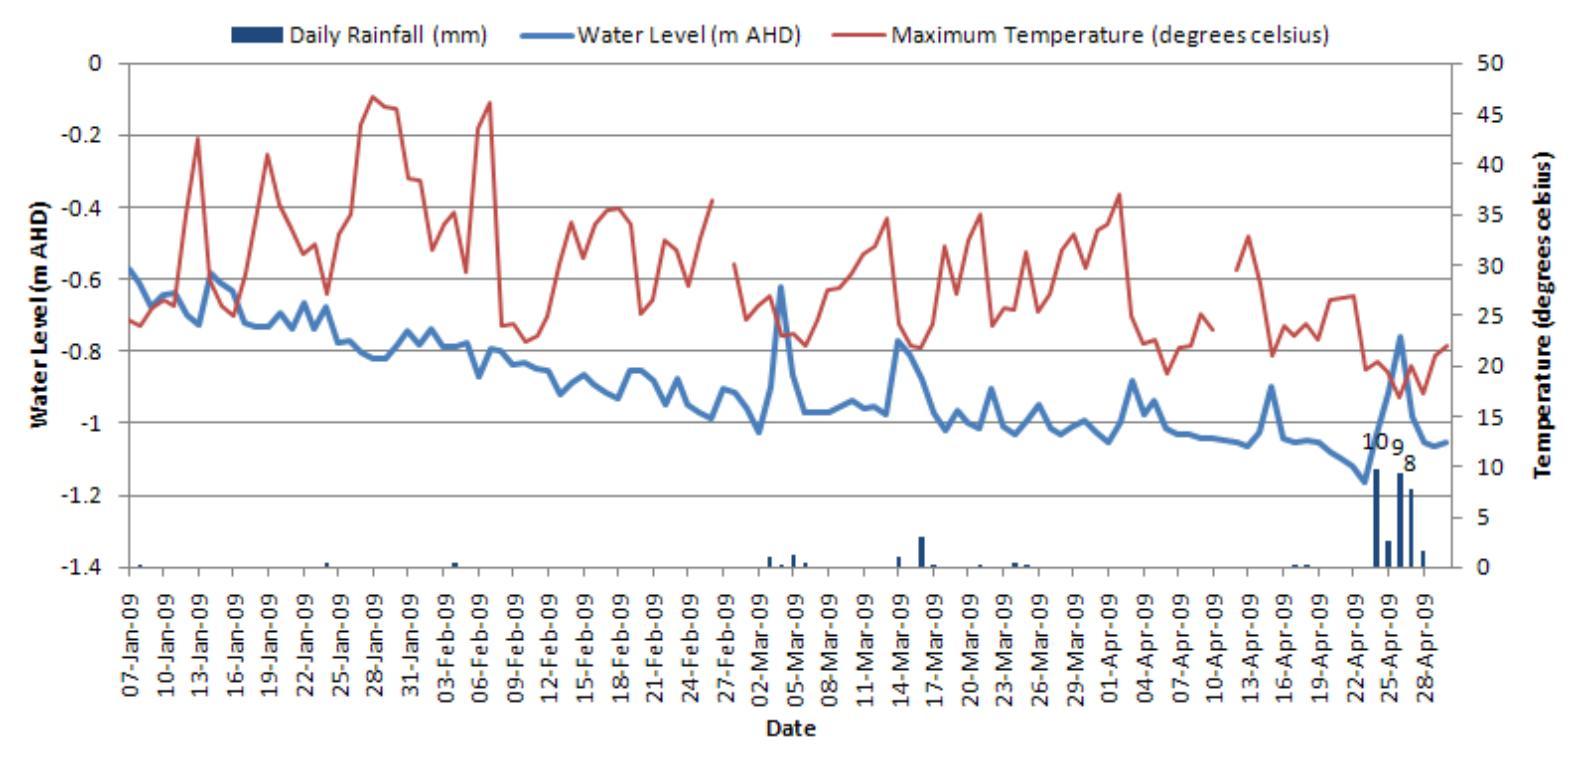
River Murray at Murray Bridge (A4261162) – Daily water levels (m AHD) from 7 January to 30 March 2009. Maximum air temperature for region and daily rainfall recorded at Murray Bridge are also shown.
