**REVIEW OF MANAGEMENT OPTIONS FOR FOUR
RIVER BANK COLLAPSE HIGH RISK SITES**

Department of Environment, Water and Natural
Resources

07093AA-AD Final report
12 December 2012

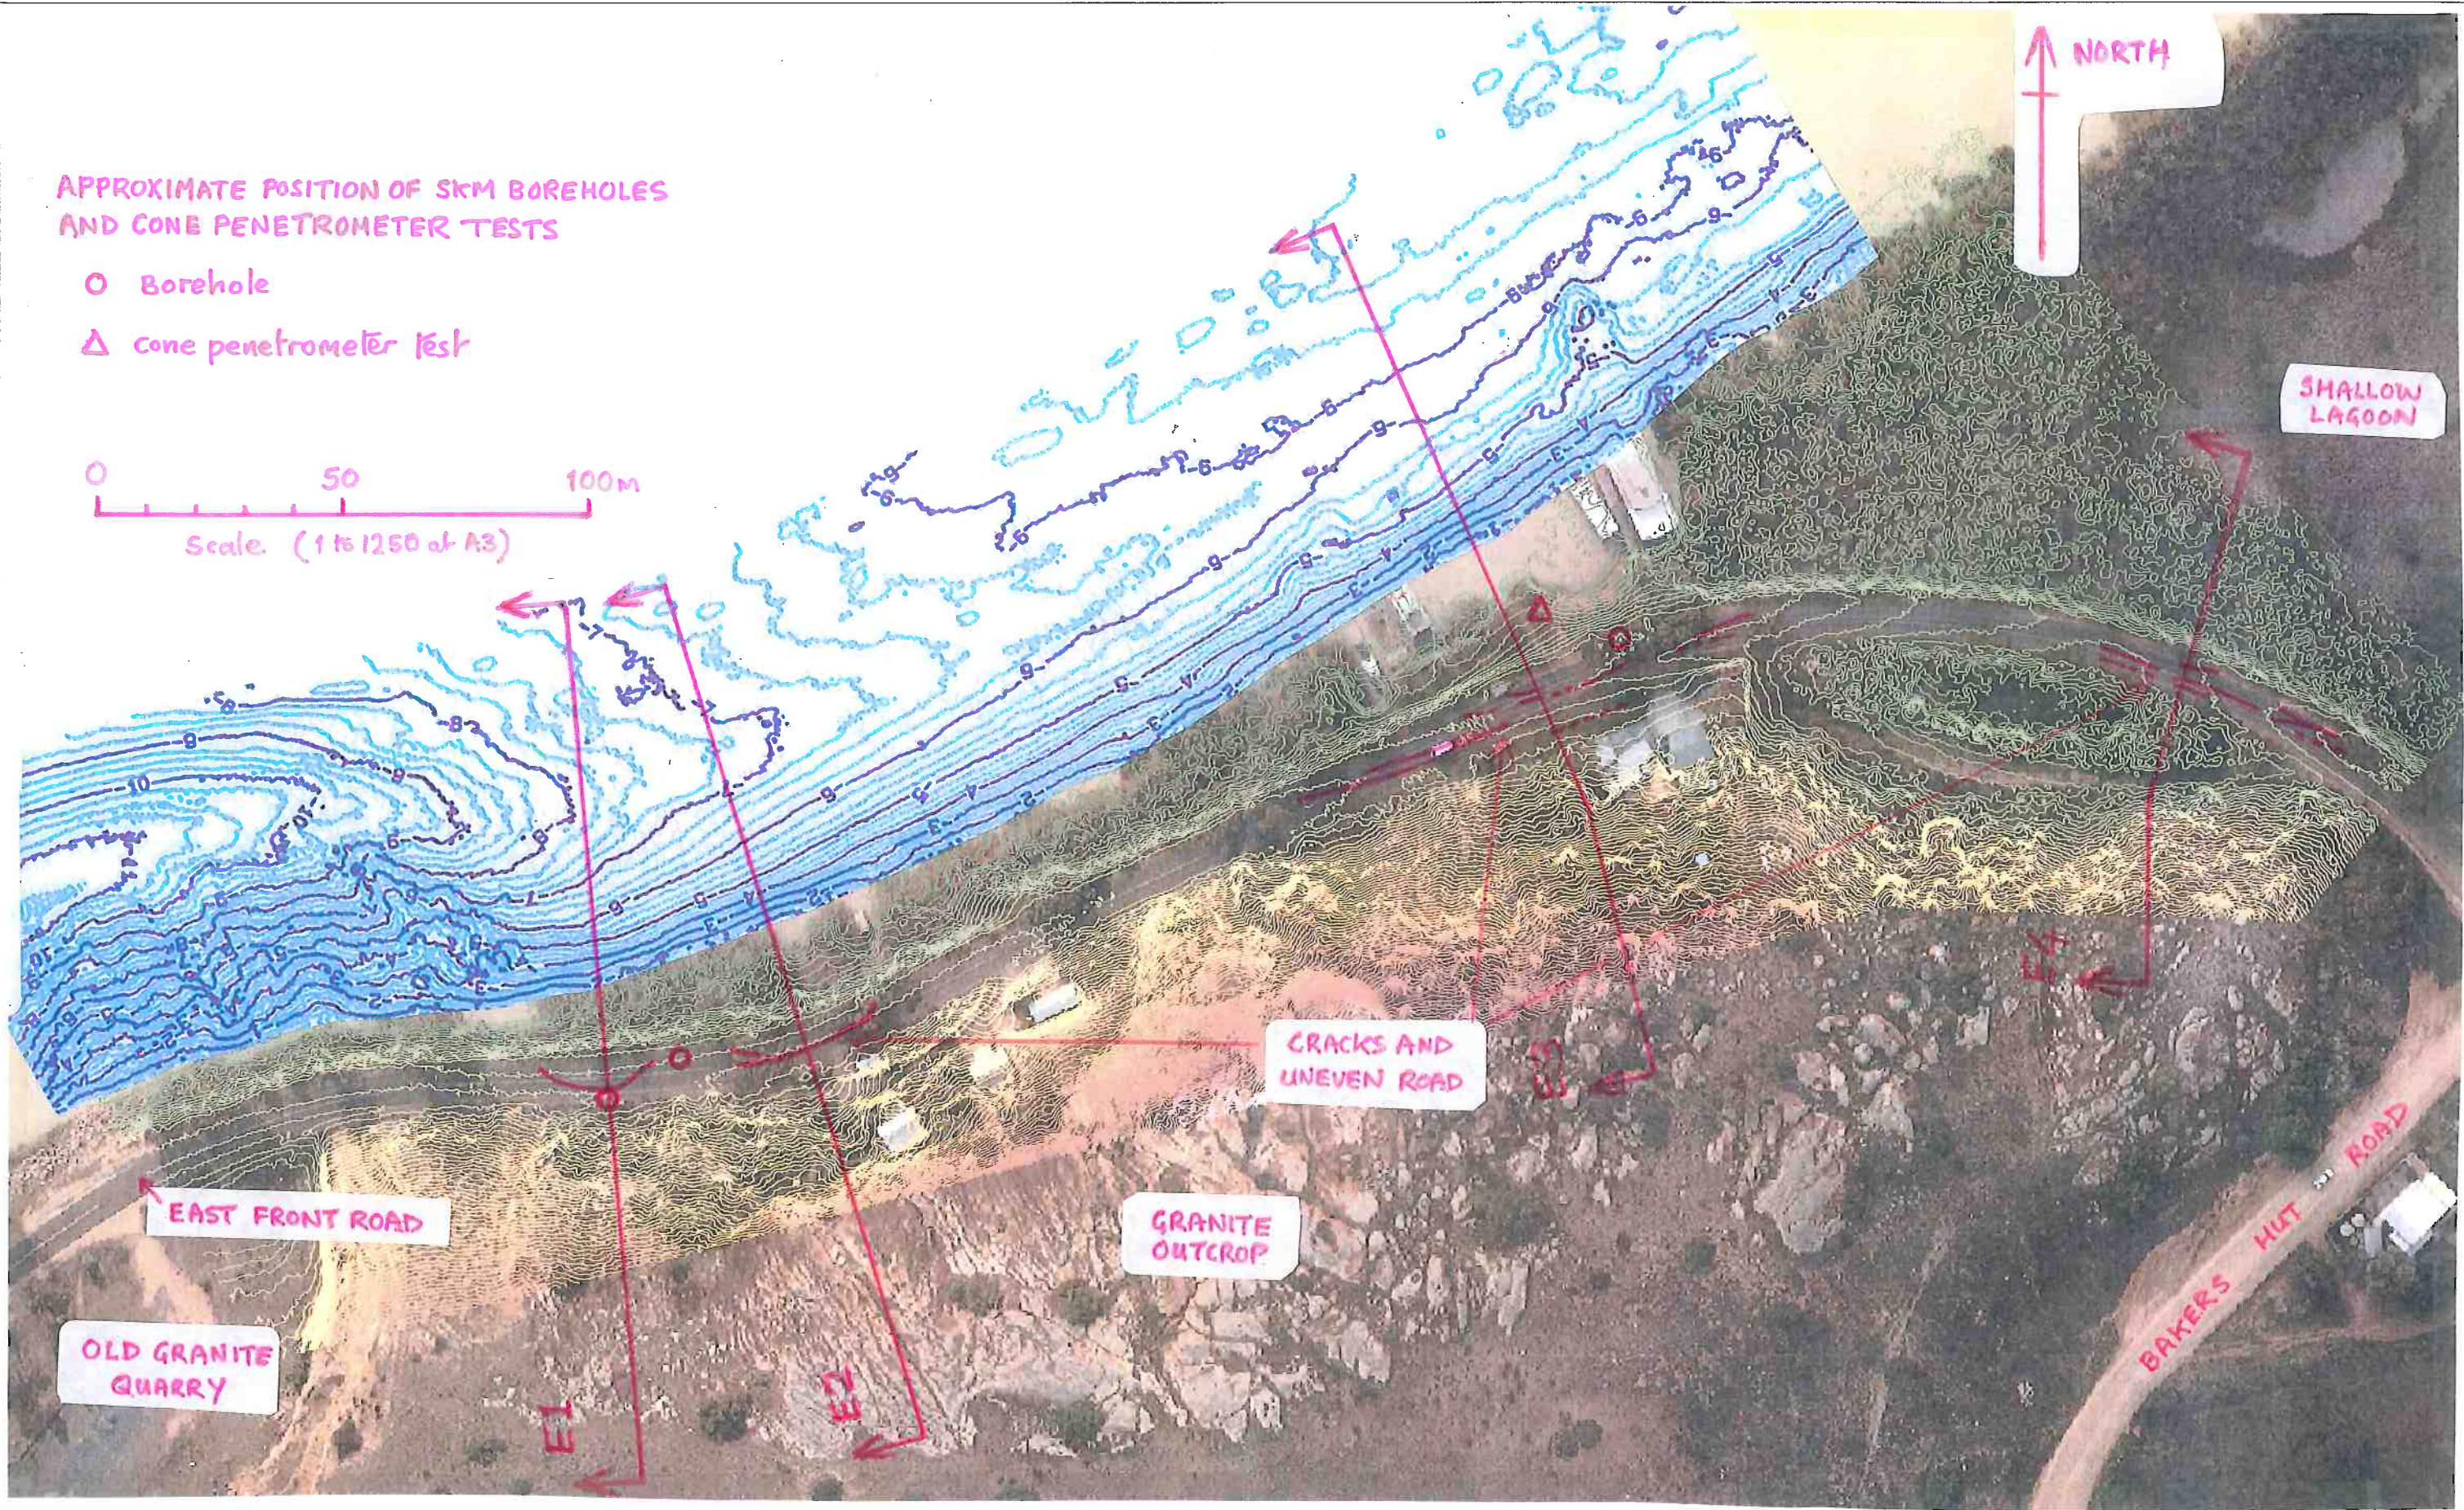
figure no: FIGURE 1

The first four sketches on Figure 1 summarise what has happened in the past 120,000 years (until European settlement). The bottom sketch summarises the present situation where the landscape has been modified by cut and fill and there is infrastructure close to the river. From the riverbank collapse point of view the most significant subsurface material is the Soft Clay which underlies the banks of the river. As discussed in Section 3.1 and Appendix C, most if not all of the riverbank collapses in the past few years have been because the Soft Clay next to the river has failed (given way).

The left hand side of the bottom sketch on Figure 1 shows the typical distribution of subsurface materials near the sides of the river valley. In this situation the Soft Clay overlies stiffer soil (in places) and a sloping surface of rock. Overlying the wedge of Soft Clay there may be some younger slope deposits (Holocene Colluvium) and Fill. Three of the four sites reviewed in this study (East Front Road near Mannum, Caloote Southern Residential Area and Woodlane Reserve) are near the valley sides and have subsurface conditions broadly similar to those shown on the sketch.

The right hand side of the bottom sketch on Figure 1 shows the typical subsurface conditions away from the sloping sides of the river valley. In this situation the rock is deeper and the Soft Clay is much thicker. The subsurface conditions at the fourth site reviewed in this study (River Front Road, Murray Bridge) are broadly similar to this part of the sketch.

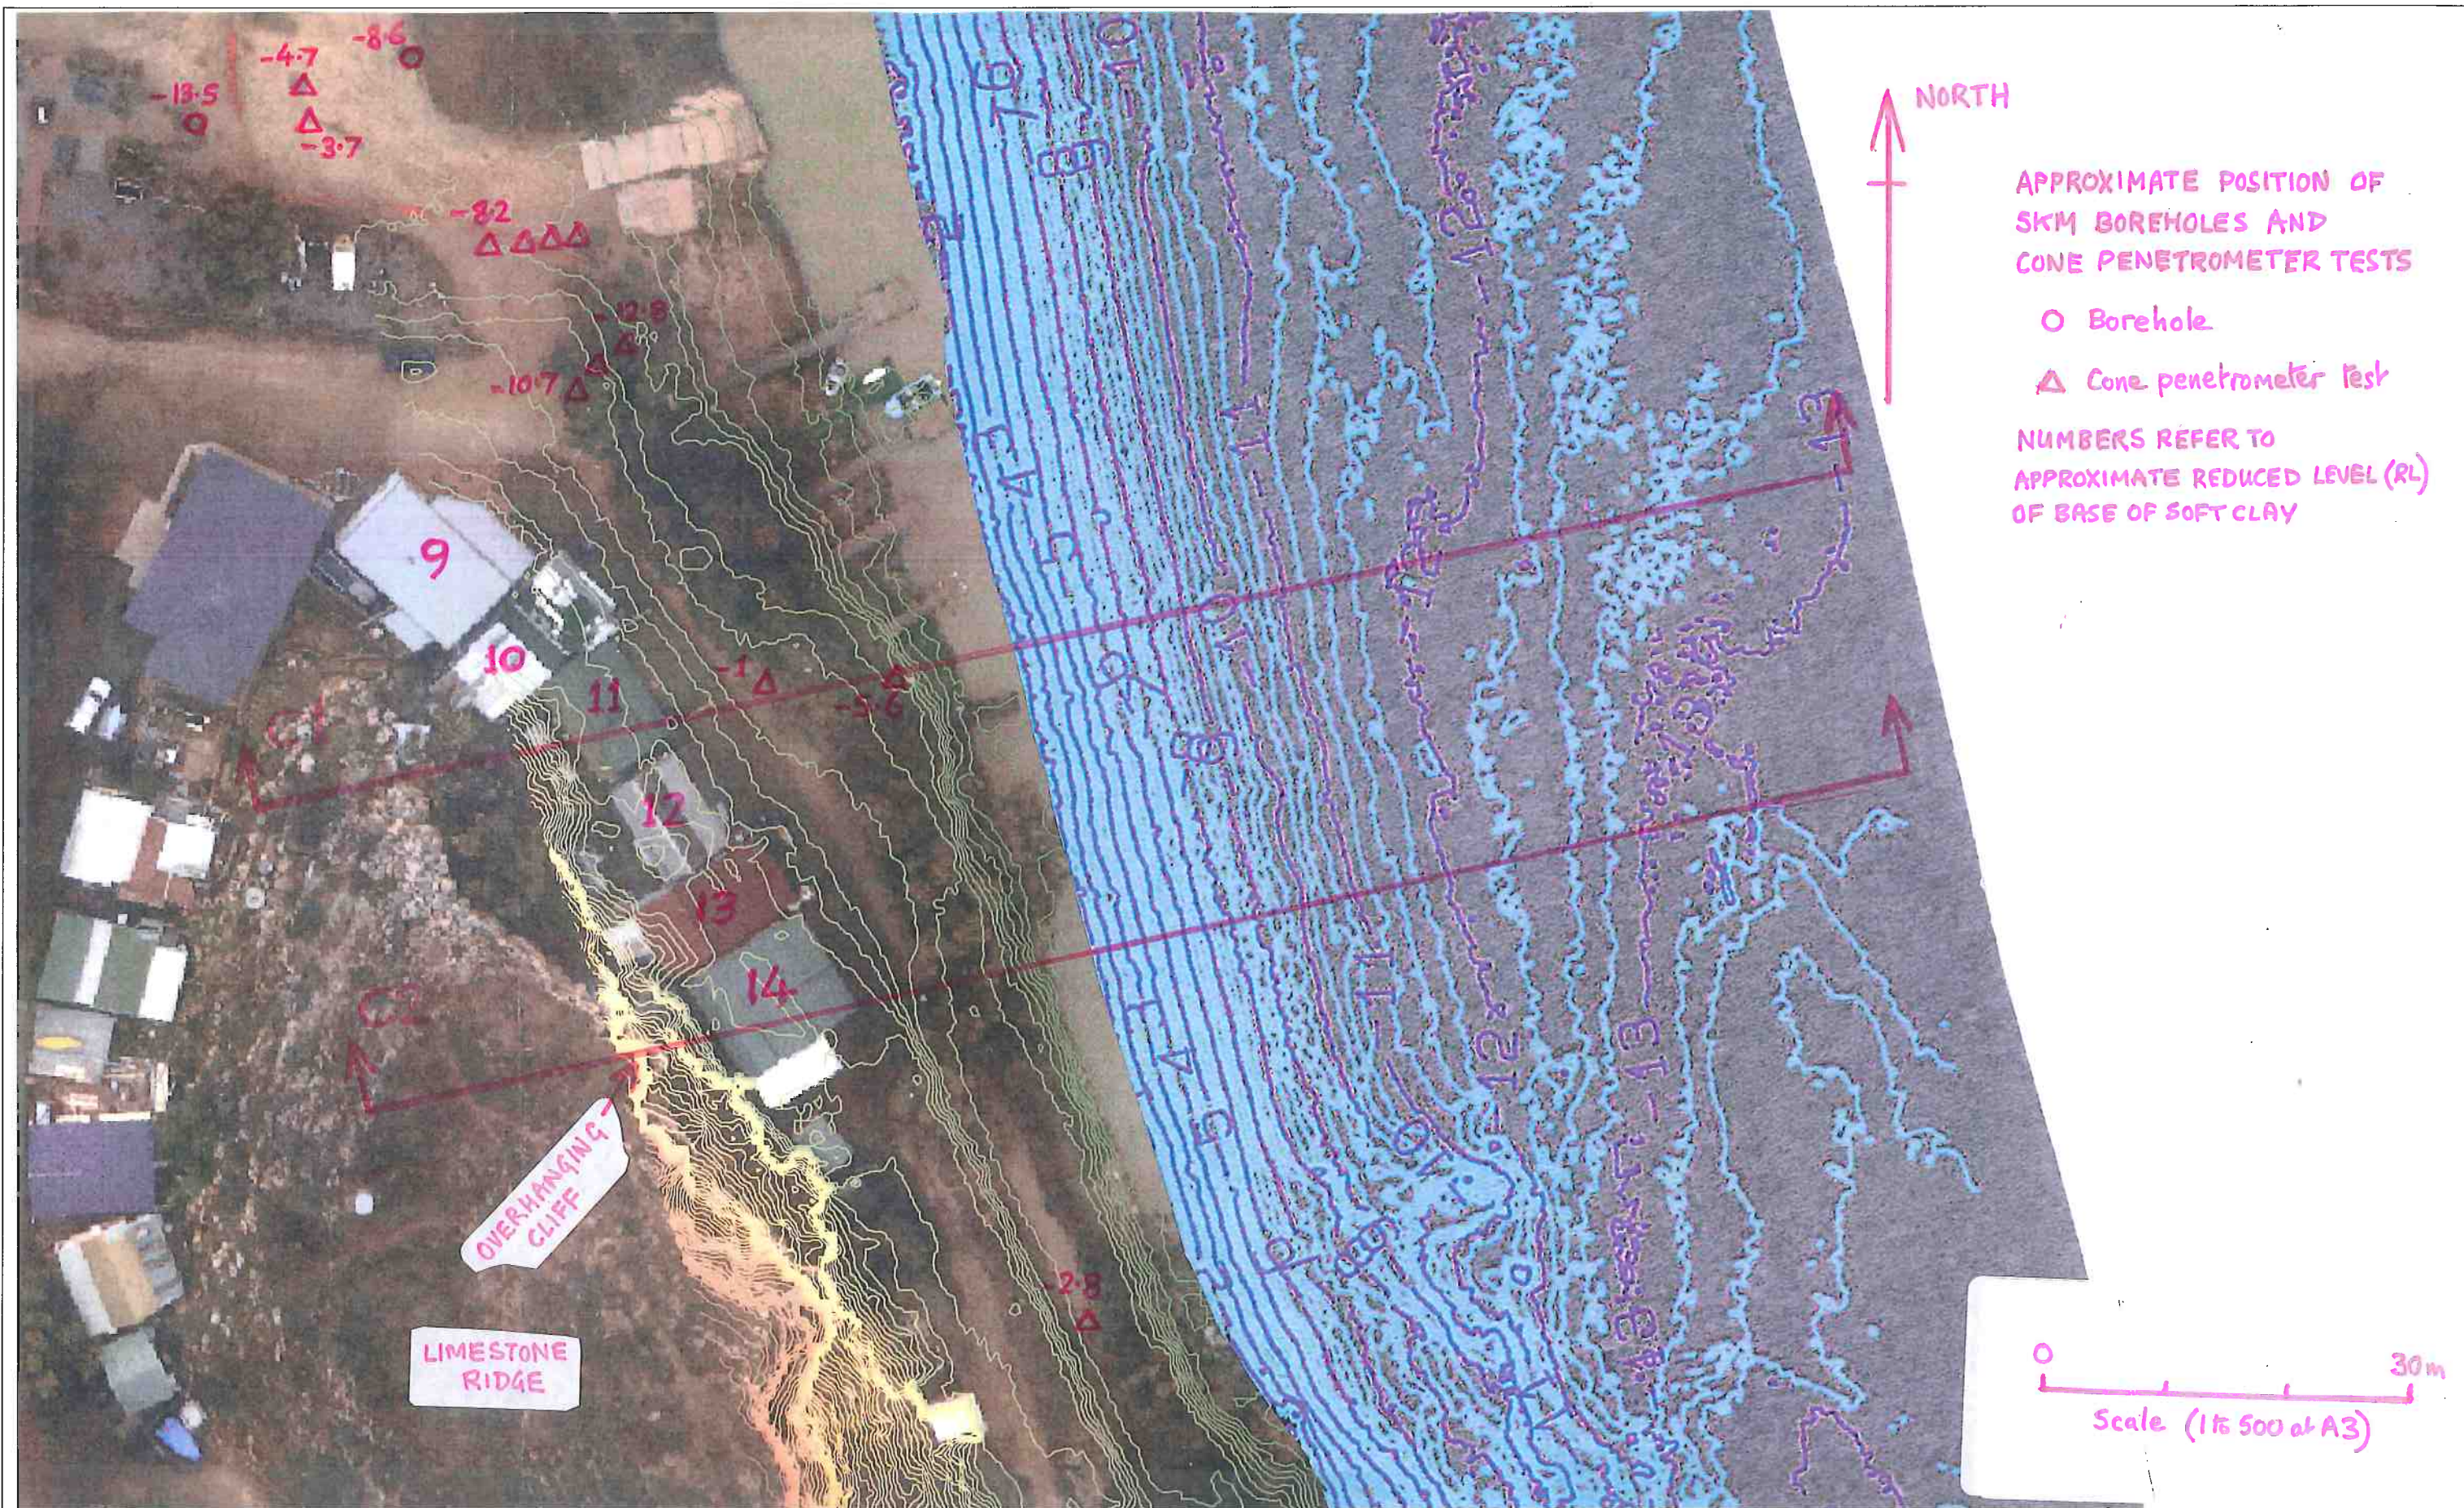
As shown on Section E3 (Figure 3) there is a wedge of Soft Clay below the road. The wedge of Soft Clay is overlain by Fill. In places there may also be some Holocene Colluvium overlying the Soft Clay as shown on the diagrammatic sketches on Figure 1.

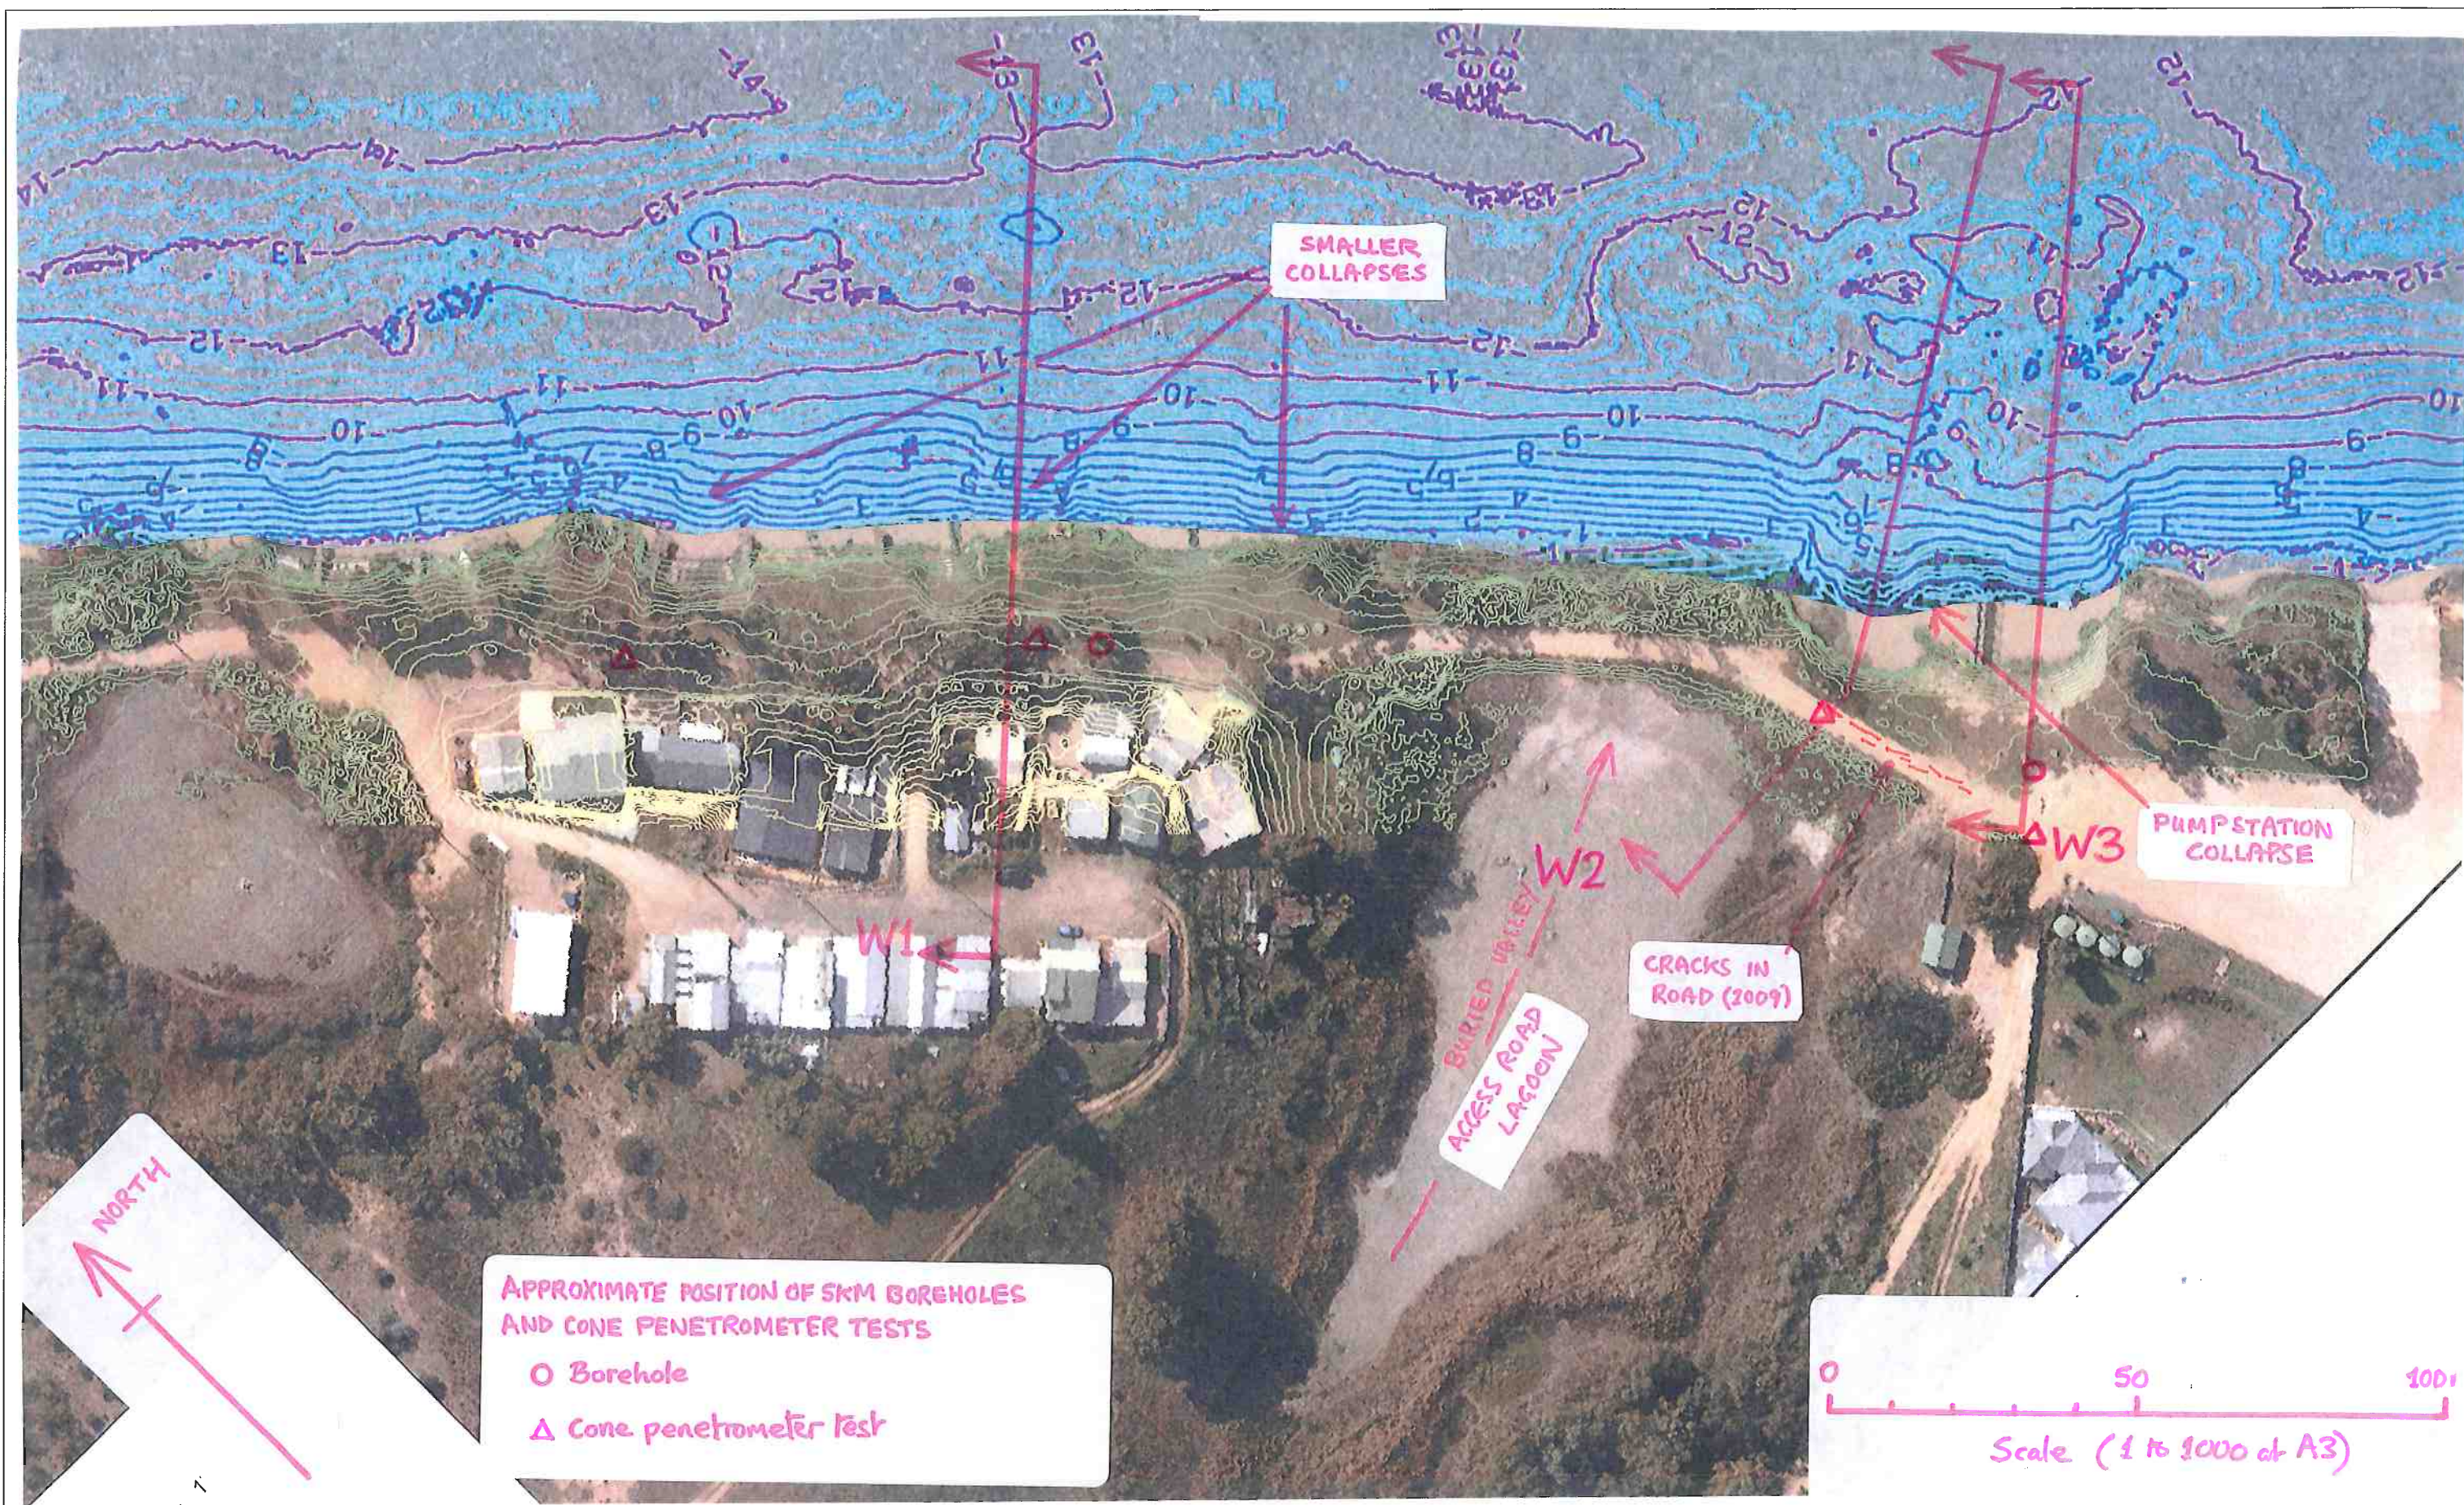
As shown on Section C1 (Figure 5) there is a wedge of Soft Clay below the river bank. In places the Soft Clay is overlain by Holocene Colluvium and Fill (as shown on the diagrammatic sketches on Figure 1). The Soft Clay may have extended inland on Section C1 as far as the verandah of No. 11 (house). Above about RL 0 m the Soft Clay is probably desiccated and therefore has a higher undrained shear strength. The Soft Clay is likely to be underlain by Stiffer Soils and Limestone.

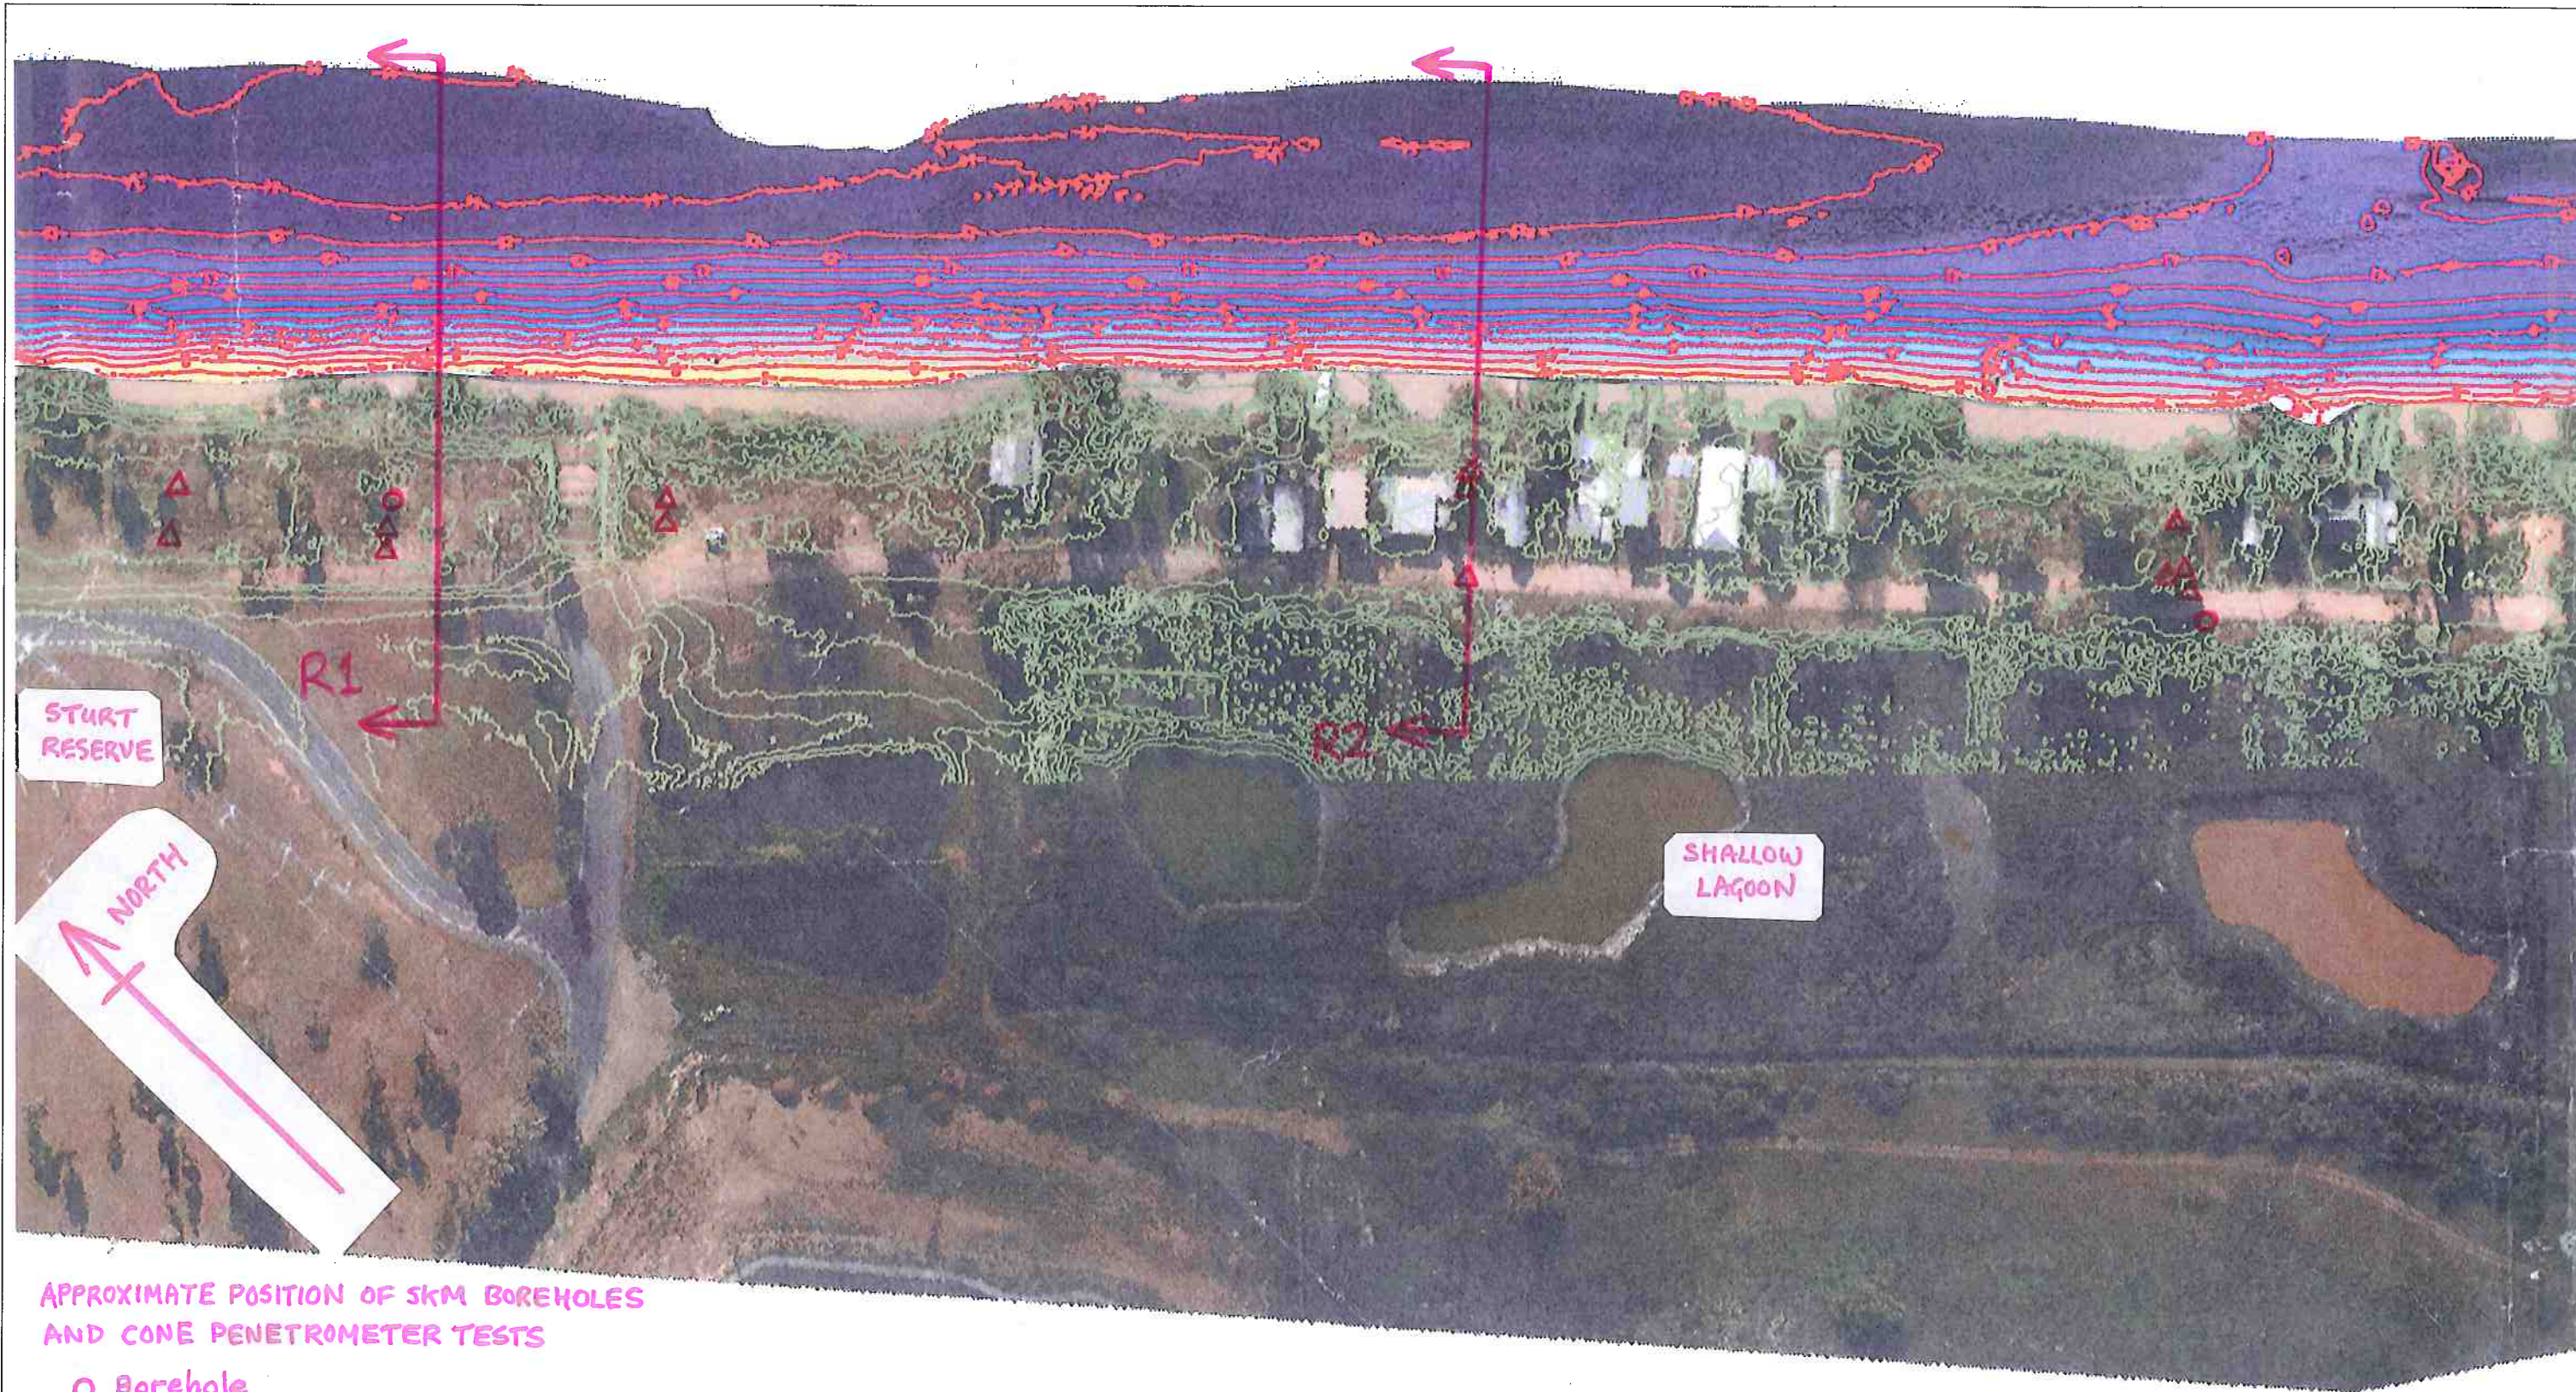
As shown on Section W1 (Figure 7) there is a wedge of Soft Clay below the river bank in the area in front of the houses. On the riverbank the Soft Clay is overlain by Holocene Colluvium and Fill (as shown on the diagrammatic sketches on Figure 1). The Soft Clay is underlain by Stiffer Soil (including older alluvium) and limestone which can be observed in cuttings near the houses.

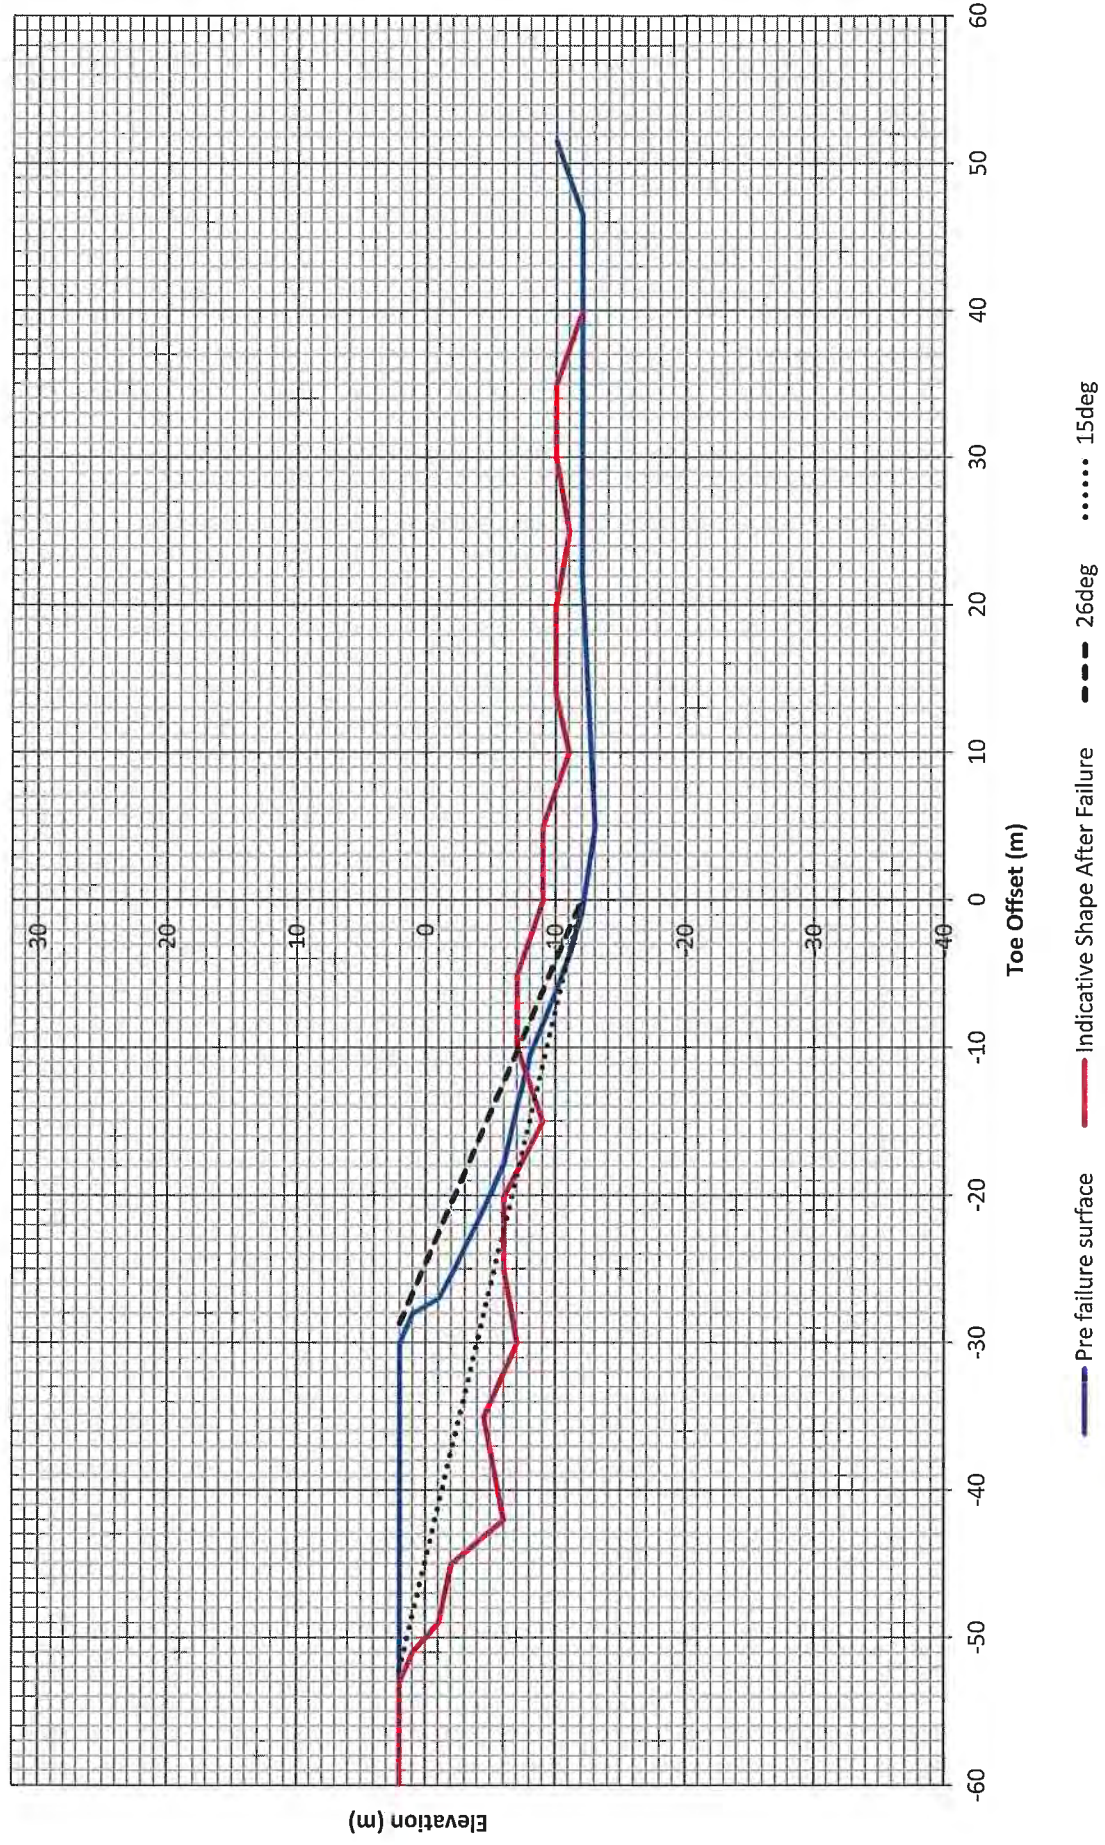
1. Long Island Marina, Upstream

The Long Island Marina slope pre-failure profiles (Nos. 1 and 2 in Appendix B) are from the late February 2009 bathymetry. The upstream profile (No. 1) is located about 10 m upstream of the large February 2009 failures through a section of riverbank that subsequently failed. The downstream pre-failure profile (No. 2) is located about 10 m downstream of the large February 2009 failures. The post failure profiles shown are based on the approximate shape of the nearby slope failure. They are indicative only, but do show how the failed mass broke up and spread into the river.

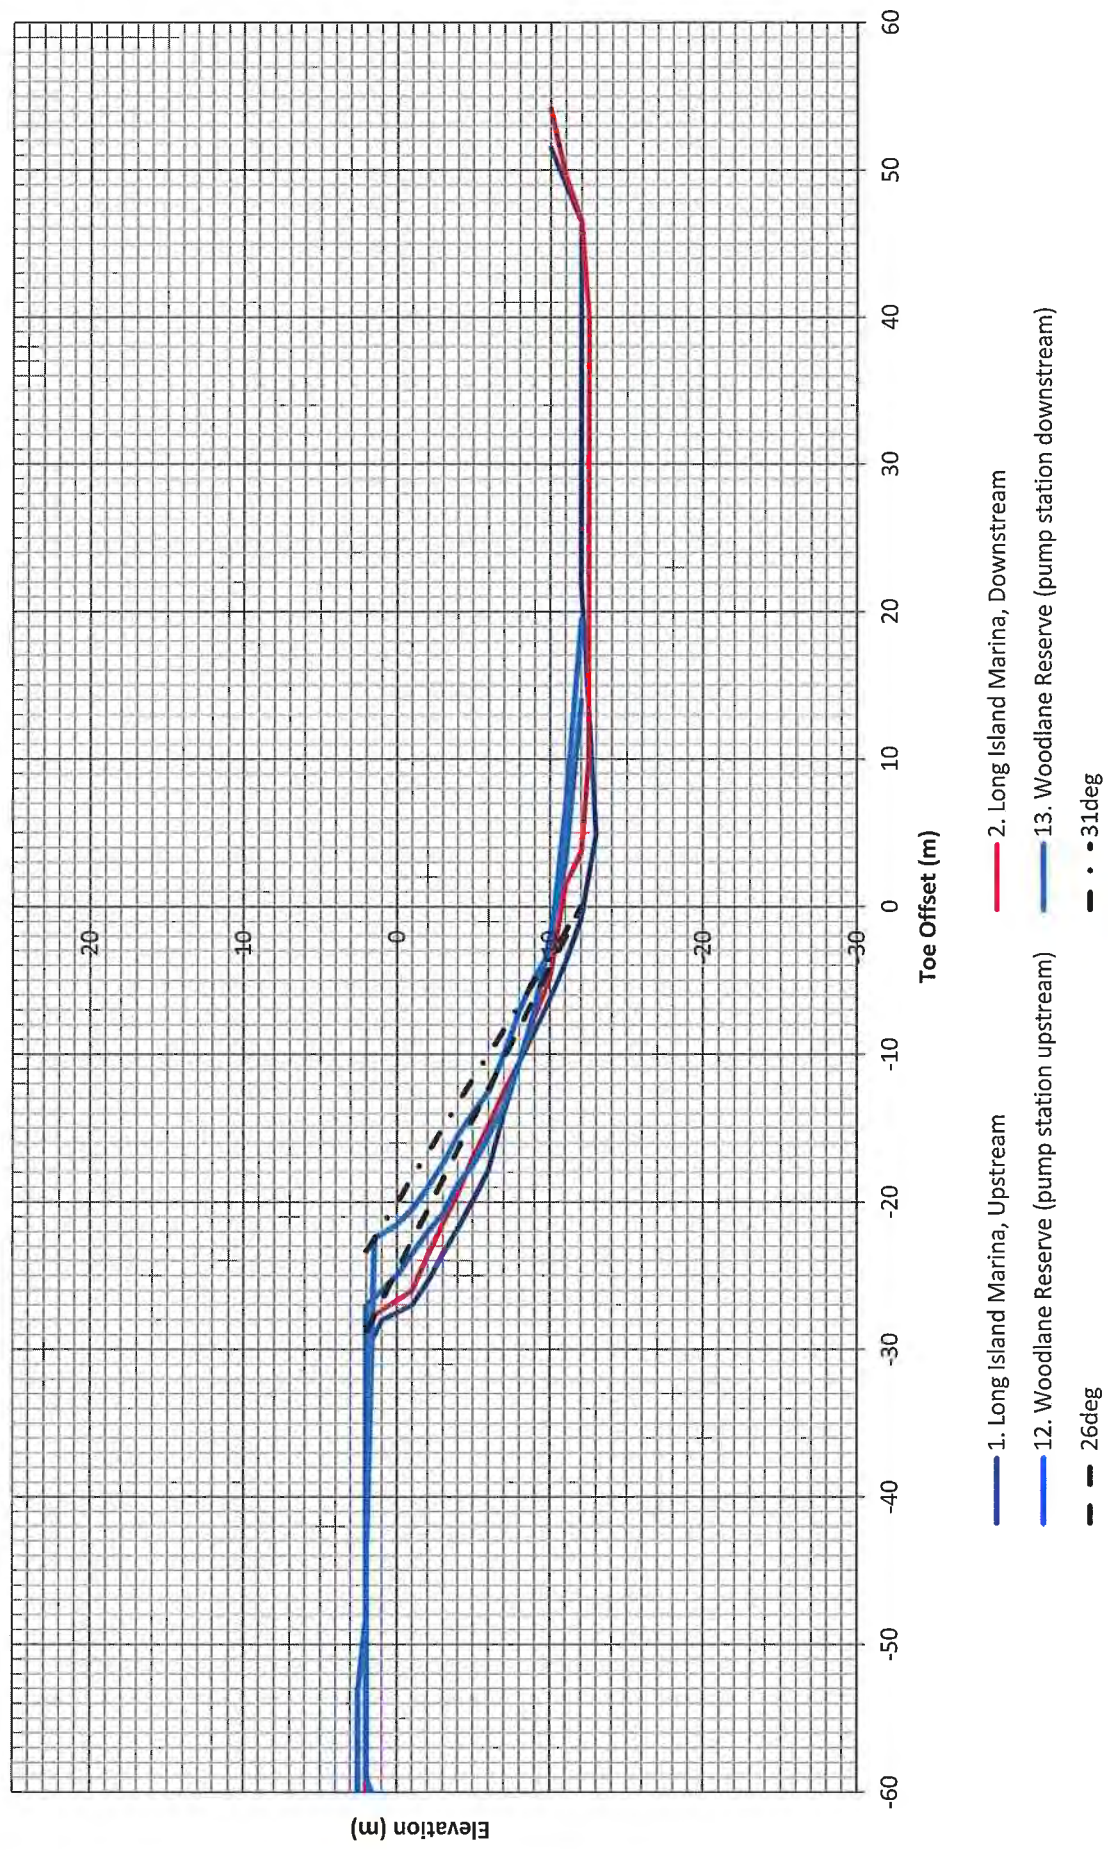
22. Pre- Failure of Type A Failures overlaid

6. The pre-failure and post-failure geometry of slope profiles 1, 2, 12 and 13 have been overlaid on single plots on profiles 22 and 23 (as discussed in Section C2 in Appendix C). These are Type A failures as discussed in Section 3.1.

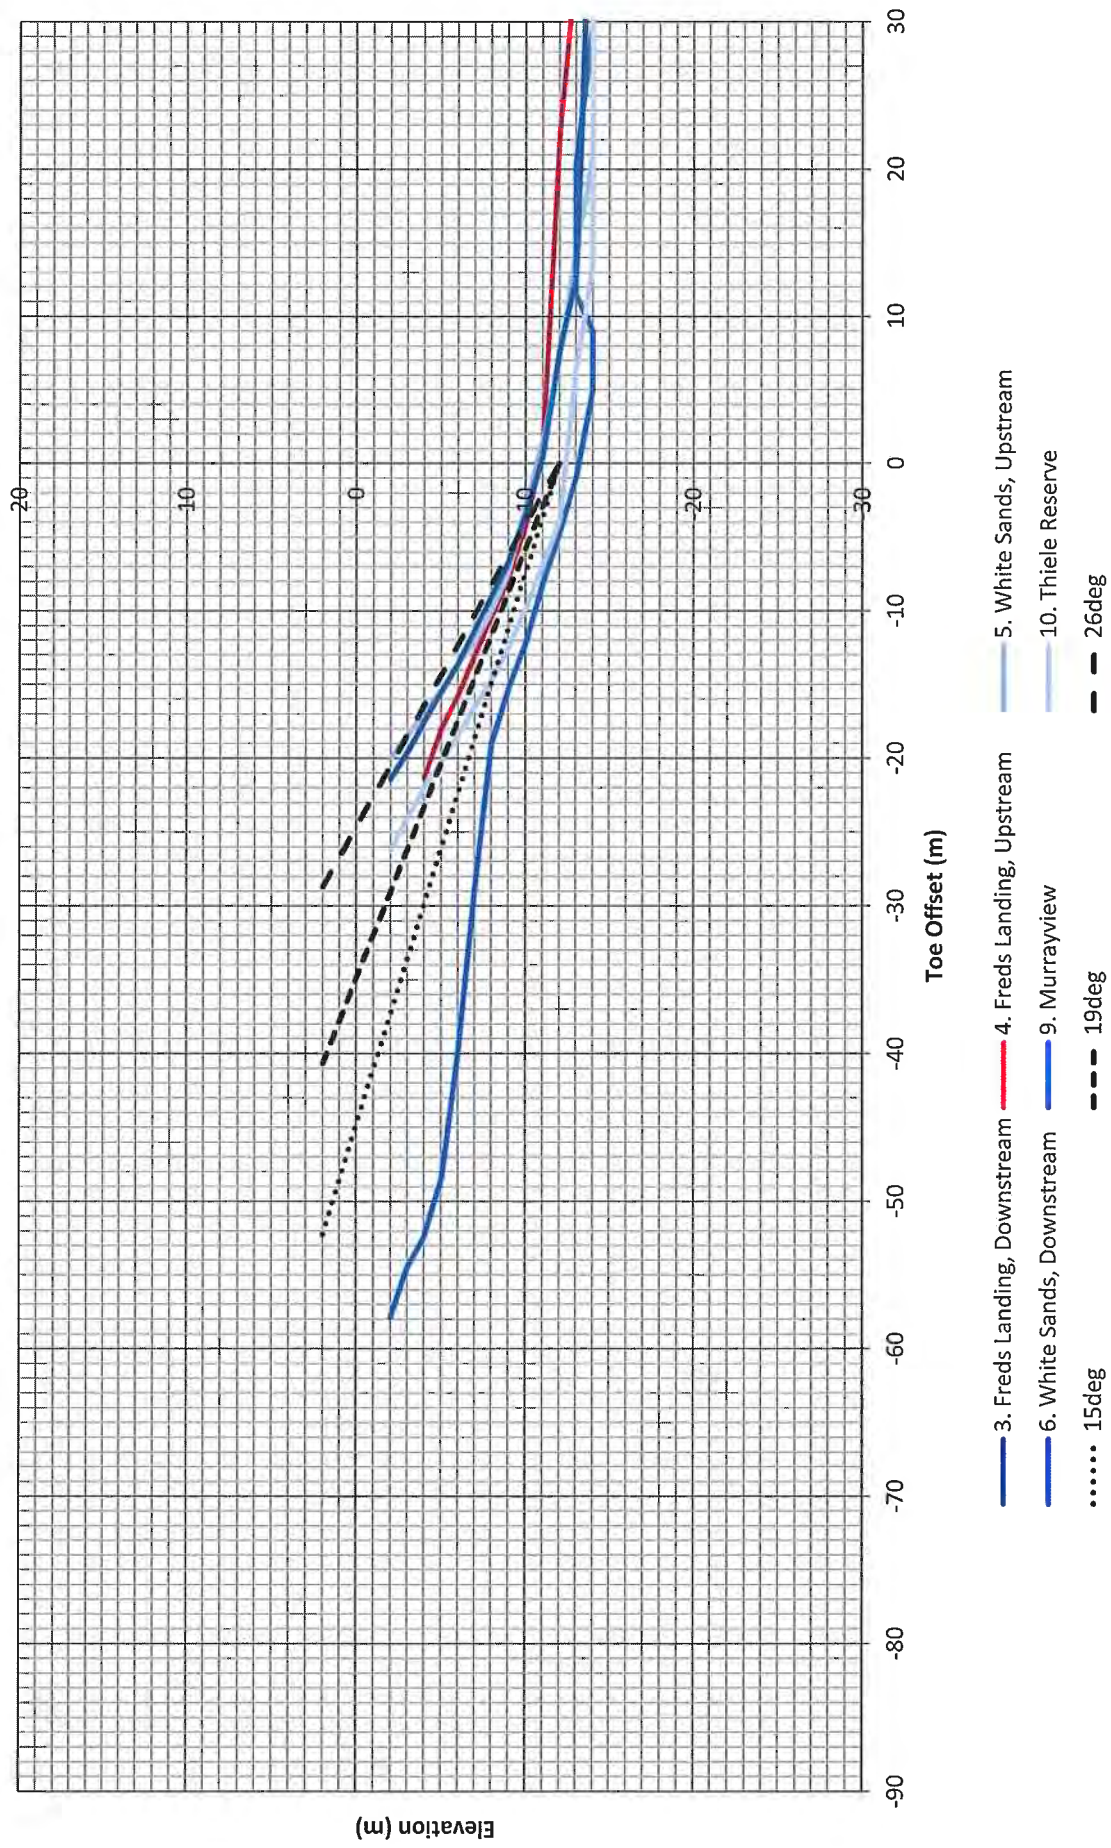
24. Pre- Failure of Type B Failures overlaid

7. The pre-failure and post-failure geometry of slope profiles 3 to 6, 9 and 10 have been overlaid on single plots on profiles 24 and 25. These are Type B failures as discussed in Section 3.1 and in Section B2 of this appendix.
