**REVIEW OF MANAGEMENT OPTIONS FOR FOUR
RIVER BANK COLLAPSE HIGH RISK SITES**

Department of Environment, Water and Natural
Resources

07093AA-AD Final report
12 December 2012

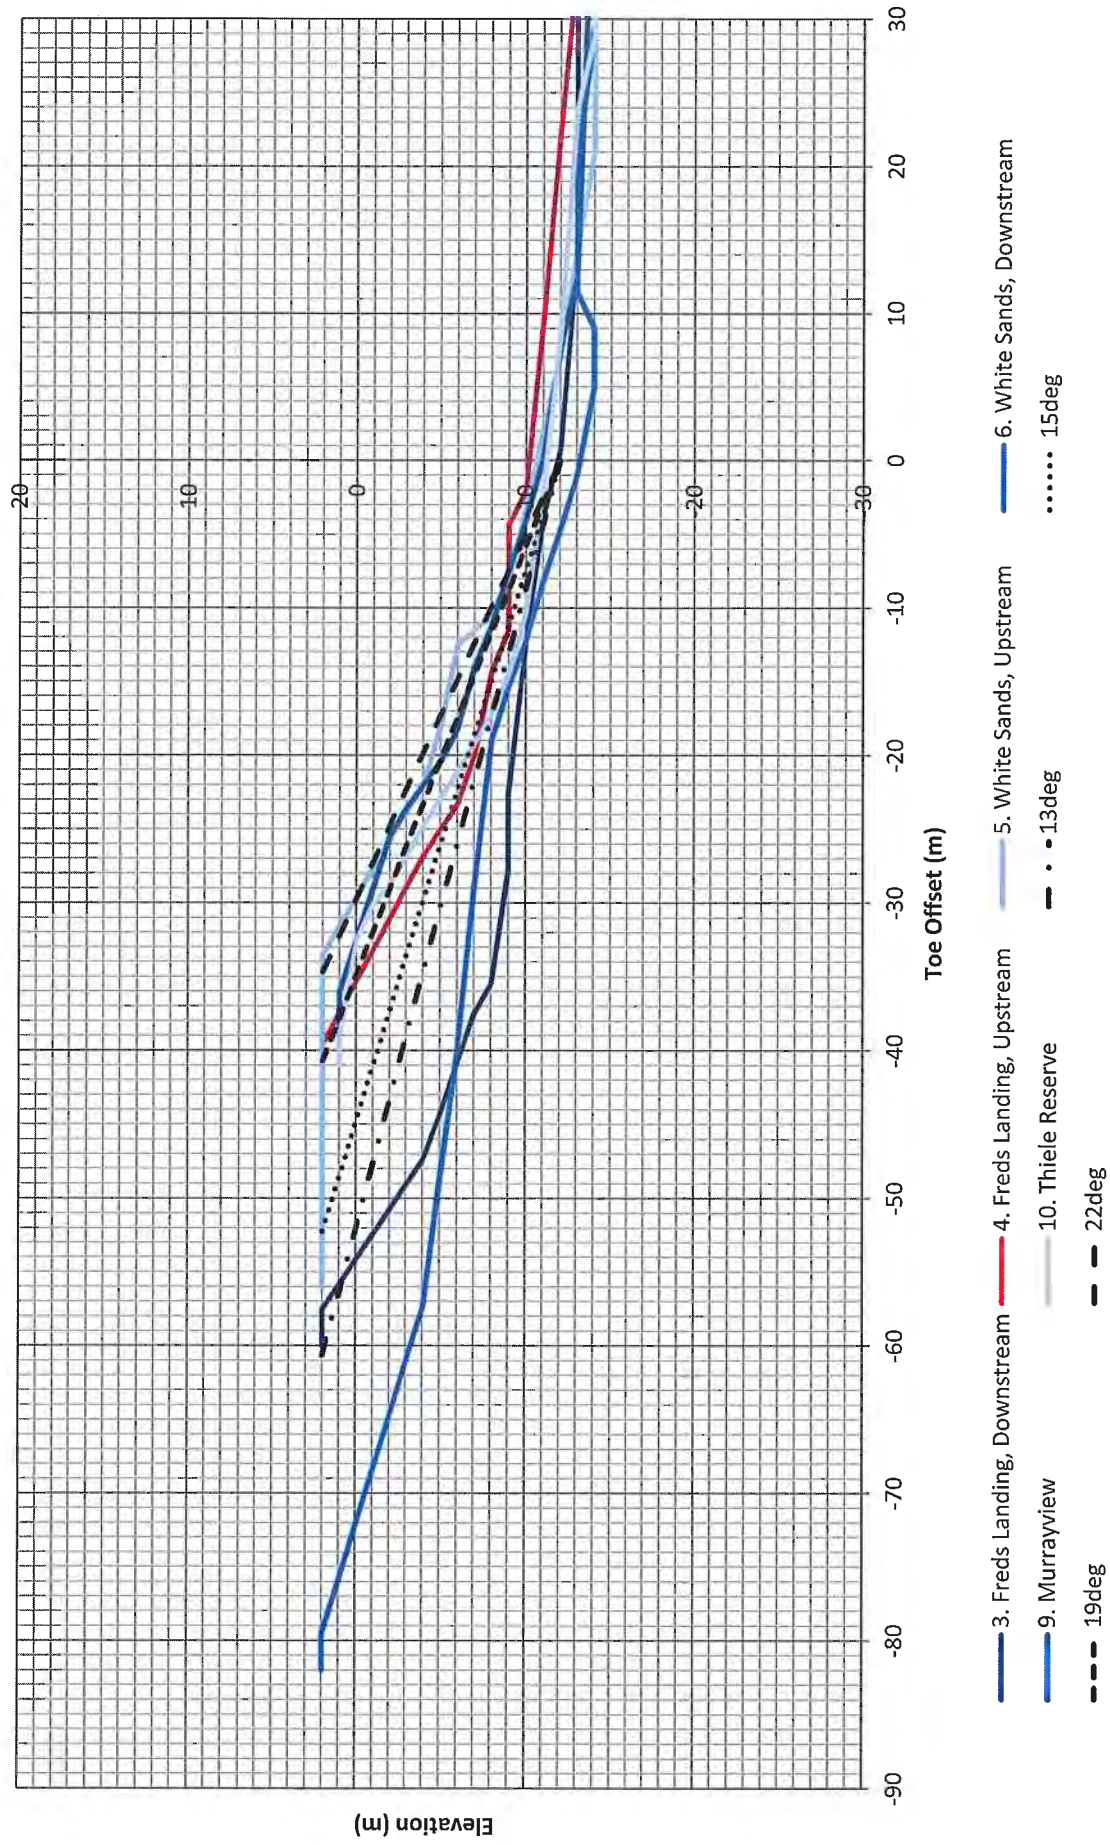
25. Post-Failure of Type B Failures overlaid

7. The pre-failure and post-failure geometry of slope profiles 3 to 6, 9 and 10 have been overlaid on single plots on profiles 24 and 25. These are Type B failures as discussed in Section 3.1 and in Section B2 of this appendix.

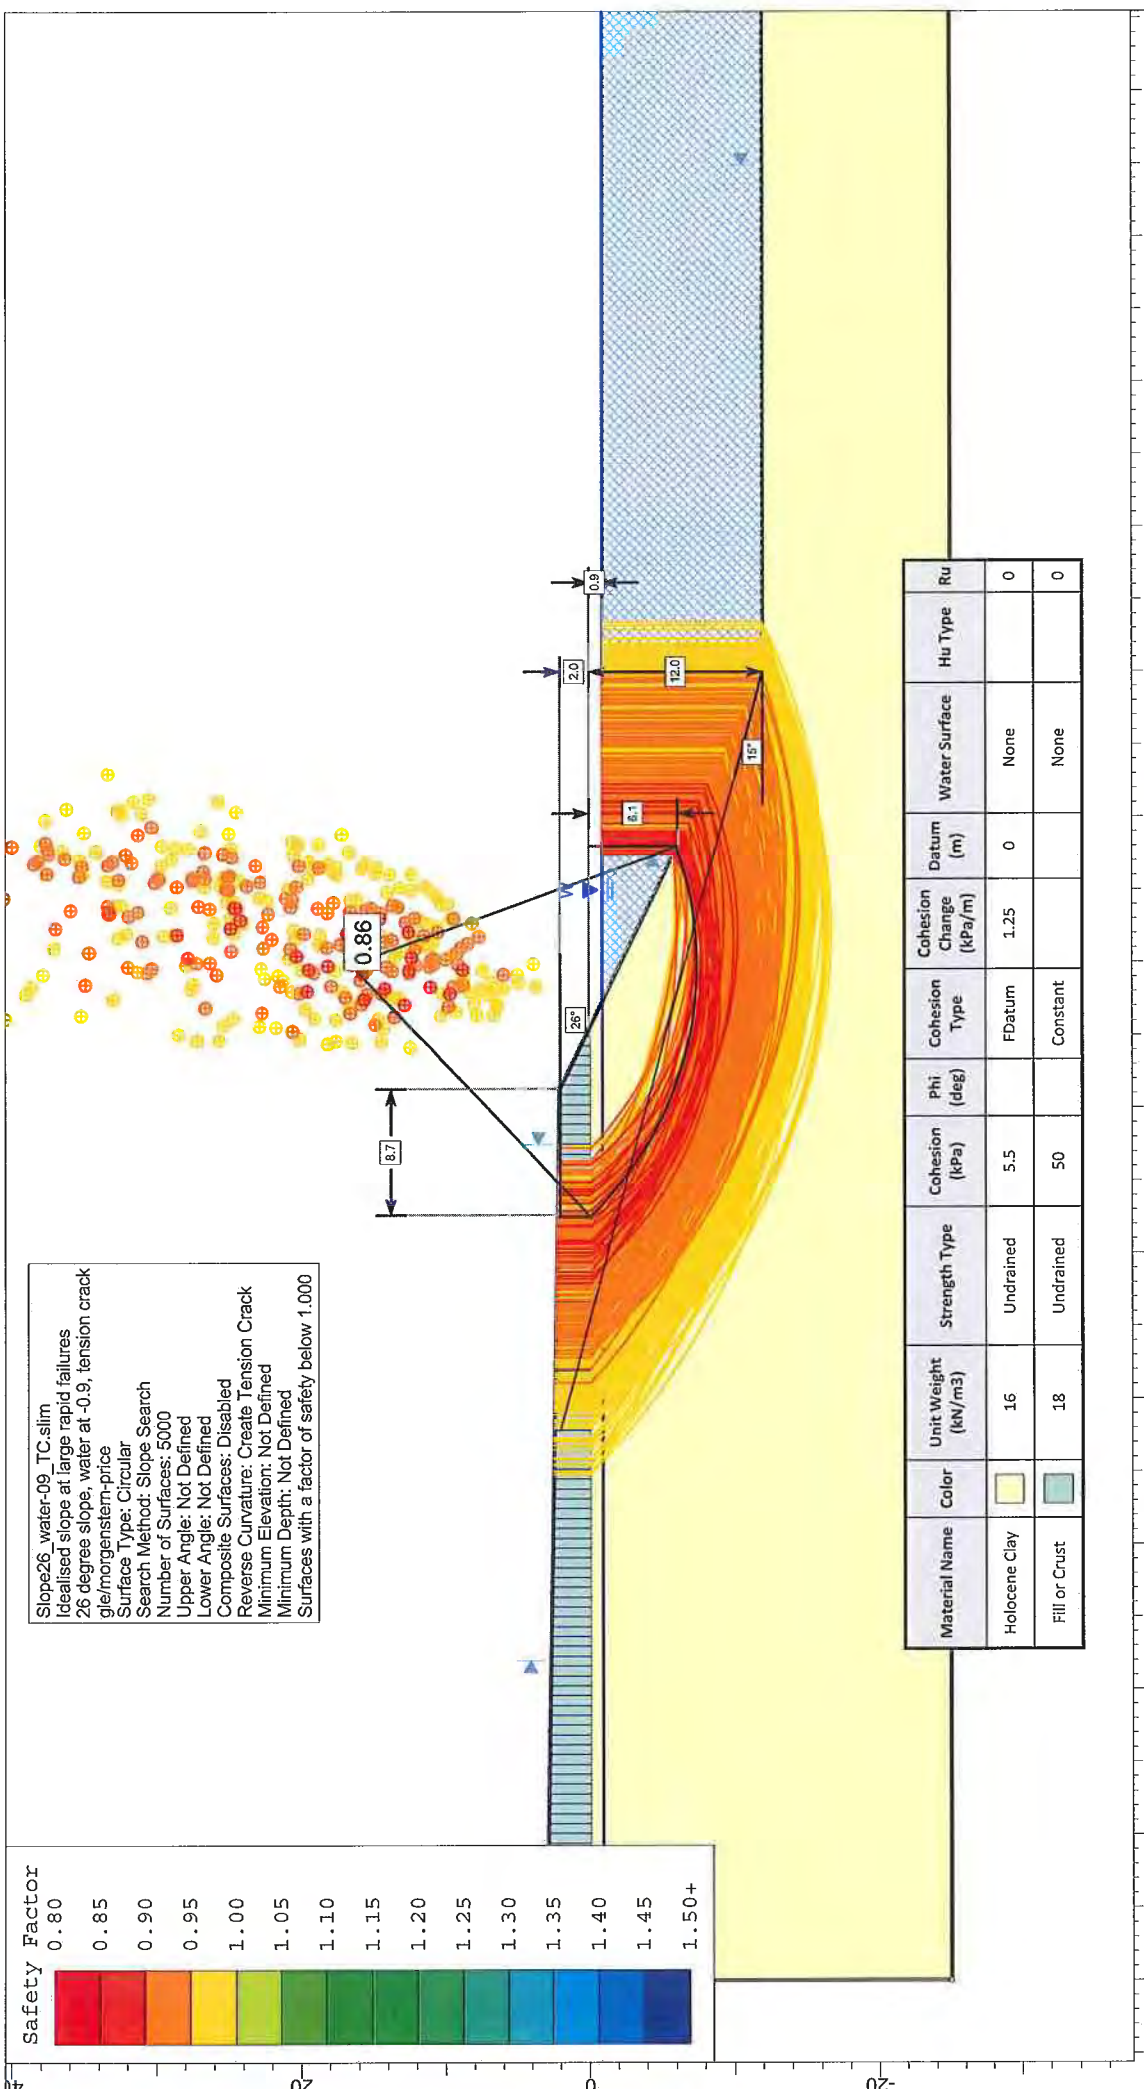
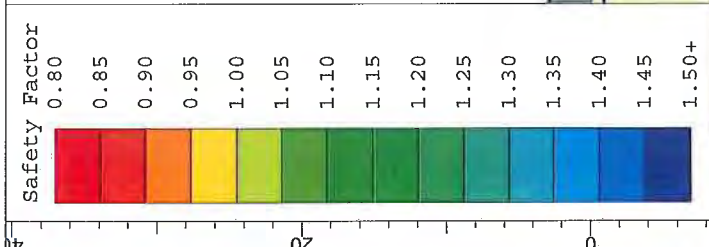
C7

- Non circular failure surfaces do not significantly alter the stability assessments.
- A tension crack in the crust/fill gives almost the same FOS as a drained crust.

- If undrained parameters without a tension crack are used the FOS is about 1.1. The development of a tension crack (relatively quick loss of strength) would give a good explanation for the onset of a sudden failure and large travel distances (which is consistent with the observations).

Idealised slope at large rapid failures
26 degree slope, water at -0.9, tension crack

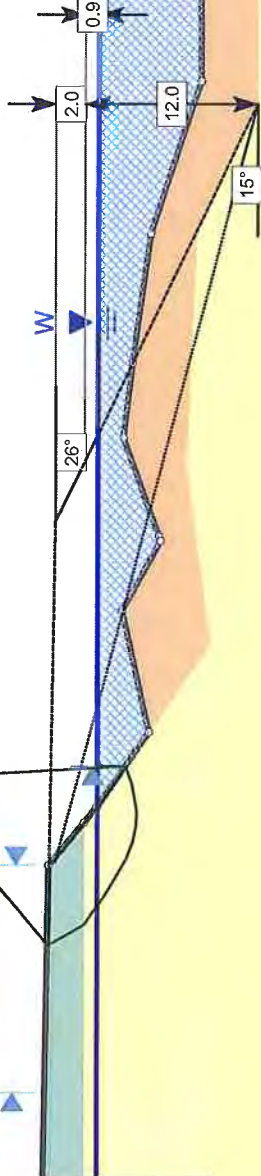
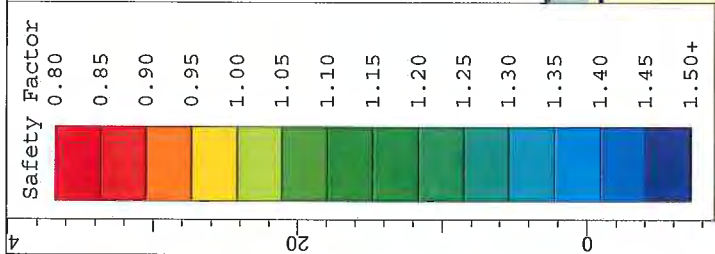
For the large collapses what almost certainly happens is a progressive failure of the riverbank. The initial failure creates a back scarp steeper than the original slope. After the initial failure (in some cases apparently only seconds or minutes after) the new back scarp fails and pushes the debris associated with the initial failure across the river. In the larger failures this process might be repeated several times.

Figures C13 and C14 (Appendix C) show two stages in the progressive failure process.

Author		RAD		Client: Coffey Geotechnics Pty Ltd	
Approved	Approved		Model of progressive failure final		Project:
Date	Date		Model of progressive failure final		Title:
Scale	Scale		26 degree slope, water at -0.9		
Orig Size	Orig Size		GEOTMEND07093AA-AB		fig no:
				C14

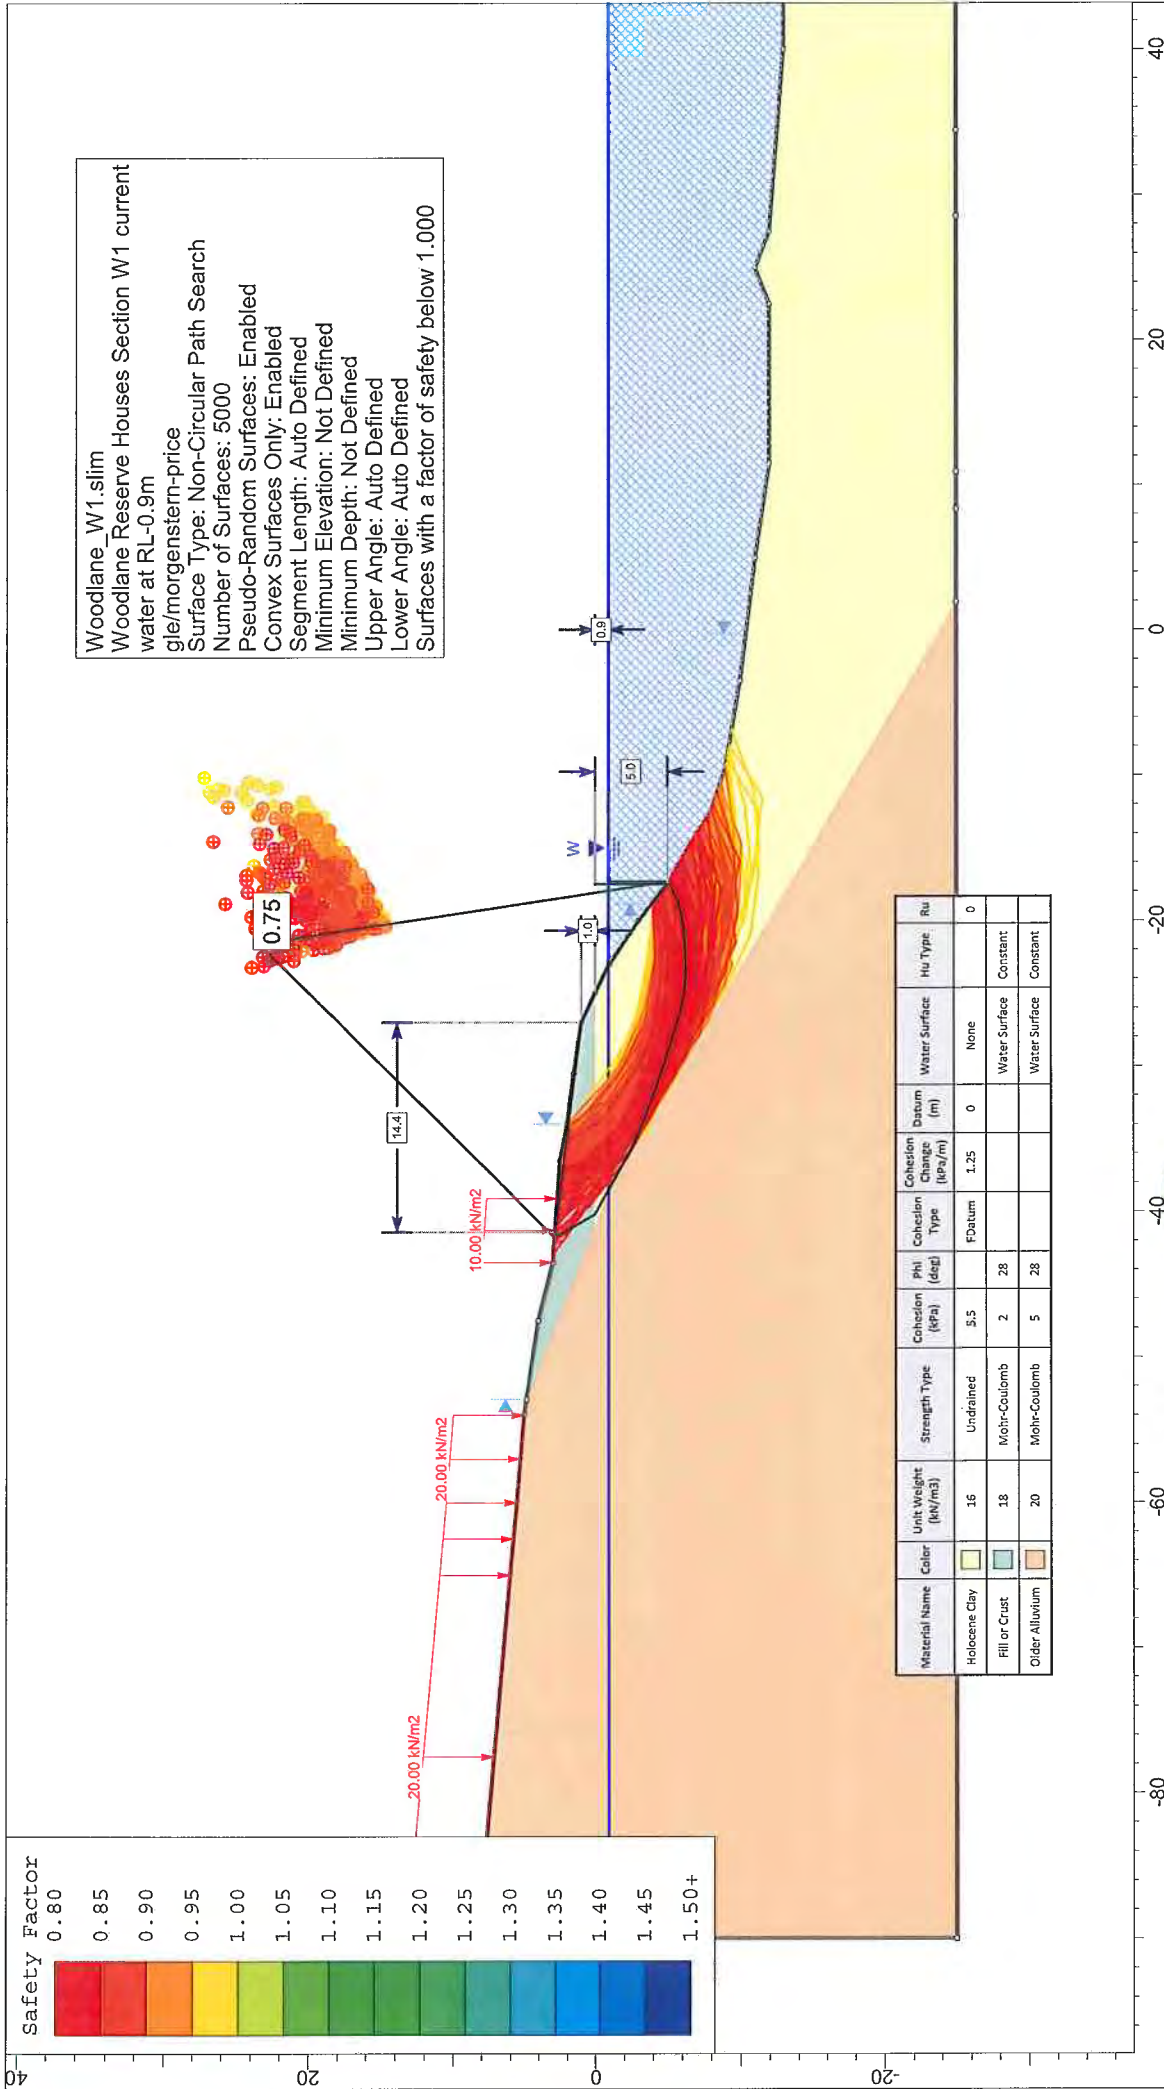
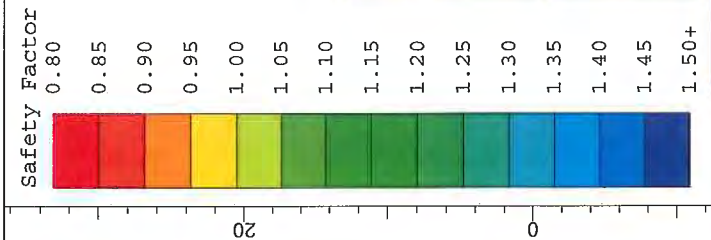
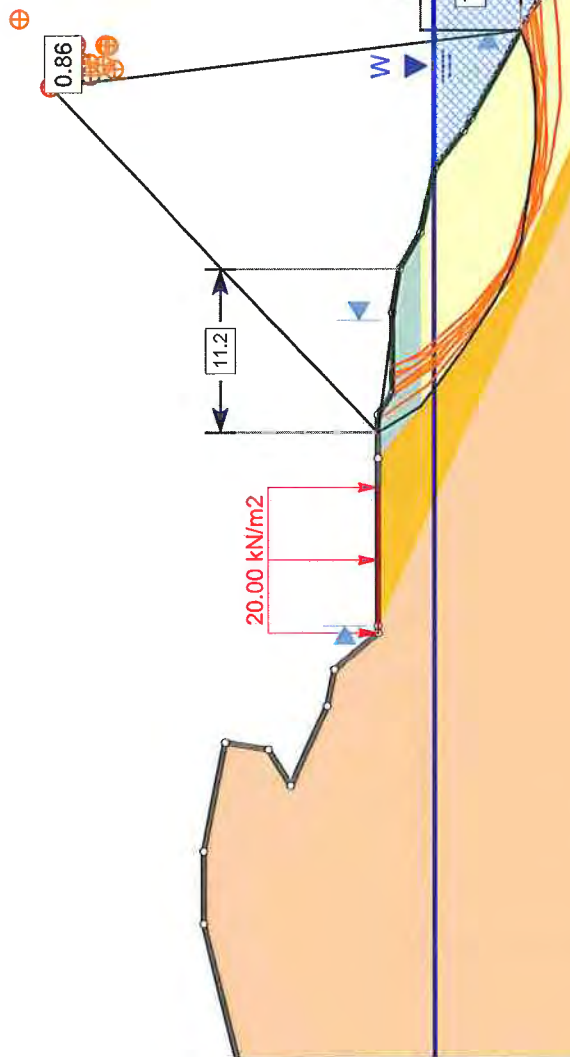
Client:	Coffey Geotechnics Pty Ltd
Project:	Woodlane Reserve Houses Section W1 current
Title:	Woodlane Reserve Houses Section W1 current water at RL-0.9m
doc no:	GEOTMEND07093AA-AB
fig no:	D8
