11 November 2010

## **River Bank Collapse Hazard - Lower River Murray Stability Risk Assessment for Caloote Landing**

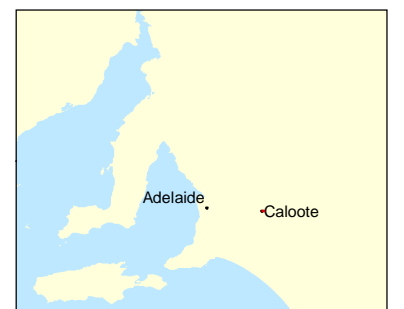
Figure 6 - Caloote Landing Site Management Plan for pool levels higher than 0.0m AHD

- The risks of failure at Car Park, Picnic Shelter and Northern Residential Areas are tolerable for pool levels above RL+0.0m AHD at Caloote. Mitigation requires application of ALARP principles. A suggested site design for managing access in these areas is shown in **Figure 6** attached.

Based on current water levels, which DFW advise are likely to persist for the next two years at above about +0.3m AHD, we have developed **Figure 6** attached as a proposed management plan, with permanent traffic control bollards, signage, pool water level gauge and relocated picnic shelter, to reflect the safety priorities shown on **Figure 5** and discussed above.

- To reduce risk to public safety, it is recommended that the picnic shelter to be relocated behind the grey/green line in **Figure 5**, as shown on **Figure 6**.

- Restrict parking to the area landside of the red line in **Figure 5** as shown by bollards on **Figure 6** in the immediate term, with the provision that when water level goes below 0.0 m AHD, more conservative precautions need to be put in place, reflecting the grey/green line on **Figure 5**;
