McLaren Vale Prescribed Wells Area

2018–19 groundwater status overview

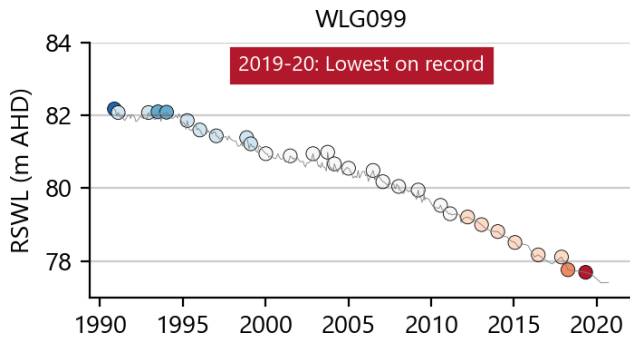
Water levels in Port Willunga Formation aquifer monitoring wells are mainly at 'lowest on record' levels in 2019

- All monitoring wells are at their lowest levels on record to the east of McLaren Vale, where the aquifer is unconfined and irrigation extraction is concentrated
- In the western part of the aquifer, where the aquifer is confined, groundwater levels are generally more stable and most wells recorded stable or rising five-year water level trends
- The figure below shows long-term groundwater levels in a well near McLaren Flat showing a gradual decline of water levels since the mid-1990s, which may be due to lower rainfall and sustained extraction of groundwater.

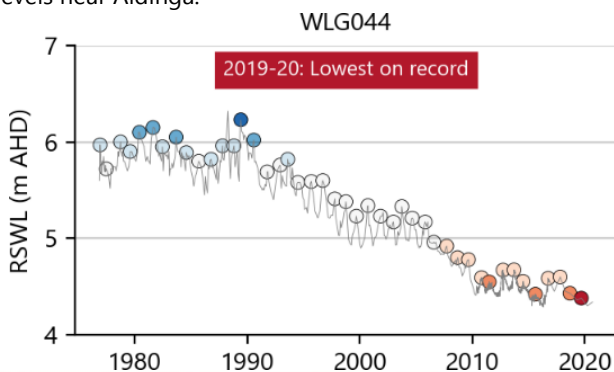
Pressure levels in Maslin Sands aquifer monitoring wells are mainly at 'average' to 'lowest on record' levels in 2019

- In the Maslin Sands aquifer, water levels in 31% of monitoring wells are at 'average' levels while 38% are at 'lowest levels on record'. Declines in water levels may be due to an extended duration of the pumping season following generally below-average rainfall during 2018–19. 50% of wells showed rising trends over the last five years
- In the period 2015–19, 75% of monitoring wells recorded rising or stable water levels
- The figure below shows a long-term decline in groundwater levels near Aldinga.

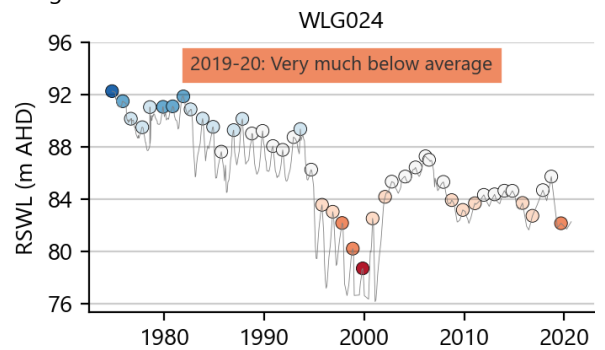
Water levels in fractured rock aquifer monitoring wells are mainly at 'average' to 'lowest on record' levels in 2019

- This is likely due to below-average rainfall during 2018–19. Groundwater levels in this aquifer are generally very responsive to rainfall patterns
- The figure below shows groundwater levels since monitoring began in 1974.

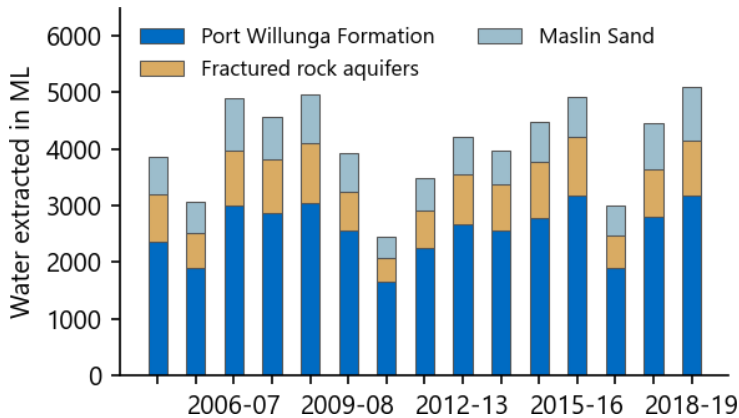
Total groundwater use (excluding stock and domestic use) in 2018–19 was 5096 ML, the highest since 2004–05

- Water use was higher than previous years due to irrigation demand; this is likely to be due to the lower-than-average summer rainfall
- Most of the groundwater extraction occurred from the Port Willunga Formation aquifer (62%), with 19% pumped from the Maslin Sands aquifer and 19% from the fractured rock aquifers.

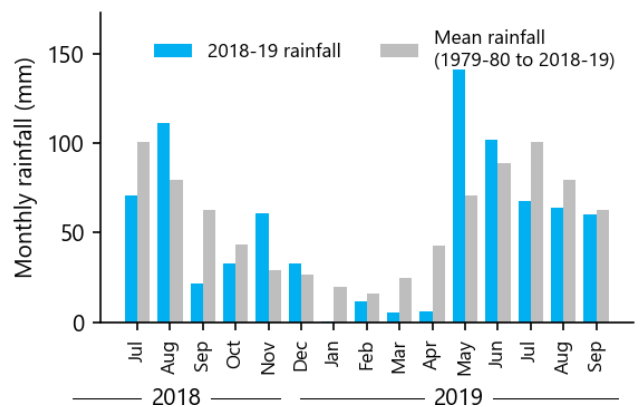
Rainfall was lower than average for 2018–19

- Rainfall at Willunga (597 mm) was marginally less than the long-term (1979–80 to present) average of 605 mm
- The long-term rainfall trend has been stable. There have been notable periods of above-average rainfall (e.g. 1992–93 and 2016–17) and below-average rainfall (e.g., 1982–86, 2007–09 and 2014–16)
- The annual rainfall in 2018–19 at Mount Bold Reservoir (613 mm) was significantly less than the long-term average of 804 mm
- Mount Bold Reservoir rainfall station has observed a marginally declining rainfall trend (-2 mm/y) over the long-term record (1979–80 to 2018–19)
- The figure below shows monthly rainfall at Willunga in blue for July 2018 to September 2019 compared to monthly averages in grey.
