McLaren Vale Prescribed Wells Area

2019–20 groundwater status overview

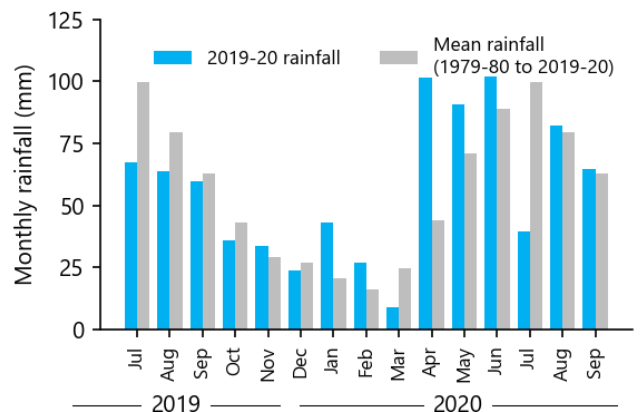
In 2019–20, rainfall was above average at Willunga and Mount Bold Reservoir

- In 2019–20, rainfall at Willunga (Bom station 23753) is 658 mm, which is 9% greater than the long-term average (1979-2020) of 606 mm.
- In 2019–20, rainfall at Mount Bold Reservoir (Bom station 23734) is 851 mm, which is 6% greater than the long-term average (1979-2020) of 807 mm.
- Monthly rainfall totals at Willunga (below) are shown for July 2019 to September 2020 (blue), relative to corresponding long-term monthly average (1979-2020) (grey).
