McLaren Vale Prescribed Wells Area

2020–21 Groundwater status overview

McLaren Vale PWA 2020–21 Groundwater status overview

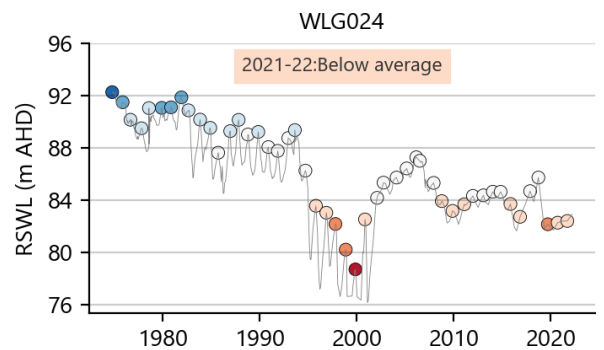
- The majority of monitoring wells (92%) show declining five-year water level trends.
- The figure below shows groundwater levels since monitoring began in 1974.

Water levels in the fractured rock aquifers are classified 'Average' in 47% of wells, and 'Below average' or lower in 41% of wells in 2021.

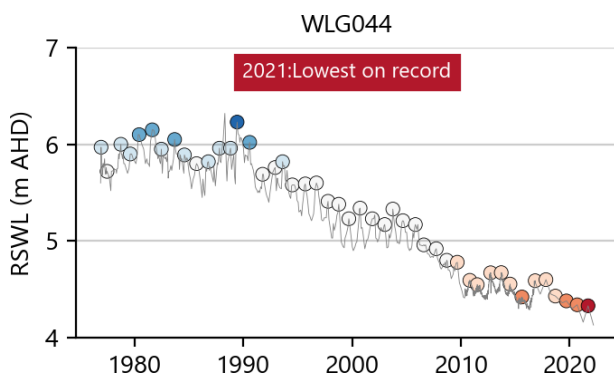
- In the Maslin Sands aquifer, water levels in 57% of monitoring wells are 'Below average' or lower.
- In the period 2017 to 2021, 81% of monitoring wells show declining water levels.
- The figure below shows a long-term decline in Maslin Sands groundwater levels near Aldinga.

Pressure levels in the Maslin Sands aquifer are mainly classified 'Average' to 'Lowest on record' in 2021.

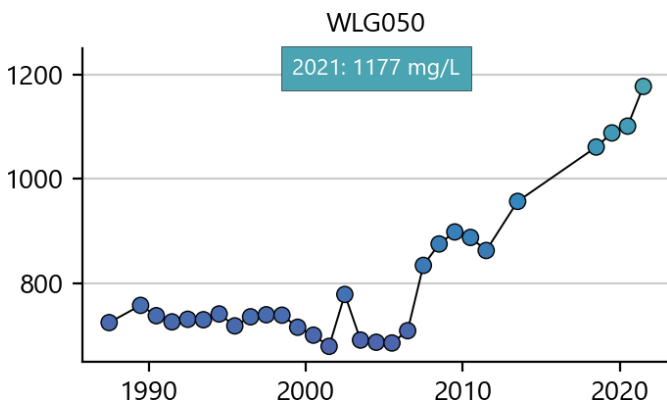
- 15-year salinity trends in the Port Willunga Formation aquifer are increasing in most wells (75%) with the median trend being an increase of 0.33%/year.
- 15-year salinity trends in the Maslin Sands aquifer are increasing in the majority of wells (66%) with the median trend being an increase of 0.20%/year.
- 15-year salinity trends in the fractured rock aquifers are increasing in the majority of wells (57%), with the median trend being an increase of 0.13%/year.
- Rising salinities occur toward the northern boundary of the Maslin Sands aquifer. These increases may be due to upward leakage of the saline groundwater from the underlying fractured rock aquifer (see example below).

In 2021, groundwater salinity from 244 wells ranges from 265 to 3,511 mg/L with a median of 1,086 mg/L.
