# McLAREN VALE PWA

## GROUNDWATER LEVEL AND SALINITY STATUS REPORT

2009–10

DEPARTMENT FOR  
WATER

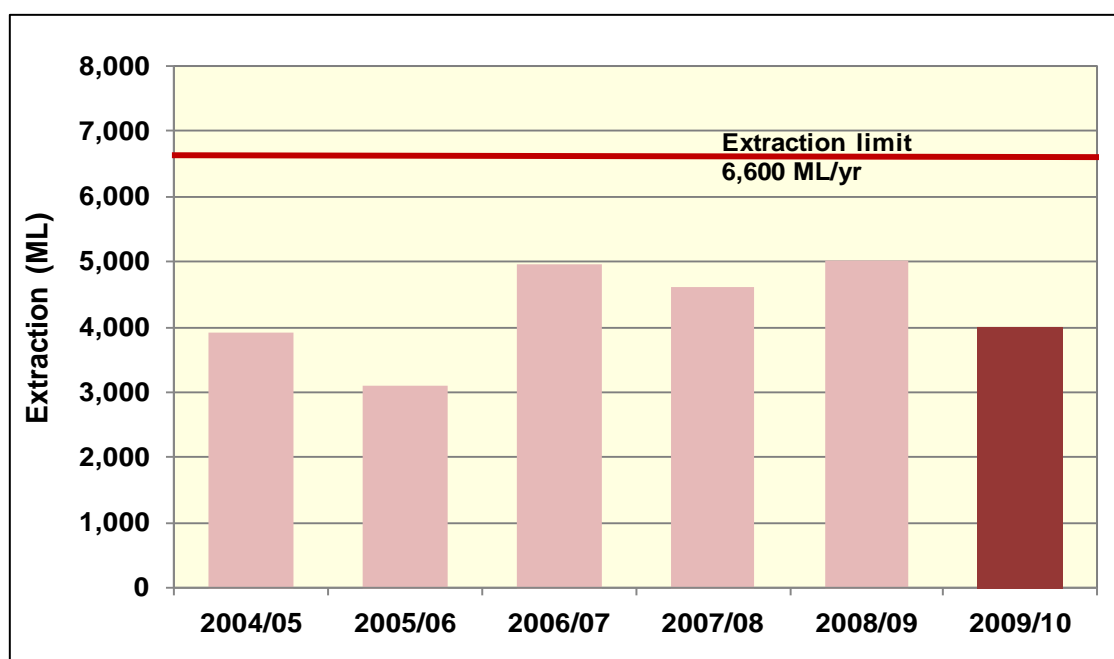
Figure 8. Historic licensed groundwater use in the McLaren Vale PWA

Groundwater extractions (excluding stock and domestic use) in the McLaren Vale PWA for 2009–10 totalled 3990 ML, which represents a reduction of 20% from the previous year and is well below the extraction limit of 6600 ML (Fig. 8). This reduction is probably due to above-average rainfall. Most of the groundwater extractions (65%) occur from the Port Willunga Formation Aquifer (PWF), with 18% pumped from the Maslin Sands Aquifer (MSA) and 17% from the Fractured Rock Aquifer (FRA) whilst the remainder is extracted from the Quaternary and Blanche Point Formation aquifers (Fig. 9). Groundwater is used primarily for the irrigation of vines.

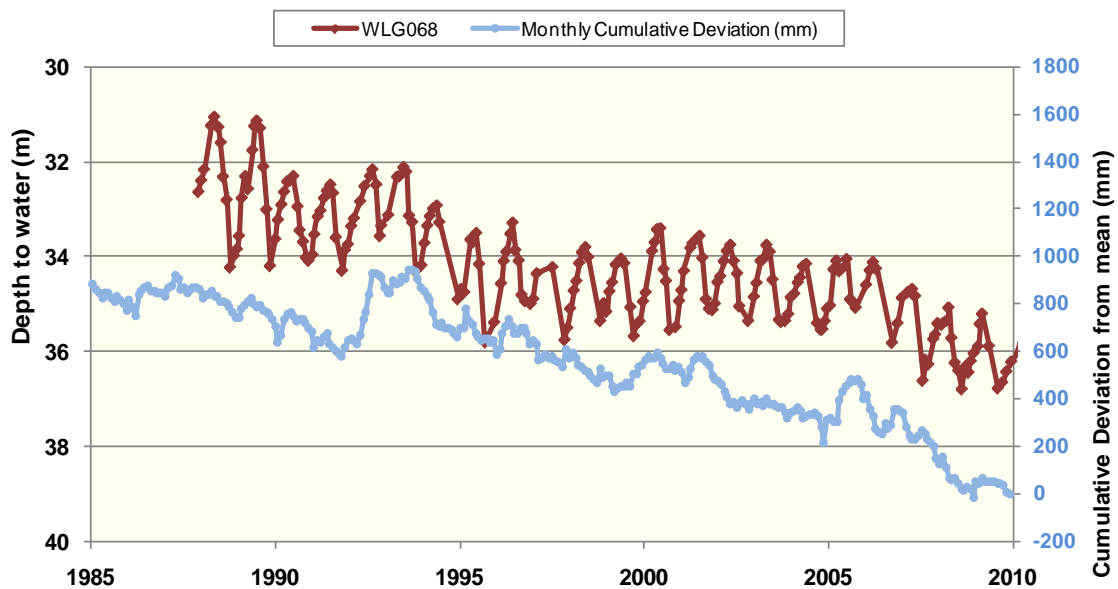
**Figure 14.** Comparison of rainfall deviation from the mean and groundwater level trends of the PWF Aquifer in the McLaren Vale PWA

Although the Port Willunga Formation is a confined aquifer, the observed groundwater levels largely follow the rainfall trends which show the close relationship between levels in WLG068 and the cumulative deviation from mean monthly rainfall recorded at Willunga (Fig. 14). Following the wet period in 1992–93, groundwater levels have reflected the long interval of below-average rainfall that has occurred since then.

An exception to this trend can be seen by well WLG088 which shows stable groundwater levels and is representative of other wells located toward the coast where the Port Willunga Formation aquifer discharges and where there is little pumping.
