7 July 2010

Document No. 107662007 005 L Rev1

**LANDSLIDE RISK MANAGEMENT, EAST FRONT ROAD,
MANNUM TO YOUNGHUSBAND, RIVER MURRAY, SOUTH AUSTRALIA**

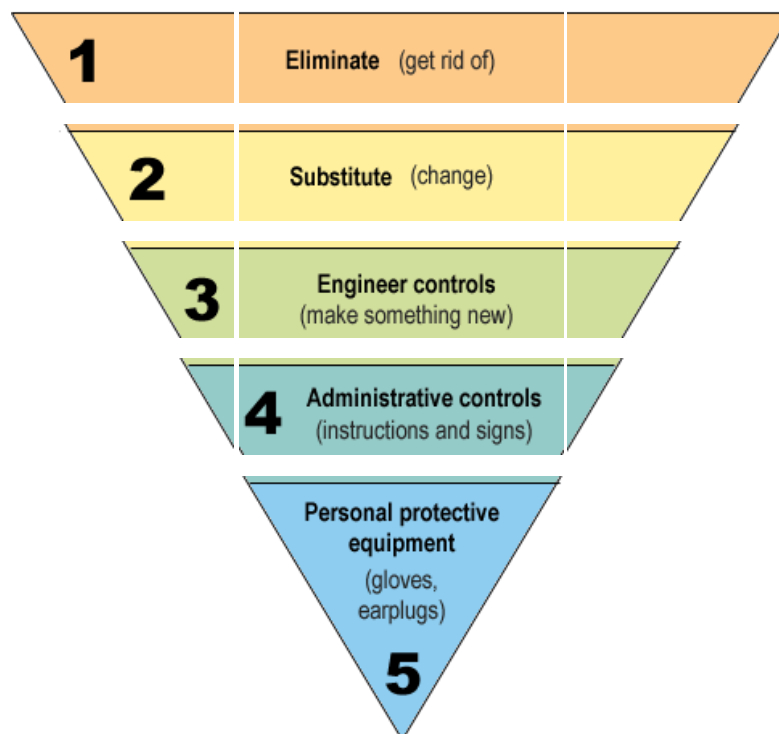
The following diagram (taken from the Safework SA website) shows the hierarchy of control for managing practically any risk. The hierarchy indicates which control measures are conceptually more desirable than others.

Some preliminary options for managing the landslide risks along East Front Road are discussed below with reference to the hierarchy of control.
