Barossa Prescribed Water Resources Area Fractured rock aquifers

2018 Groundwater level and salinity status report

2018 Status summary Barossa PWRA Fractured rock aquifers

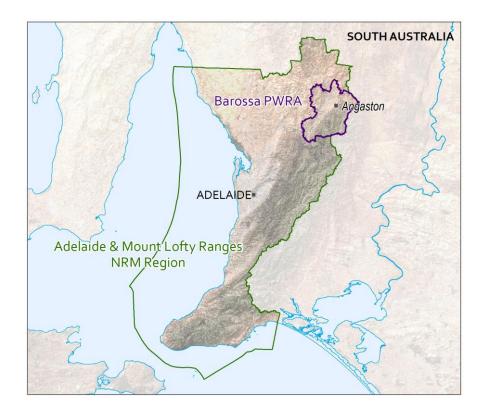
Regional setting

The Barossa PWRA encompasses both the highland areas of the Mount Lofty Ranges and the Barossa Valley. It is located approximately 60 km north-east of Adelaide and lies within the Adelaide and Mount Lofty Ranges Natural Resources Management Region. It is a regional-scale resource for which groundwater, surface water and watercourse water are prescribed under South Australia's *Natural Resources Management Act 2004* and a water allocation plan provides for their sustainable management.

The Barossa PWRA consists of three major groundwater systems: two sedimentary aquifers (Upper and Lower) and the FRAs that underlie the sedimentary aquifers and crop out in the ranges to the east and west of the valley. The FRAs of the Barossa PWRA is the focus of this report.

Groundwater flow within the FRAs generally follow topography, flowing from higher elevations of the Mount Lofty Ranges to lower areas within the valley, with some groundwater discharge occurring to streams and the sedimentary aquifers.

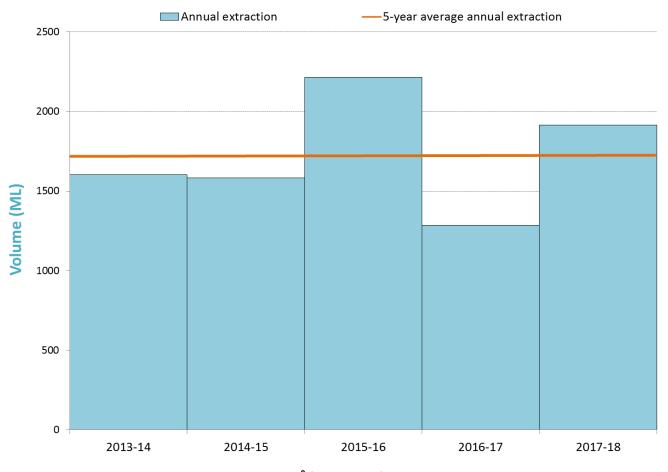
Figure 2. Annual and monthly rainfall for the past five water-use years recorded at Tanunda (BoM Station 23318)⁷

See Figures 1 and 2

Rainfall station	The Tanunda Bureau of Meteorology (BoM) rainfall station, number 23318, is located near the township of Tanunda which is in the western part of the Barossa PWRA.
Annual total ¹	475 mm
	62 mm (12%) less than the five-year average of 537 mm
	70 mm (13%) less than the long-term (1900–2018) average of 545 mm
Groundwater extraction See Figure 3	
Allocated volume ^{1,2}	7862 ML across all aquifers (Upper, Lower and fractured rock)
Licensed groundwater extractions ^{1,3}	1914 ML from the fractured rock aquifers
Extraction volume comparison ⁴	49% greater than the previous year
Extraction volume comparison	4570 greater than the previous year
