SA River Murray Flow Report

Report #14/2023

Issued 10:00 am 6 April 2023

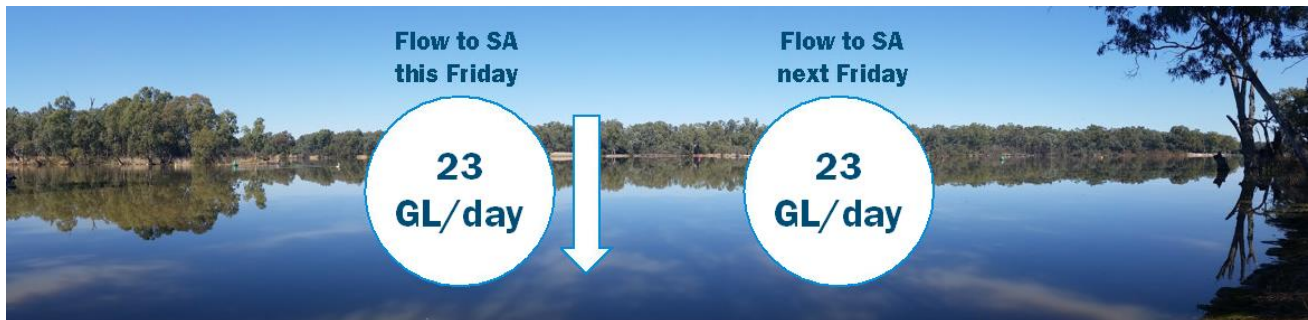
The flow at the South Australian border is approximately 23 GL/day and is forecast to remain around 23 GL/day over the coming week. The current flow at the border comprises:

The flow over Lock 1 is approximately 22 GL/day and will decrease to around 21 GL/day over the coming week.
