SA River Murray Flow Report

Report #40/2023

Issued 12:00 pm 6 October 2023

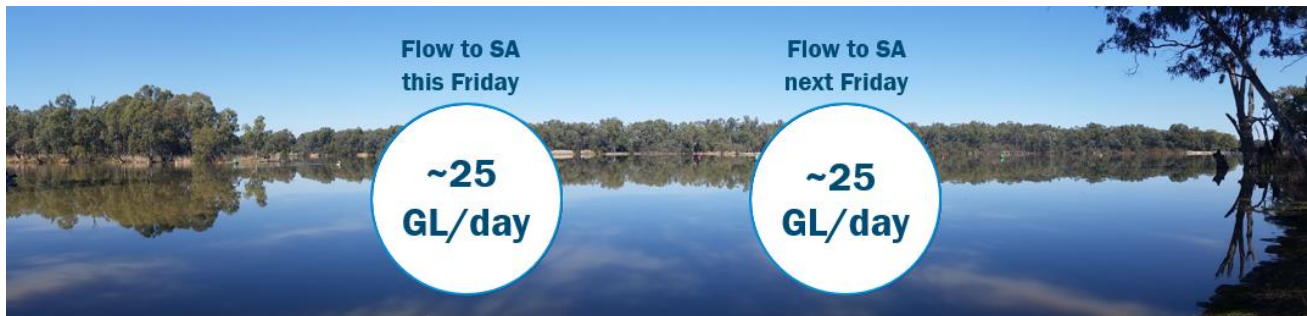
The flow at the South Australian border is approximately 25 GL/day and will remain around 25 GL/day over the coming week **depending on river operations**.

The flow over Lock 1 is approximately 23 GL/day and will increase to around 24 GL/day over the coming week.

The current flow at the border comprises the full October Entitlement Flow (5.5 GL/day) plus Additional Dilution Flow (ADF), water for the environment and interstate trade adjustments.
