SA River Murray Flow Report

Report #41/2023

Issued 12:00 pm 13 October 2023

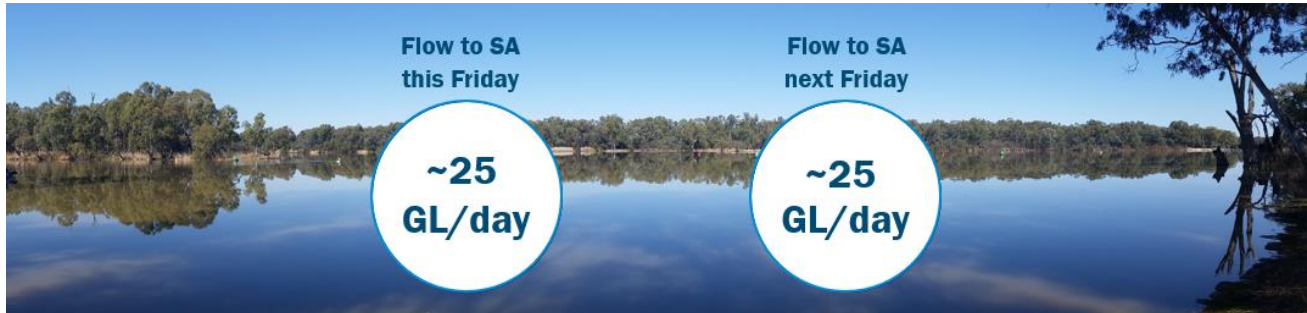
Flow outlook

The flow at the South Australian border is approximately 25 GL/day and will remain around 25 GL/day over the coming week **depending on river operations**.

The current flow at the border comprises the full October Entitlement Flow (5.5 GL/day) plus unregulated flow, Additional Dilution Flow (ADF), water for the environment and interstate trade adjustments.

The flow over Lock 1 is approximately 25 GL/day and will decrease to around 24 GL/day over the coming week.
