SA River Murray Flow Report

Report #46/2023

Issued 12:00 pm 17 November 2023

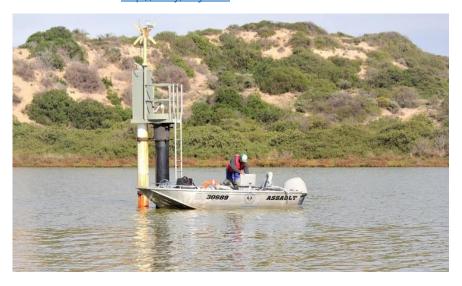
Photo 1: Water quality monitoring stations are located throughout the Coorong and Lower Lakes. Photo credit: DEW.
