SA River Murray Flow Report

Report #44/2023

Issued 12:00 pm 3 November 2023

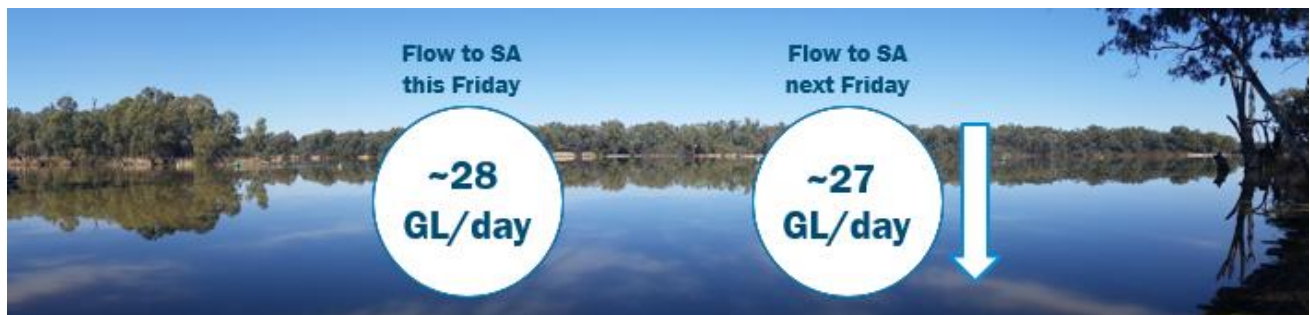
Flow outlook

The flow at the South Australian border is approximately 28 GL/day and will decrease to around 27 GL/day over the coming week **depending on river operations**.

The current flow at the border comprises the full November Entitlement Flow (6 GL/day) plus unregulated flow, water for the environment and interstate trade adjustments.

The flow over Lock 1 is approximately 26 GL/day and will remain around 26 GL/day over the coming week.
