# SA River Murray Flow Report

Report #46/2024

Issued 1:30 pm 15 November 2024

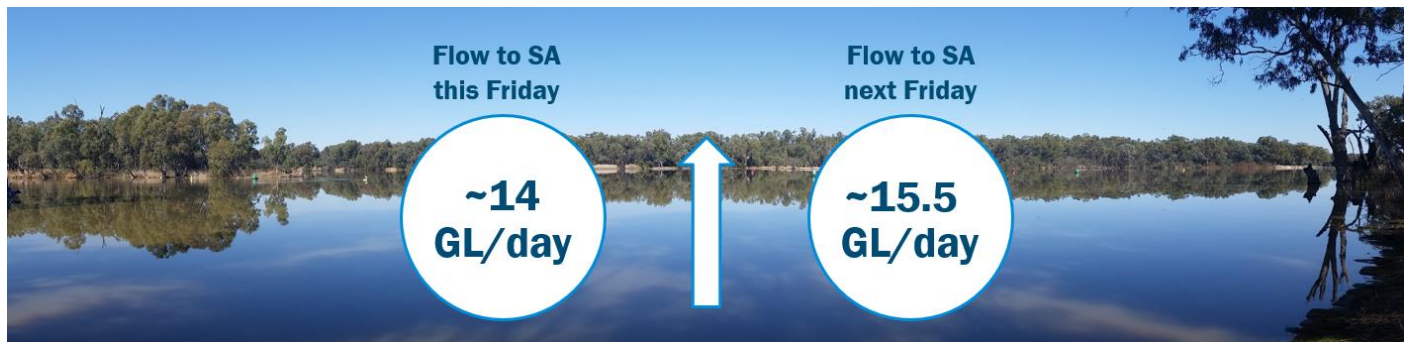
The flow at the South Australian border is approximately 14 GL/day and is expected to increase to approximately 15.5 GL/day by next Friday, **depending on river operations**.

The flow over Lock 1 is currently approximately 12 GL/day, but it is expected to increase to 13 GL/day by next Friday. It is important to note that flow forecasts in this advice are based on the information available at the time of preparation. Advice may change as new gauging information becomes available or due to rainfall events or changed operations upstream.

Flows at the South Australian border are expected to rise to a peak of approximately 15.5 GL/day by the end of November, driven by environmental water releases from the Goulburn, Campaspe, Broken and Murrumbidgee River systems, noting that flow forecasts may be subject to change dependent on river operations and catchment rainfall.
