SA River Murray Flow Report

Report #27/2025

Issued 12 pm 4 July 2025

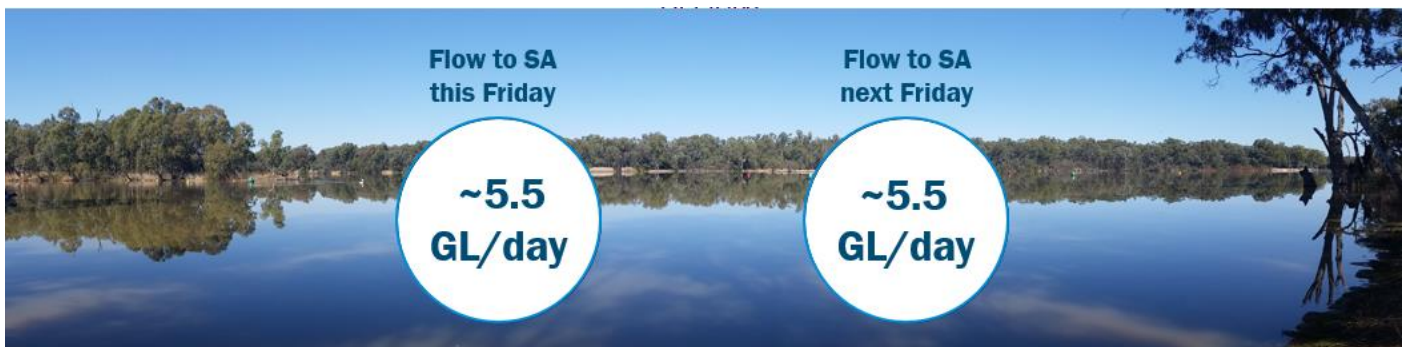
Flow outlook

The flow at the South Australian border is approximately 5.5 GL/day and is expected to remain at that flow rate to next Friday.

The flow over Lock 1 this Friday is approximately 4.5 GL/day and is expected to increase to 5.0 GL/day by next Friday.
